## Whole Body Vibration Exposure and Seat Effective Amplitude Transmissibility of Air Suspension Seat in Different Bus Designs

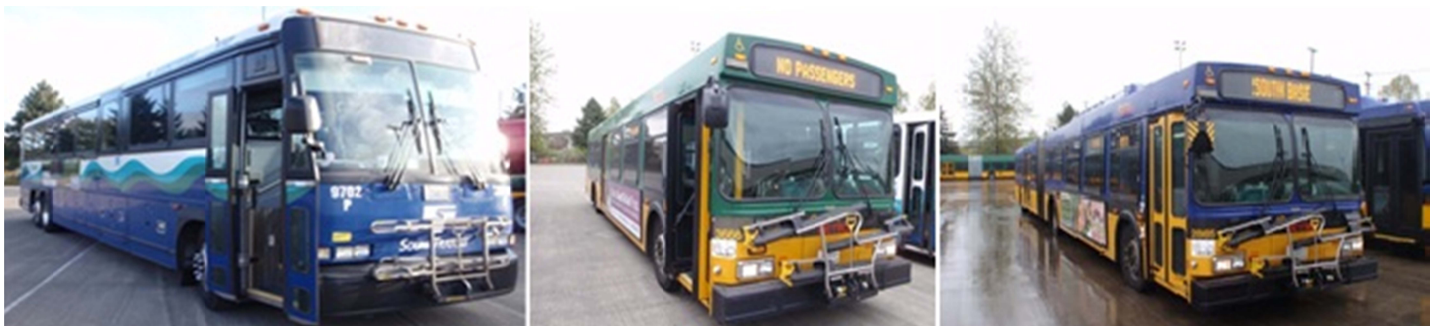
Figure 1 - high-floor coach bus (left), low-floor coach bus (middle), and low-floor articulating bus (right)

**Vehicles.** The experiment was conducted on a 13.9-meter-long, 5-year-old, high-floor coach bus (Model D4500; Motor Coach Industries Inc; Winnipeg, Manitoba, Canada), a 12.2-meter-long, 11-year-old, low-floor coach bus (Model D40LF; New Flyer; Winnipeg, Manitoba, Canada) and an 18.3-meter-long, 11-year-old, low-floor articulating bus (Model D60LF; New Flyer;

Winnipeg, Manitoba, Canada). These buses had different suspension systems. That is, the suspension system in low-floor coach and articulating buses has limited travel and was designed for rapid passenger entry and exit, whereas the suspension system in high-floor coach bus had a greater range of travel and was designed for longer haul travel.
