# **Moving Longwall Shield Supports at York Canyon Coal Mine, Raton, N. Mex.**

**Bureau of Mines Information Circular/1977**

By Richard H. Oitto, David W. Wisecarver, and William E. Sikes

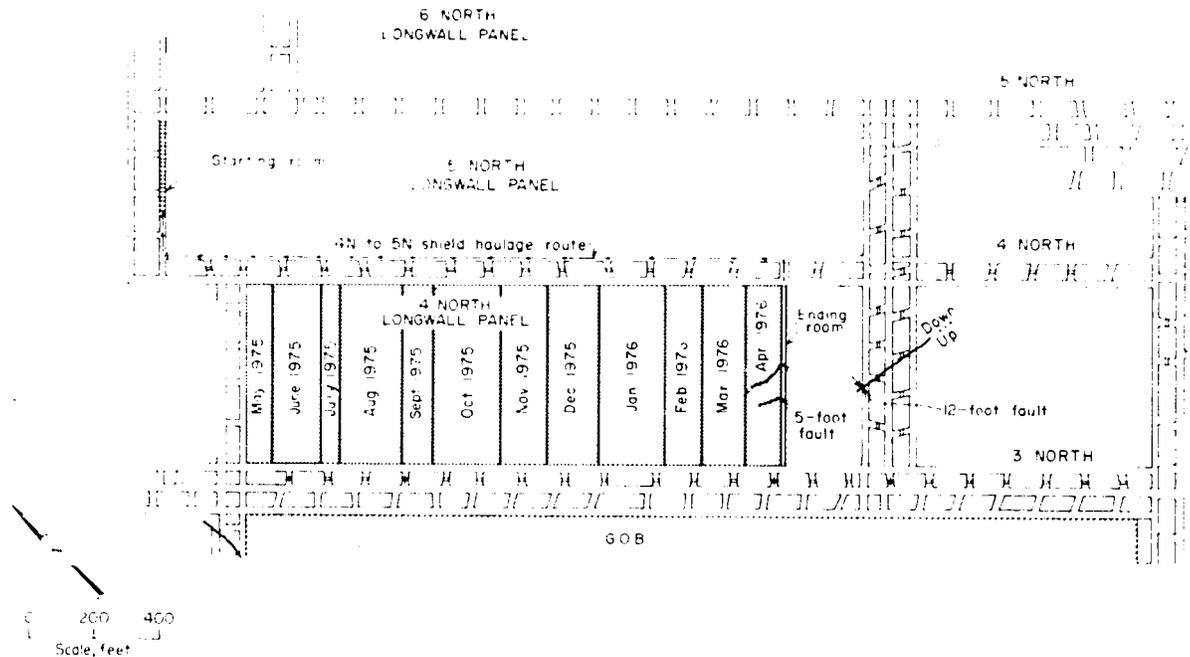
FIGURE 1. - Longwall shield support test site at York Canyon underground coal mine.

The program includes mining of three longwall panels at the York Canyon mine with planned production of about 1,200,000 tons of raw coal. Panel layouts are given in figure 1. Panel 4N, now completed, had a face length of 550 feet. The panel length of 4N was shortened because two faults were intercepted, each of which had 5 feet of displacement at the final 4N face. Mine management knew that one fault might be encountered and that it had a

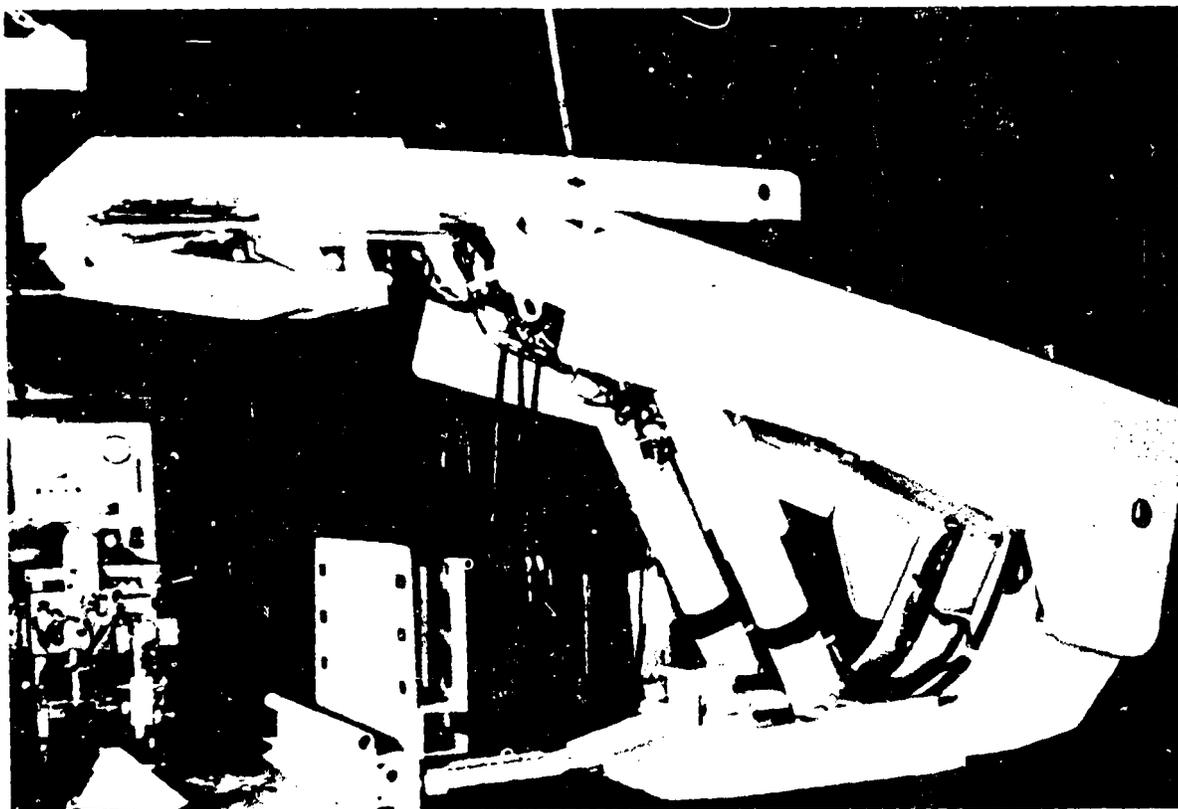
FIGURE 2. - Hemscheidt 320 HSL two-legged shield support.

The 4N longwall support system had 116 shield supports of the type (Hemscheidt 320 HSL)<sup>4</sup> illustrated in figure 2. This support is a caliper shield type wherein (1) hydraulic or spring-actuated side sealing plates are used to provide skin-to-skin contact and reduce flushing of gob between the supports and (2) the canopy moves in a circular arc about the main hinge point as it is raised or lowered. Width of the supports is 59 inches. Maximum height is 142 inches, and closed height is 59 inches. Weight is about 11-1/2 tons.

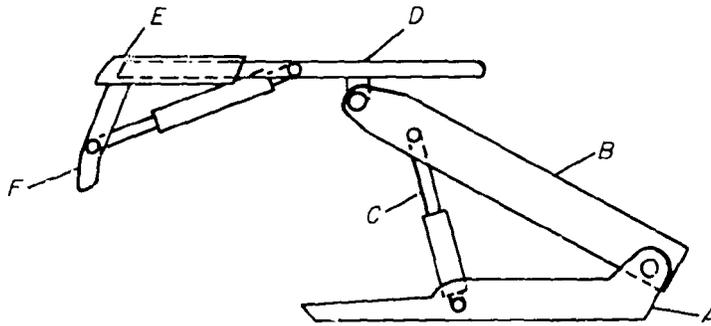
| A | Split base skid | D | Roof canopy |
| B | Gob shield | E | Extensible roof canopy |
| C | Support leg (2) | F | Face guard |

FIGURE 3: - Diagrammatical view of the caliper shield.

Major and basic parts of the caliper shield are shown in figure 3. The base (A) is a twin-beam articulated arrangement where one beam can be lifted relative to the other, a feature which facilitates self-cleaning; through alternate raising and blocking, raising of the entire shield can be accomplished. The gob shield (B) links the base and canopy and is attached by heavy pins; the angled gob shield provides protection from and support of the gob. The two hydraulic legs (C) have a support capacity of 176 tons each,

are double acting, and are equipped with mechanical extensions to enhance operation and increase range. A roof canopy (D) linked to the gob shield, covers the work area and transfers roof load to gob shield and support base. Additions and/or accessories to the roof canopy are the extension (E) and the face guard (F). The canopy extension has 20 inches of travel and permits the operator to adjust the canopy tip to the face as seam height changes. The face guard can be placed against the face to provide support and protection against coal bumps and falls. It is also useful in the overhead installation of wire mesh. Hydraulic components such as rams, valves, and control blocks round out the complete shield.

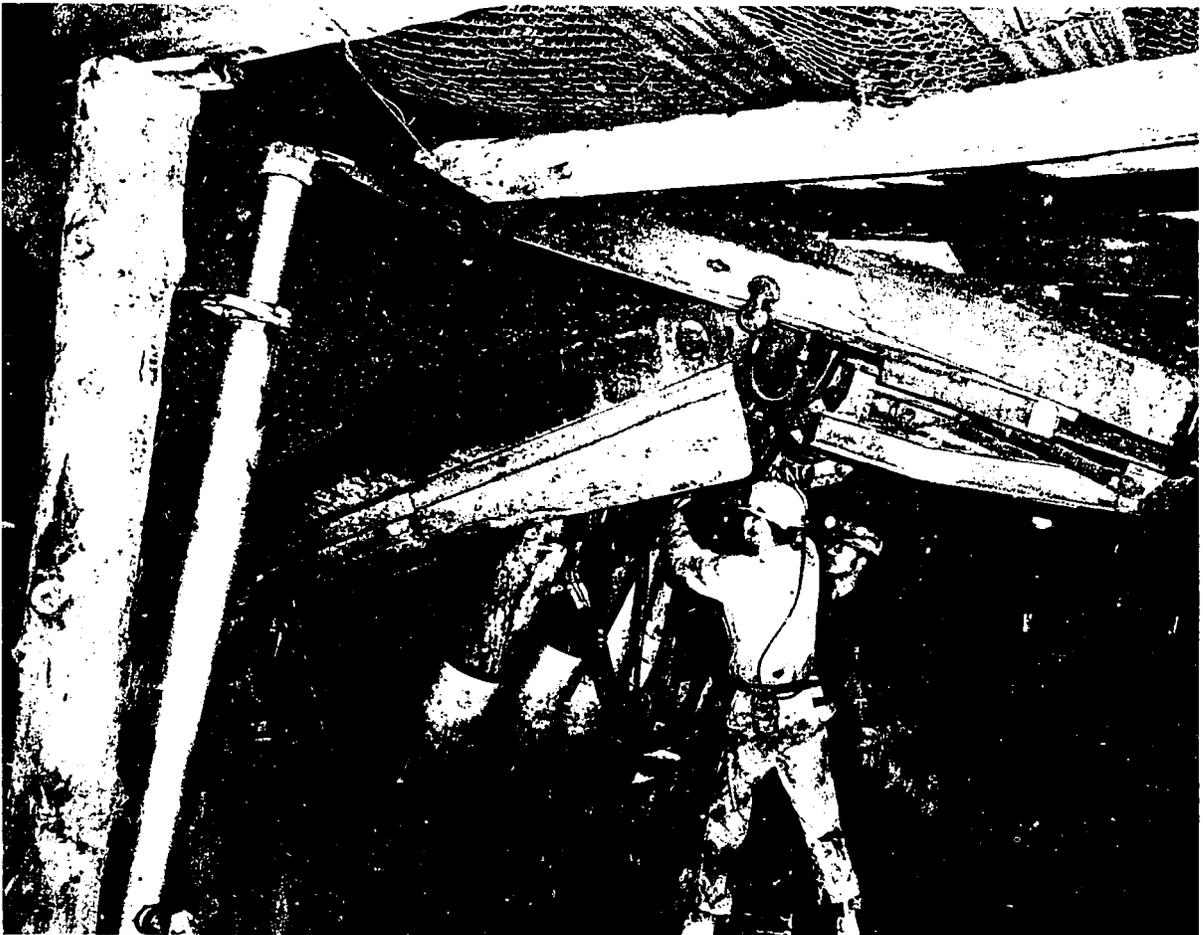
FIGURE 5. - Shield with roof canopy lowered free from roof.

2. Moved split rings (collar) for regulating leg travel to top set of grooves on leg extensions so that shield legs could be retracted to minimum mining height. Lowered shield until roof canopy was free from roof (fig. 5).

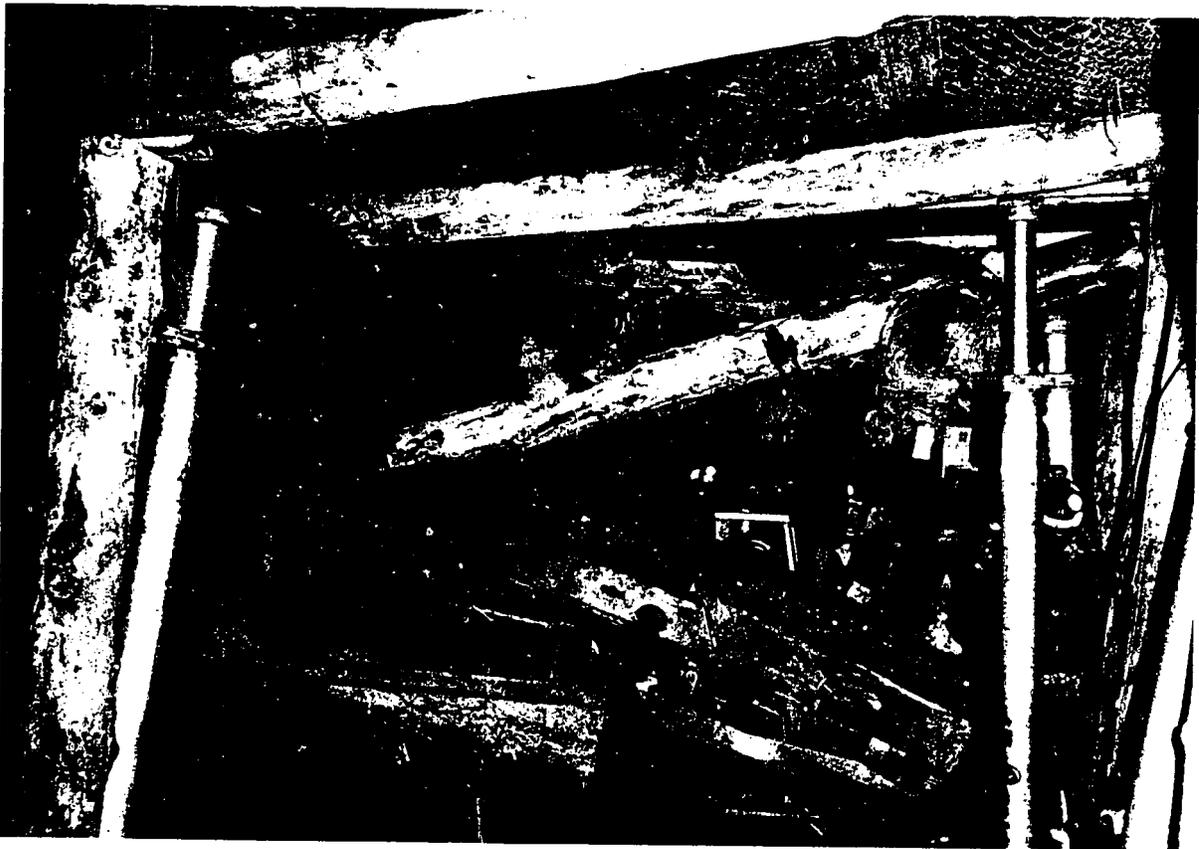
FIGURE 6. - Installing wooden crossbar over lowered shield.

6. Retracted roof canopy extension and pinned it in place.
7. Lowered shield to lowest mining height.
8. Using the roof canopy as a work platform, replaced the post-plank set with a 1-foot-diameter wooden crossbar over the shield extending from the face to the gob (fig. 6). A single hydraulic prop placed near the face end of the crossbar pivoted the crossbar and held it against the roof.

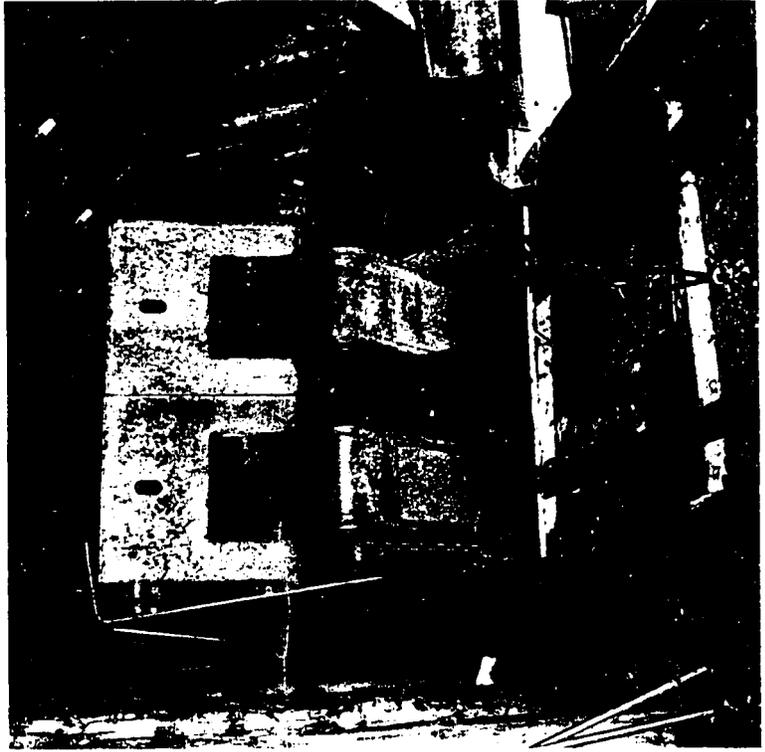
FIGURE 10. - Shield chained to sled ready for pulling to headgate.

18. Unchained sled, chained shield to sled using boomers (chain tighteners) to tighten chains, attached headgate hoist rope to sled (fig. 10), and pulled shield to dock at headgate (fig. 11). A worker followed the loaded sled to stop the hoist operator should the shield or sled hang up enroute. The tailgate hoist rope was pulled by the sled to the headgate for returning the sled.

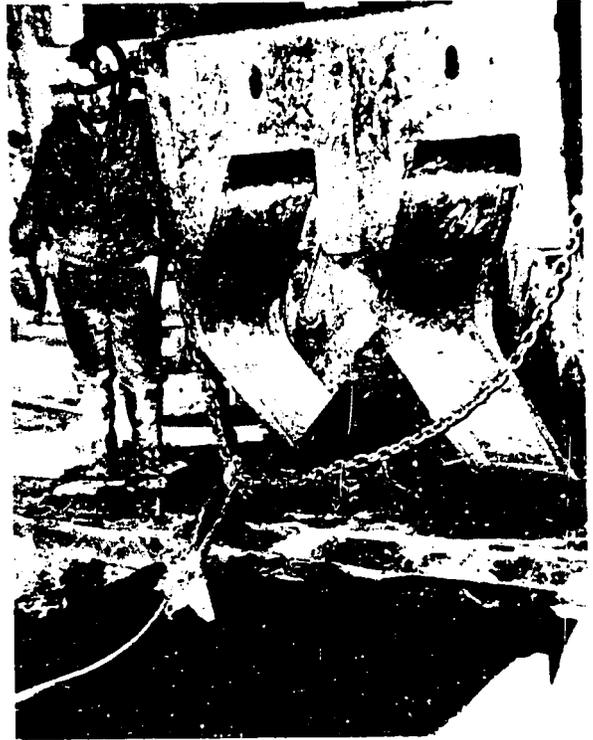
FIGURE 12. - Shield ready for pulling from sled onto trailer.

19. Unchained shield from sled, chained sled to track, and pulled shield onto low-bed trailer using headgate hoist (figs. 12 and 13).

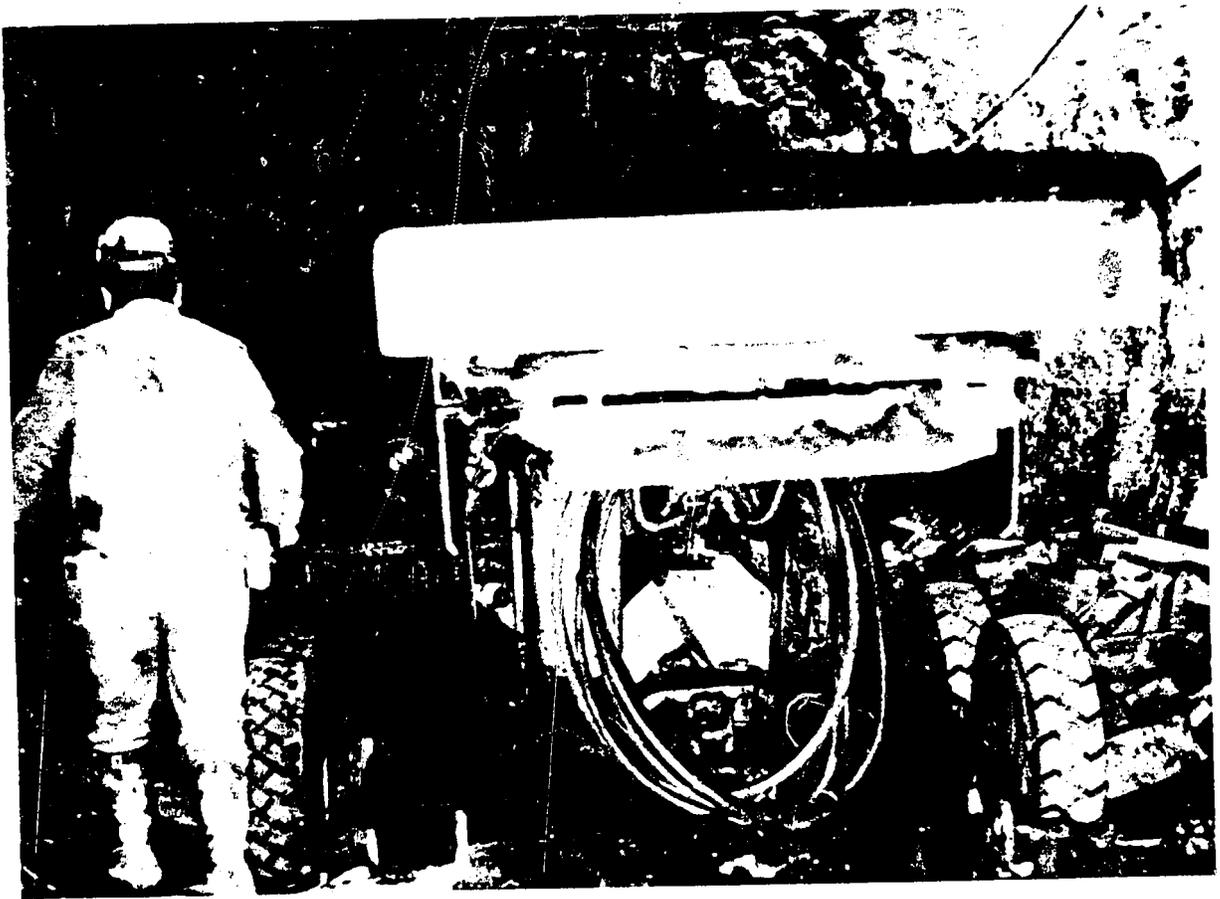
FIGURE 13. - Shield loaded on trailer.

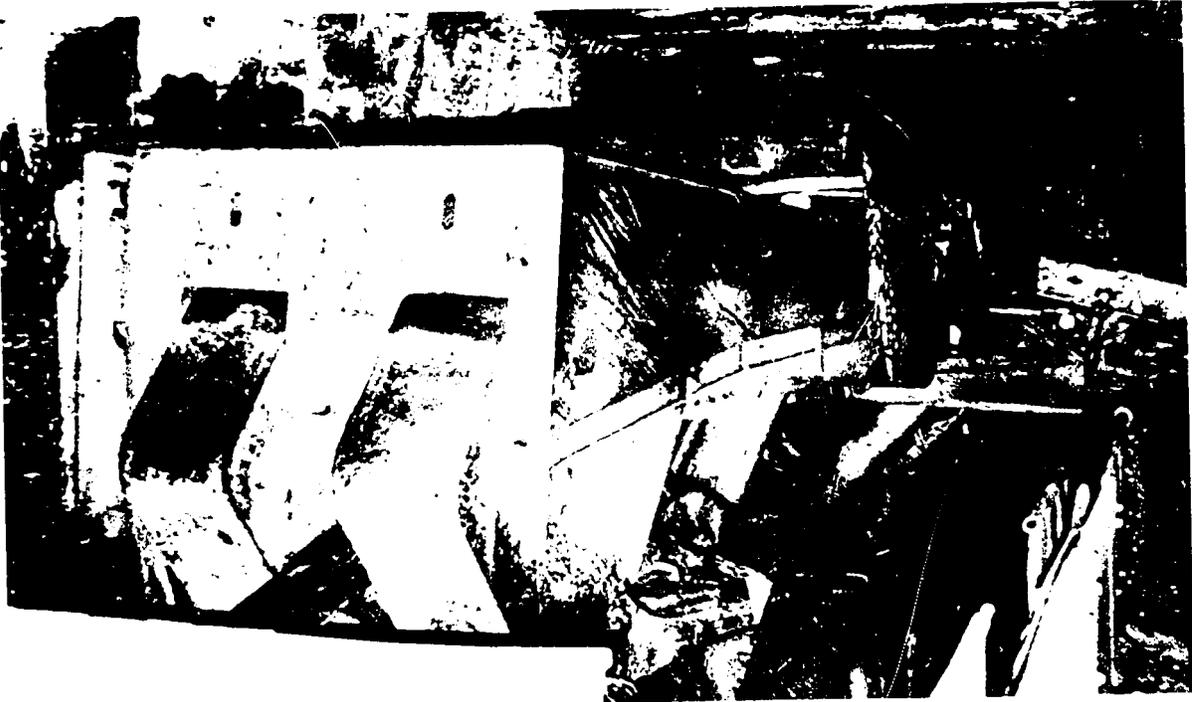
FIGURE 15. - Shield and trailer being backed into starting room.

After the conveyor panline was in place, the shield supports arrived directly from the old face, except, of course, the excess shields not needed at the new, shorter face, which were hauled elsewhere. The trailer hauling a shield was backed into the starting room (fig. 15) from the tailgate end to the spot where the shield was to be installed and was backed up to the panline at the sharpest angle obtainable, about 45°. The shield was unchained from the trailer, chained to the panline, and pulled off the trailer by jerking the trailer out from under it with the scoop tram.

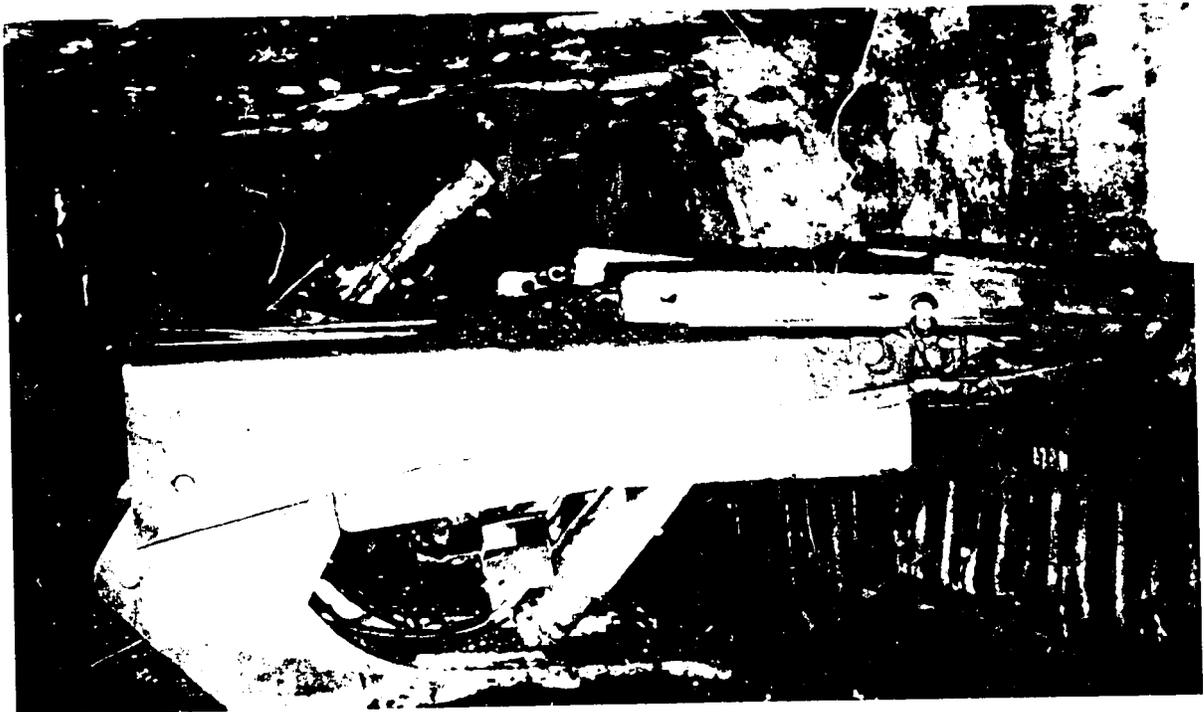
FIGURE 16. - Shield normal to panline at new face.

To move a shield perpendicular to the panline from its 45° angle, first a scoop tram nudged it around until the shield was approximately normal to the panline (fig. 16) and opposite the clevis on the panline to which its ram-connecting rods would be connected. Then the chains, wire, and pins holding the ram-connecting rods, side plate, roof canopy, and canopy extensions in place were removed; the hydraulic hoses were connected to the shield alongside; and the shield was extended upward part way to make room for working under the roof canopy. A spare hydraulic pack powered the shields since the hydraulic pack at the old face was needed for the removal of shields there. Next the ram connecting rods were chained to the panline clevis, and by alternately operating the ram and taking up slack in the chain, the shield was pulled up to the panline and the connecting rods were connected to the clevis.

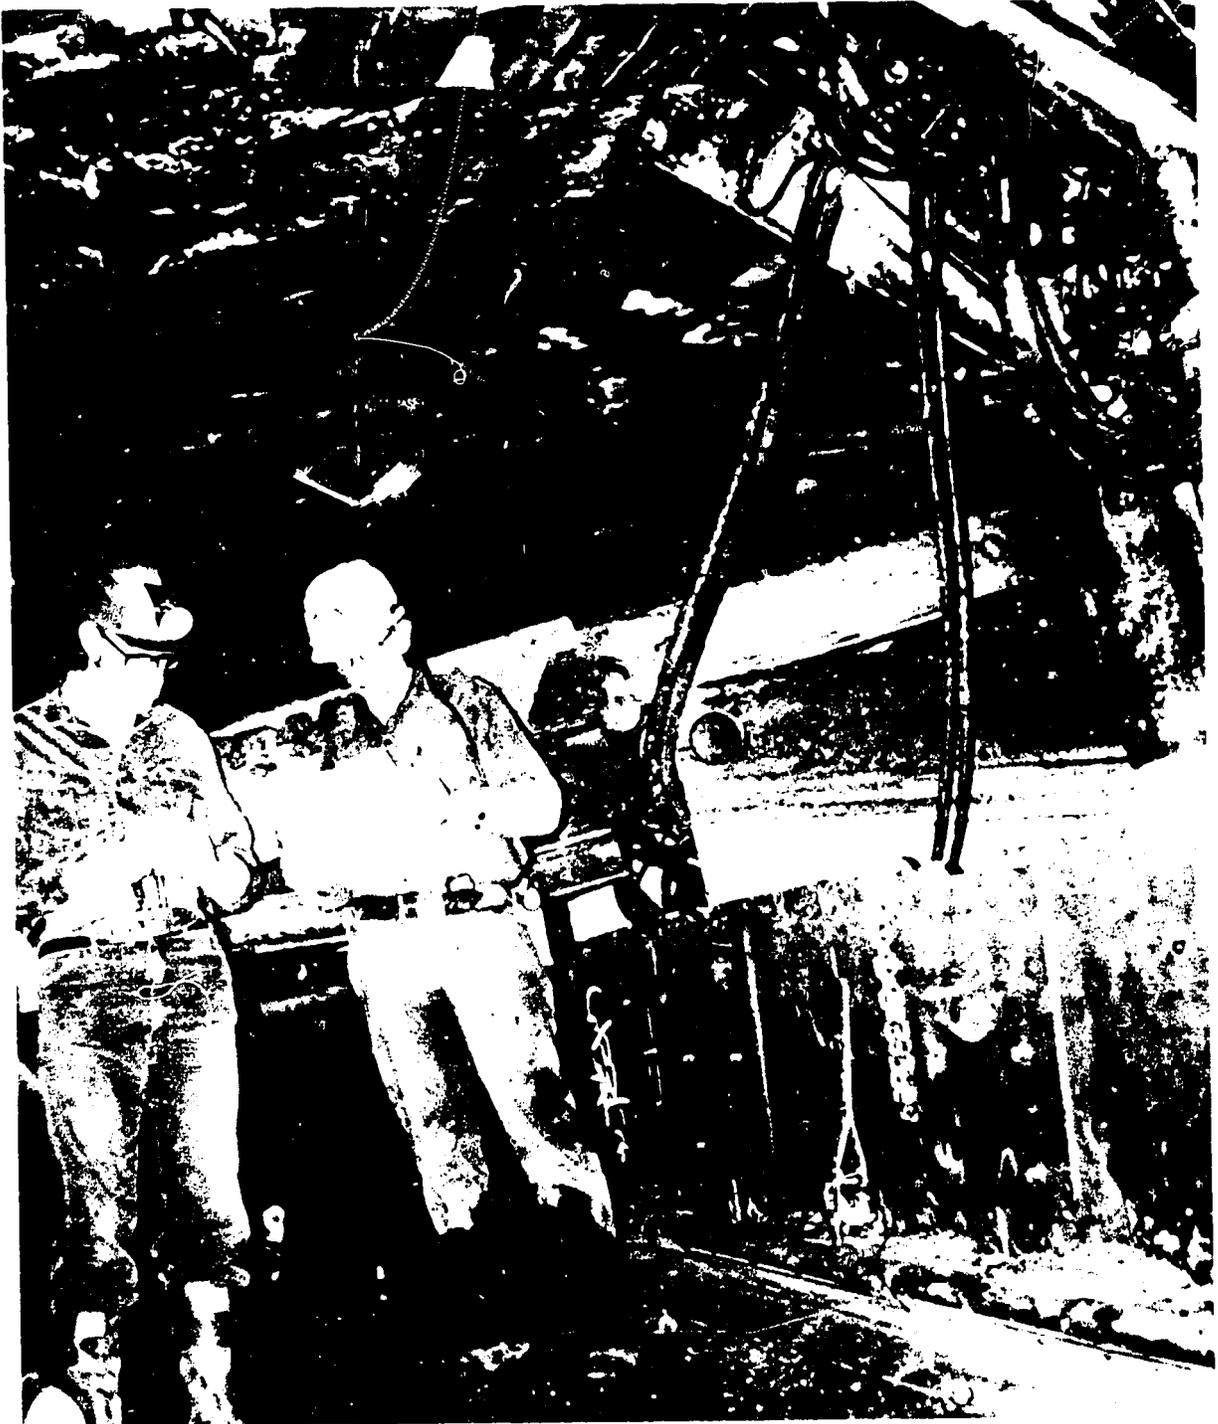
FIGURE 17. - Shield (foreground) extended against roof and shield (background) ready for extending.

Alinement and spacing of the shield to its neighbor were accomplished by either pushing against the neighbor with the side plate to increase the spacing or using the side plate and a chain to pull the shield closer to its neighbor. After the shield was properly alined and spaced, the leg extensions were adjusted for the mining height and the roof canopy was set against the roof (fig. 17).
