Investigation of Geomechanical Behavior of Laminated Rock Mass Through Experimental and Numerical Approach

**INVESTIGATION OF GEOMECHANICAL BEHAVIOR OF LAMINATED
ROCK MASS THROUGH EXPERIMENTAL AND NUMERICAL
APPROACH**

Doctor of Philosophy
in
Mining Engineering

Morgantown, West Virginia
April 2022

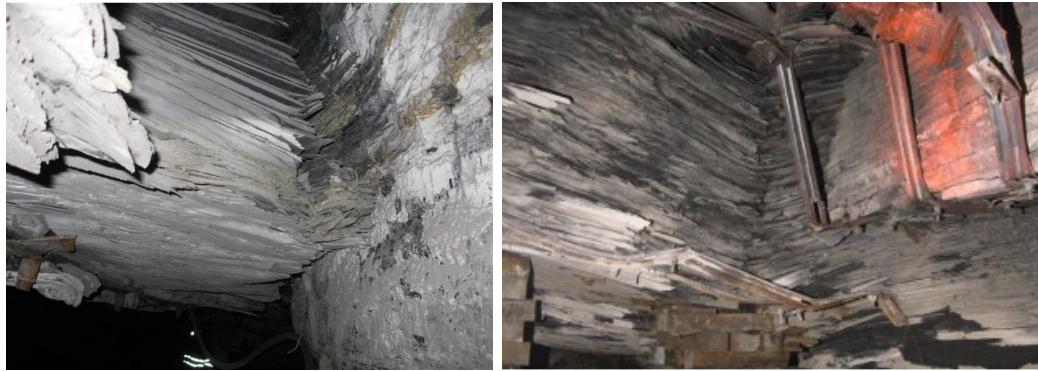
Fig. 1- 4 Cutter roof failure of shale roof (Molinda and Mark, 2010; Murphy, 2016)

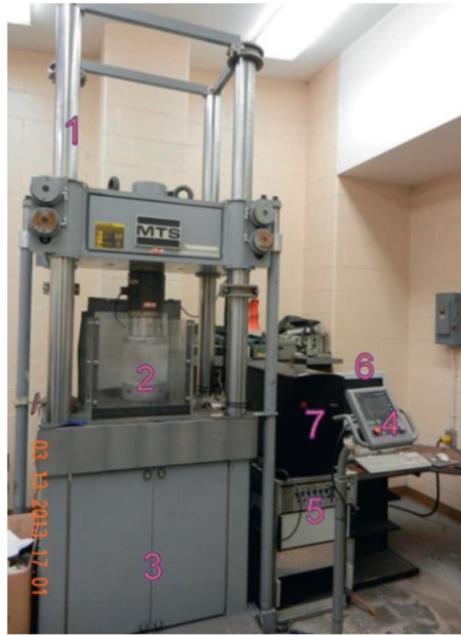
Fig. 3- 9 MTS servo-controlled compression testing machine and its components
 (1) Machine load, (2) Glass shield, (3) Hydraulic actuator, (4) Manual control system, (5) Strain Gauge control panel, (6) Computer, (7) MTS data acquisition system (Xue, 2019)

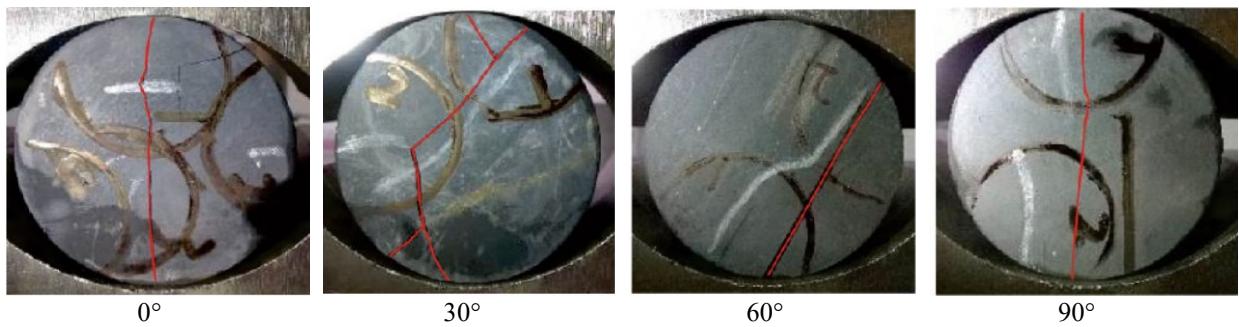
Fig. 4- 2 Fracture patterns of slate specimens with different inclined angles (He et al., 2018)
