OVERCOMING COMMON SLIP, TRIP & FALL HAZARDS

Proactive measures based on National Institute for Occupational Safety & Health research to help your operation avoid serious incidents

BY MAHIYAR F. NASARWANJI, ALAN G. MAYTON, JONISHA P. POLLARD, ASHLEY E. WHITSON, LYDIA M. KOCHER, MARY ELLEN NELSON AND PATRICK G. DEMPSEY

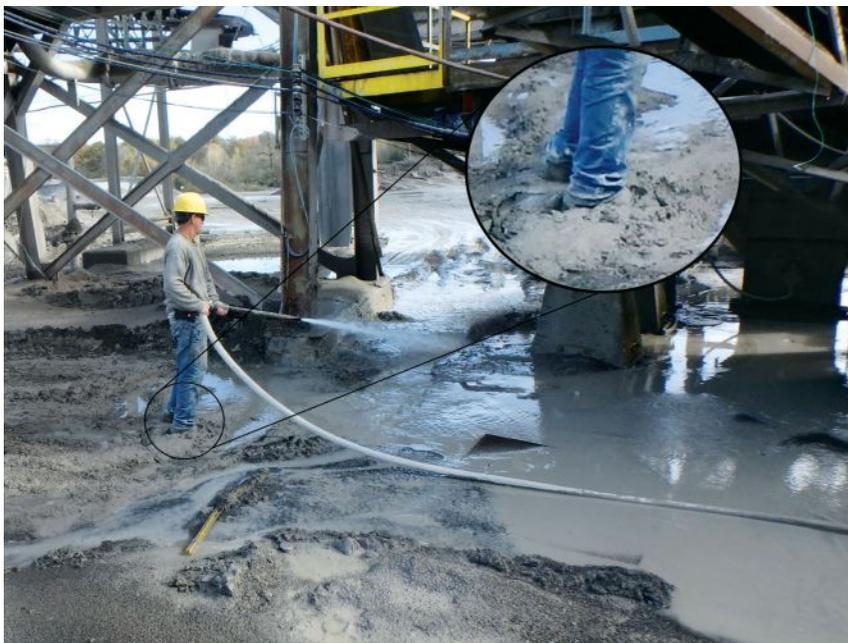
An example of solid and liquid contaminants observed during the shadowing period.

Rocks and stones on unpaved surfaces and material accumulation on paved surfaces are frequently encountered hazards.

NIOSH also studied the number of times and how often, on average, specific walkway hazards were encountered during the 36 hours of shadowing. Solid debris included rocks and stones on unpaved surfaces and material accumulation on paved surfaces – these were the most frequently encountered hazards.

Liquid contaminants were second and primarily included pooled water, but they also included oil and other liquids.

Given these findings, mine managers should take proactive steps to help remediate slip, trip and fall hazards, such as:

- Regularly grading unpaved surfaces
- Removing large rocks and ruts from walkways and working surfaces
- Installing designated walkways as needed
- Fixing or replacing bent, broken or damaged stair treads
- Providing level, even and stable landings at the base of ladders **P&Q**
