FIELD TESTING OF ROOF BOLTER CANOPY AIR CURTAIN OPERATING DOWNWIND OF THE CONTINUOUS MINER

W. R. Reed, CDC-NIOSH, Pittsburgh, PA
M. Shahan, CDC-NIOSH, Pittsburgh, PA
V. Gangrade, CDC-NIOSH, Pittsburgh, PA
G. Ross, J.H. Fletcher & Co, Inc., Huntington, WV
K. Singh, Lively Grove Mine, Marissa, IL
T. Grounds, Lively Grove Mine, Marissa, IL

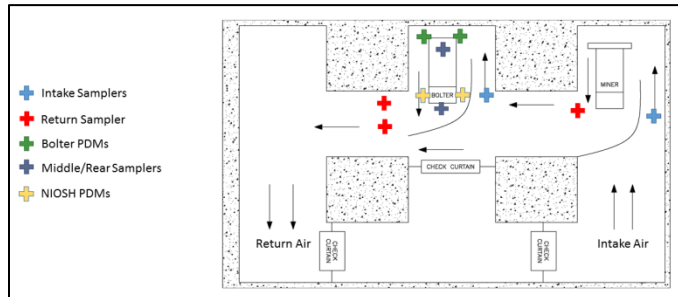
Figure 1. An example section showing the sampling locations in a blowing face ventilation system. In this example, the roof bolter is downwind of the continuous miner.

The sampling layout is shown in Figure 1. A combination of Continuous Personal Dust Monitors (CPDM) (Figure 2), Personal Data Ram 1000s (pDR), and gravimetric samplers were used for testing the CAC for respirable dust control. Gravimetric samplers consisted of Escort ELF pumps, Dorr-Oliver Cyclones, and 37-mm filters in coal cassettes. Each roof bolter operator wore a CPDM, and their locations are represented by green markers in Figure 1. The roof bolter operators also wore a pDR. In addition, two NIOSH researchers who were located behind the roof bolter machine each wore a CPDM and a pDR and are represented by the yellow markers. These NIOSH researchers always positioned themselves behind a roof bolter operator at the end of the roof bolter (i.e., one NIOSH researcher positioned himself behind the left roof bolter, while the other positioned himself behind the right roof bolter). The CM operator also wore a CPDM as did the two NIOSH researchers accompanying him (not shown).

respective locations as shown in Figure 1. Additionally, several of these sampling packages (purple markers in Figure 1) were placed on the roof bolter near the operators, but outside the zone of influence of the CAC.

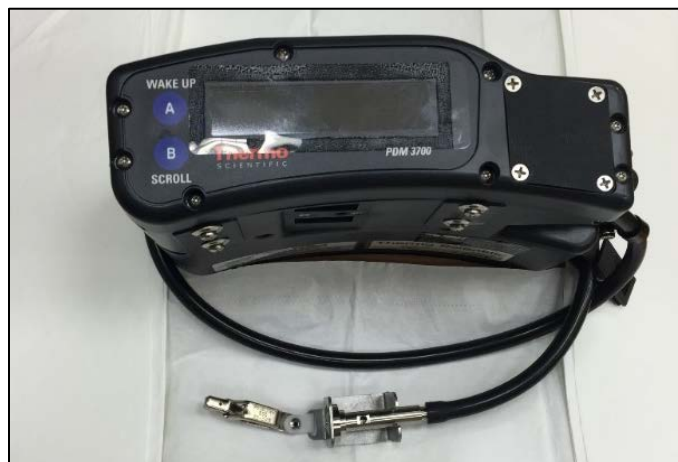
Figure 2. A CPDM 3700 respirable dust sampler.

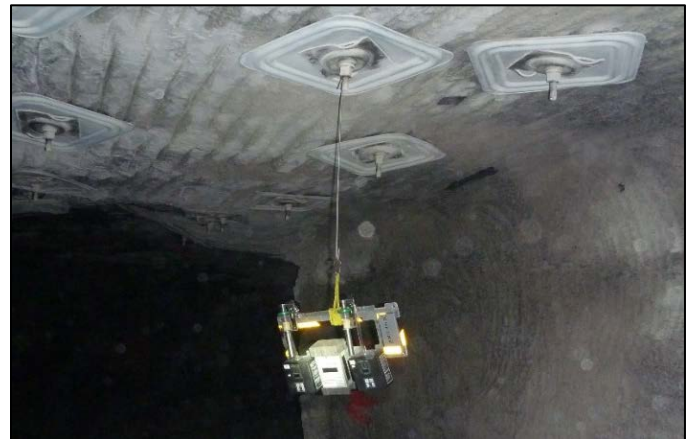
Figure 3. A typical sampling package consisting of a pDR and two gravimetric samplers. This package is typically hung from a roof bolt.

Other locations were sampled differently using sampling packages made up of one pDR in conjunction with two gravimetric samplers (Figure 3). These were used for the intake (blue markers) and return (red markers) samplers which were placed in their

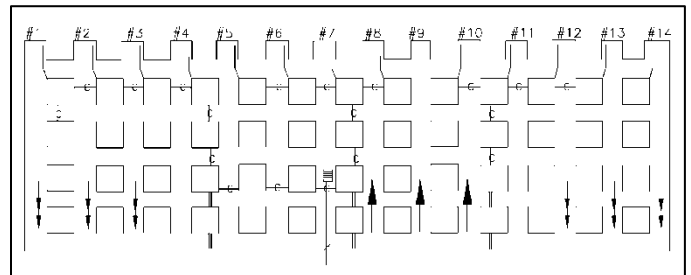
Figure 4. Typical 14-entry section layout.

Testing was completed at three different sections, each containing 14 entries using split or fishtail ventilation, with the intake in entries 8, 9, and 10. Return entries were #1, #2, #3, #4, #11, #12, #13, and #14. Figure 4 shows the typical 14-entry section. Testing occurred over four days, which was comprised of full-shift testing or more, except for day four which was approximately a half shift. ***It should be noted that the sample results of this study cannot be used for compliance sampling because the CPDMs were not prepared by MSHA-certified technicians, and the samples are not full-shift samples from a single location.***

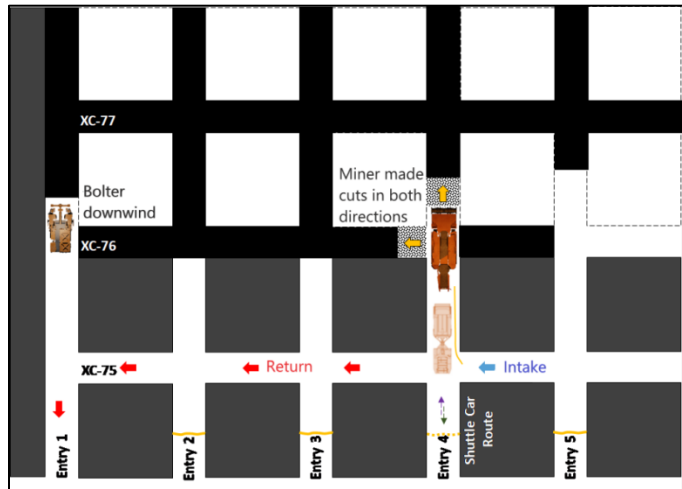
Figure 5. Location of roof bolter downwind of continuous miner on Aug 22nd. First cut with roof bolter in entry 1 and miner in entry 4. Section 2nd Main East 2nd Main North.

The following figures (Figure 5 through Figure 12) show the locations of the roof bolter and the continuous miner during operations in the study.

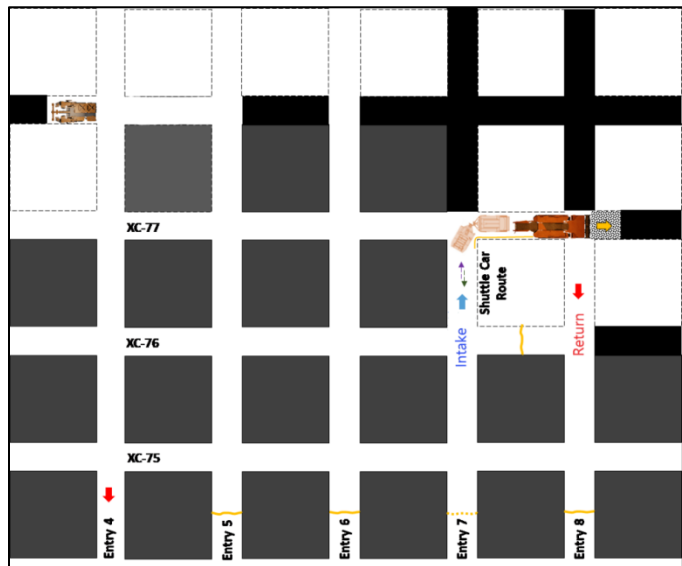
Figure 6. Location of roof bolter with respect to continuous miner on Aug 22nd. Second cut with roof bolter in entry 4 left and miner in entry 8 right. Bolter is not downwind for this cut. Section 2nd Main East 2nd Main North.

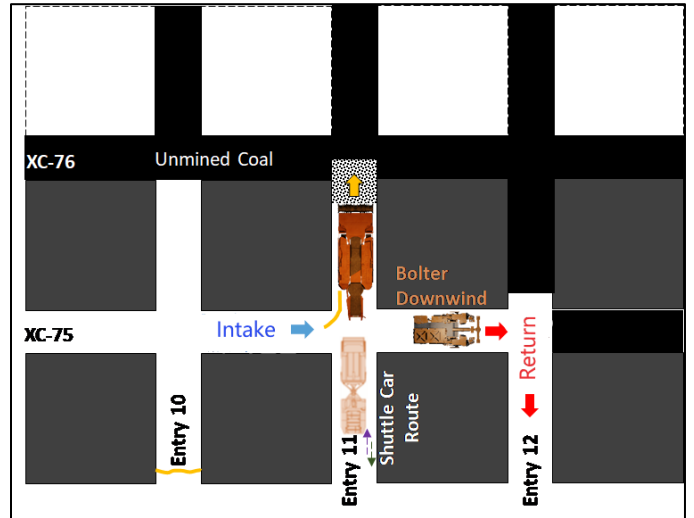
Figure 7. Location of roof bolter downwind of continuous miner on Aug 22nd. Third cut with roof bolter in entry 11 right x-cut 75 and miner in entry 11. Section 2nd Main East 2nd Main North.

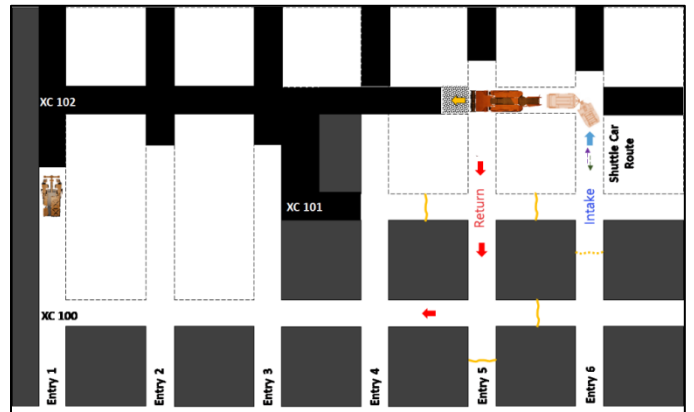
Figure 8. Location of roof bolter downwind of continuous miner on Aug 23rd. Second cut with roof bolter in entry 1 and miner in entry 5 left. Section 1st Main East 1st South.

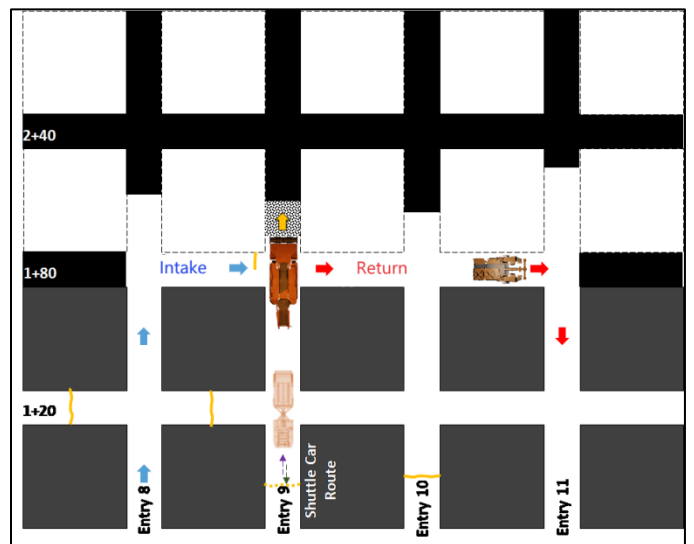
Figure 9. Location of roof bolter downwind of continuous miner on Aug 24th. Second cut with roof bolter in entry 10 right x-cut 1+80 and miner in entry 9. Section 1st Main East 1st North.

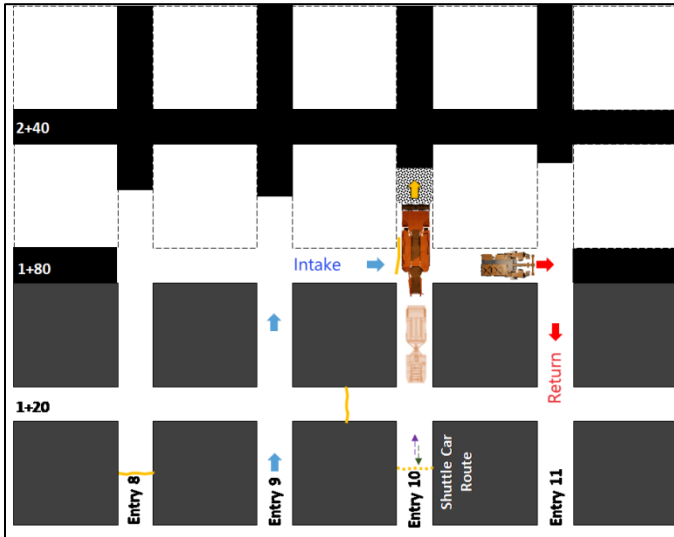
Figure 10. Location of roof bolter downwind of continuous miner on Aug 24th. Third cut with roof bolter in entry 10 right x-cut 1+80 and miner in entry 10. Section 1st Main East 1st North.

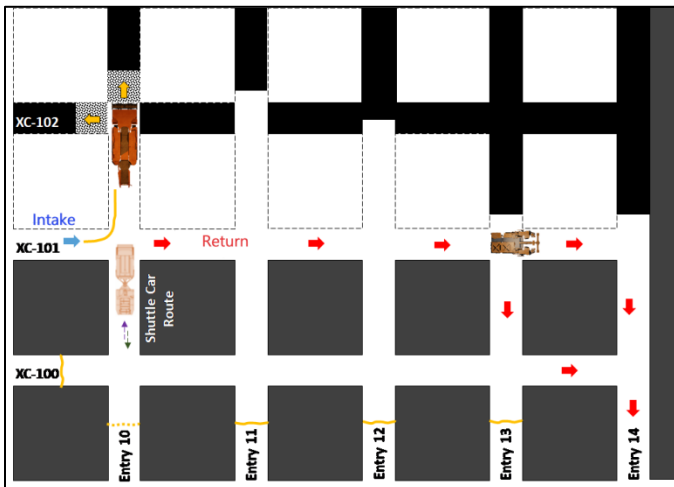
Figure 11. Location of roof bolter downwind of continuous miner on Aug 25th. First cut with roof bolter in entry 13 right x-cut 1+80 and miner in entry 10. Section 1st Main East 1st South.

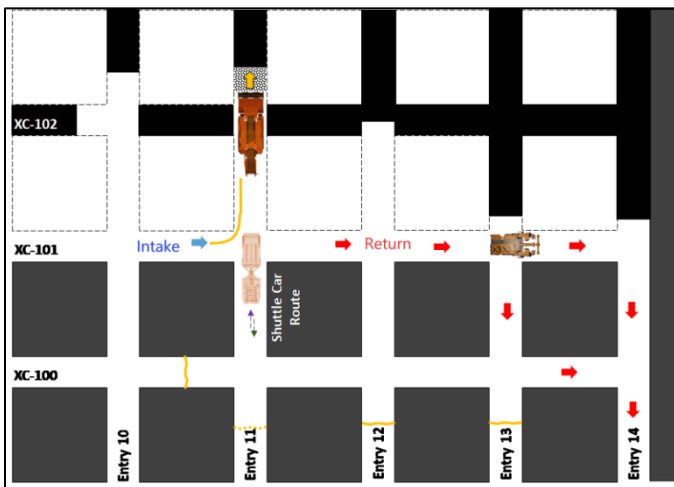
Figure 12. Location of roof bolter downwind of continuous miner on Aug 25th. Second cut with roof bolter in entry 13 right x-cut 101 and miner in entry 11. Section 1st Main East 1st South.
