Investigation of Machine-Mounted Area Lighting to Reduce Risk of Injury from Slips-Trips-Falls for Operators of Mobile Surface Mining Equipment

Alan G. Mayton¹ · Brendan Demich¹ · Mahiyar F. Nasarwanji¹

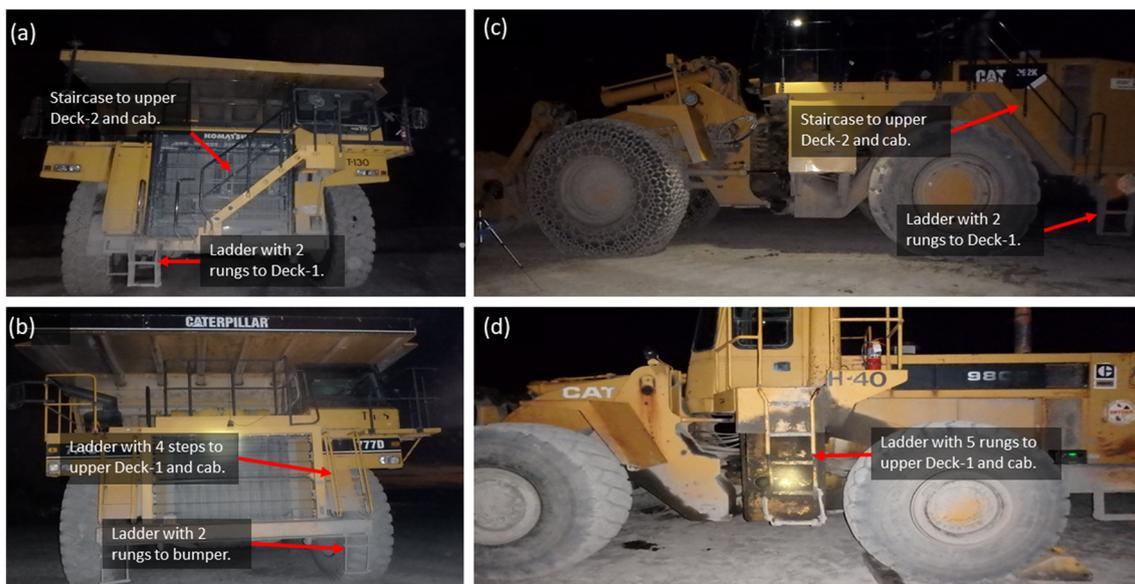
Fig. 1 Equipment evaluated as part of the study: (a) Komatsu HD 785 haul truck, (b) Caterpillar 777D haul truck, (c) Caterpillar 992 K wheel loader, and (d) Caterpillar 980C front-end loader. Inherent differences in the designs of the ingress/egress systems are evident in the photographs

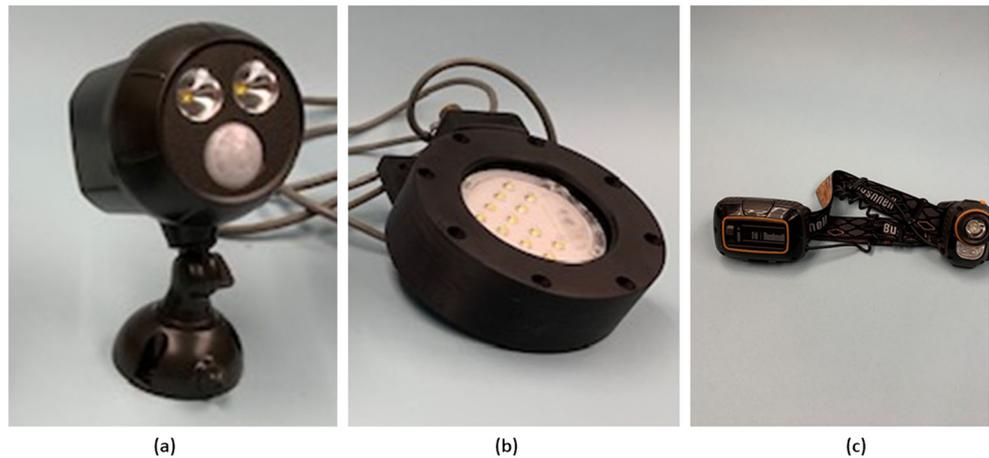
Fig. 2 Luminaires used in the study: (a) area luminaire-1, (b) area luminaire-2, and (c) headlamp

luminaire-1)—and the prototype NIOSH-developed Saturn (area luminaire-2), together with the existing headlamp luminaire provided by the mine operator (Fig. 2). An online search was carried out to determine what commercially available luminaire(s) might be appropriate and available for the intended surface mine equipment application to compare with luminaire-2. Several lighting products were considered, and luminaire-1 was selected based on its features and low cost and on the personal knowledge and experience of one of the study's authors. Moreover, luminaire-1 is typically marketed to residential customers. We selected the Saturn luminaire because of the positive results demonstrated in the mine roof bolter study [9, 10]. The two LED luminaires would constitute glare sources, whereas the headlamp would not be a glare source and instead would account for ambient lighting during trials of the ingress/egress and pre-shift walkaround activities.

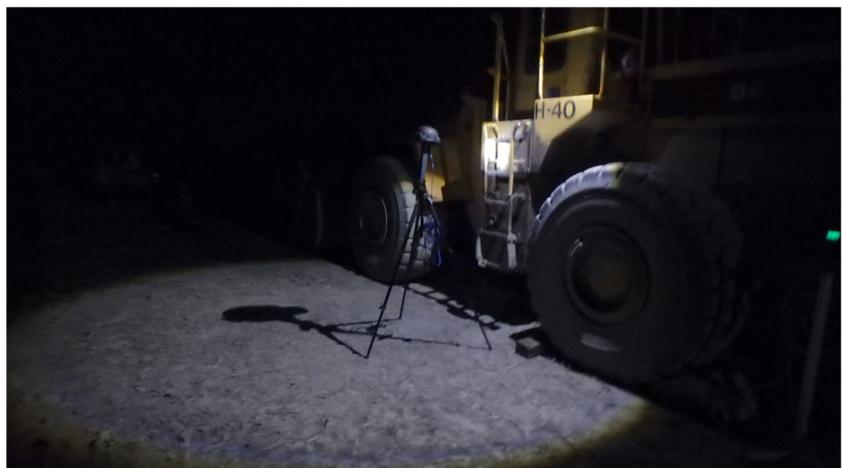
Fig. 3 Area luminaire-1 pattern displayed in setup for measurements associated with ingress/egress on the CAT 980C wheel loader

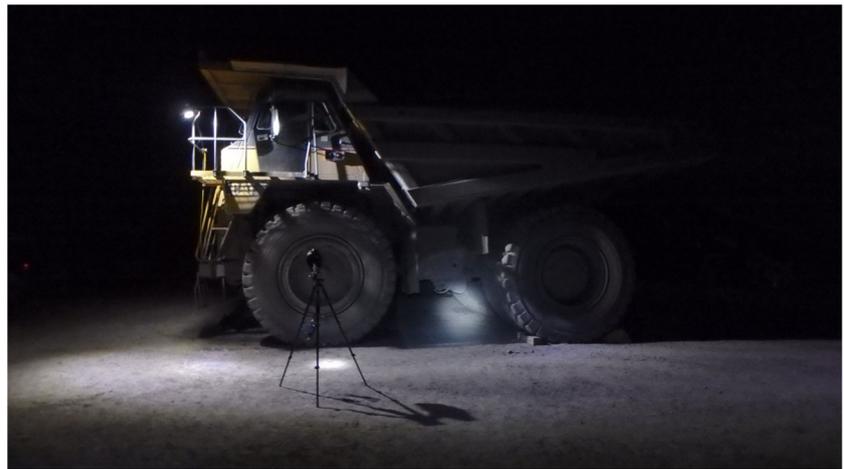
Fig. 4 Area luminaire-2 beam pattern displayed in setup for measurements associated with the pre-shift walkaround tasks on the Komatsu HD785 haul truck

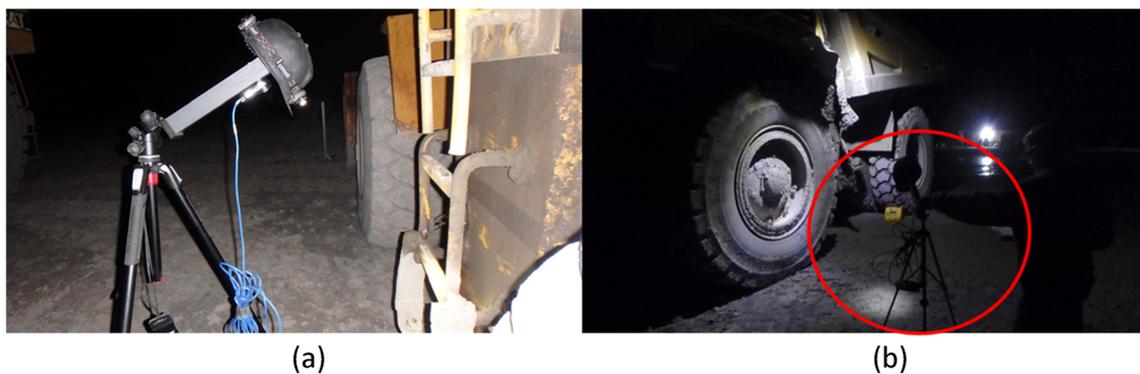
Fig. 5 The setup for measurements that represent a mine worker at (a) the ladder (first rung) of the smaller front-end loader and (b) the ground at the driver's side front tire of the haul truck during pre-shift walk-around

Next, the selected tripod, representing the machine operator, was equipped with a mine worker’s hardhat fastened to a rectangular plastic structure that allowed the T10A sensor head to be bolted at the approximate location of the worker’s eye height of 1.7 m (66 in.). The tripod was positioned approximately 1.8 m (72 in.) from the ground at a marked target location and 0.3 m (12 in.) from the first rung of the ladder and on the ground at the driver’s side front tire of the haul truck during pre-shift walkaround at approximately 1.2 m (48 in.) from the sidewall edge of the truck tire (Fig. 5a and b).

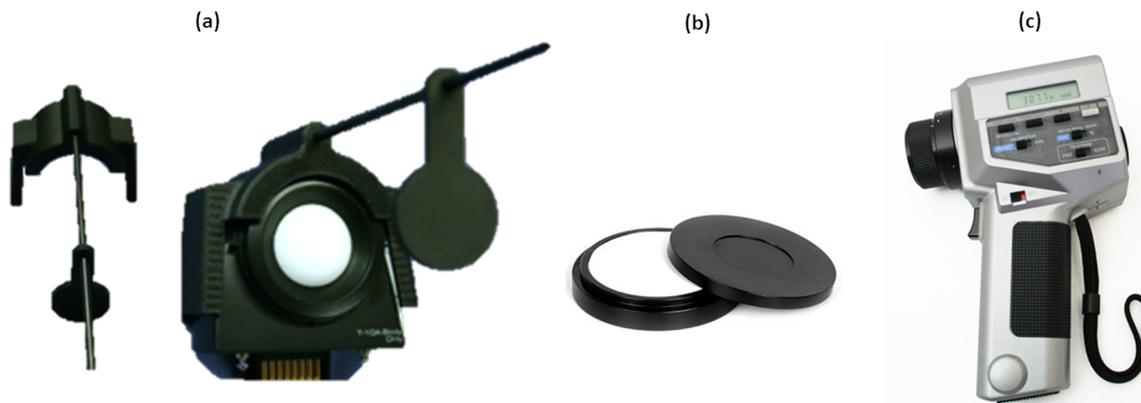
Fig. 6 Instruments used for measurement: (a) shroud and baffle assembly 3D-printed to fit over the T10A sensor head, (b) RS-3 reflectance standard used (Apogee Instruments), and (c) LS-100 photometer to measure luminance (Konica Minolta)

the target. Measurement units included lux (illuminance), nits (luminance), meters (feet or inches) for linear distance or target size, and degrees (angles). Some angles were obtained directly, whereas others had to be derived from geometric triangular distance measurements. The surround illuminance (E_s) was obtained using a baffle arrangement affixed to the T-10A sensor head mounted to the tripod hardhat location that Sammarco et al. used in their lighting study [10]. The baffle, RS-3 reflectance standard, and LS-100 photometer are shown in Fig. 6.

As mentioned above, the surround illuminance E_s was determined by designing and 3D-printing small baffles of different sizes ranging in diameter from 0.026 to 0.046 m (1–1.8 in.)

that slid along a small cantilevered rod 0.18 m (7 in.) in length and 0.0032 m (0.13 in.) in diameter. The baffle allowed a shadow to be cast on the sensor surface in order to measure surround illuminance. A similar reading of ambient illuminance (E_a) was taken without the baffle attached.

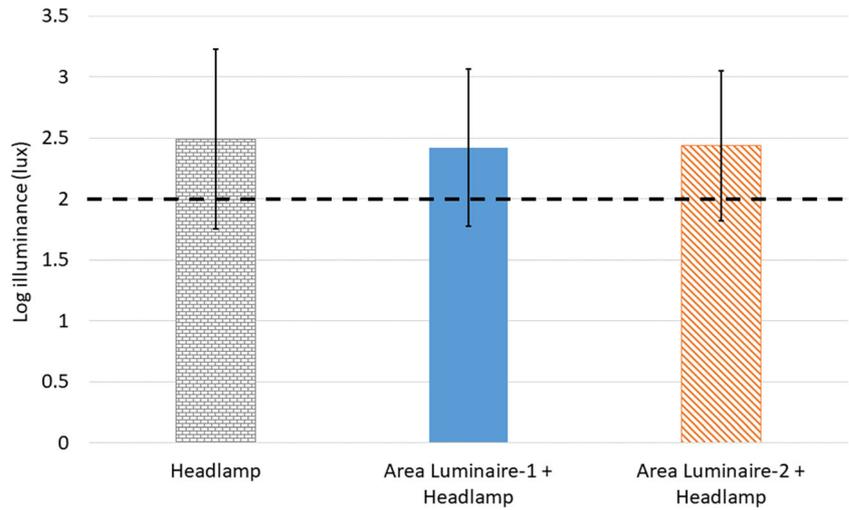
Fig. 8 Log task illuminance using the RS-3 reflectance standard for all ingress/egress and pre-shift walkaround tasks using the headlamp and the two area luminaires. The dashed line indicates the IES recommended illuminance level

Overall illumination levels with the headlamp were higher than those in the earlier study mentioned above [11]. Measurements using the RS-3 to determine illuminance were taken and available for all but 2 of the 43 ingress/egress and pre-shift walkaround tasks. Figure 8 illustrates the average illuminance levels for the headlamp and the two area luminaires compared with the recommended levels from the IES standard. On average, all luminaires, including the headlamp, provided adequate illumination.

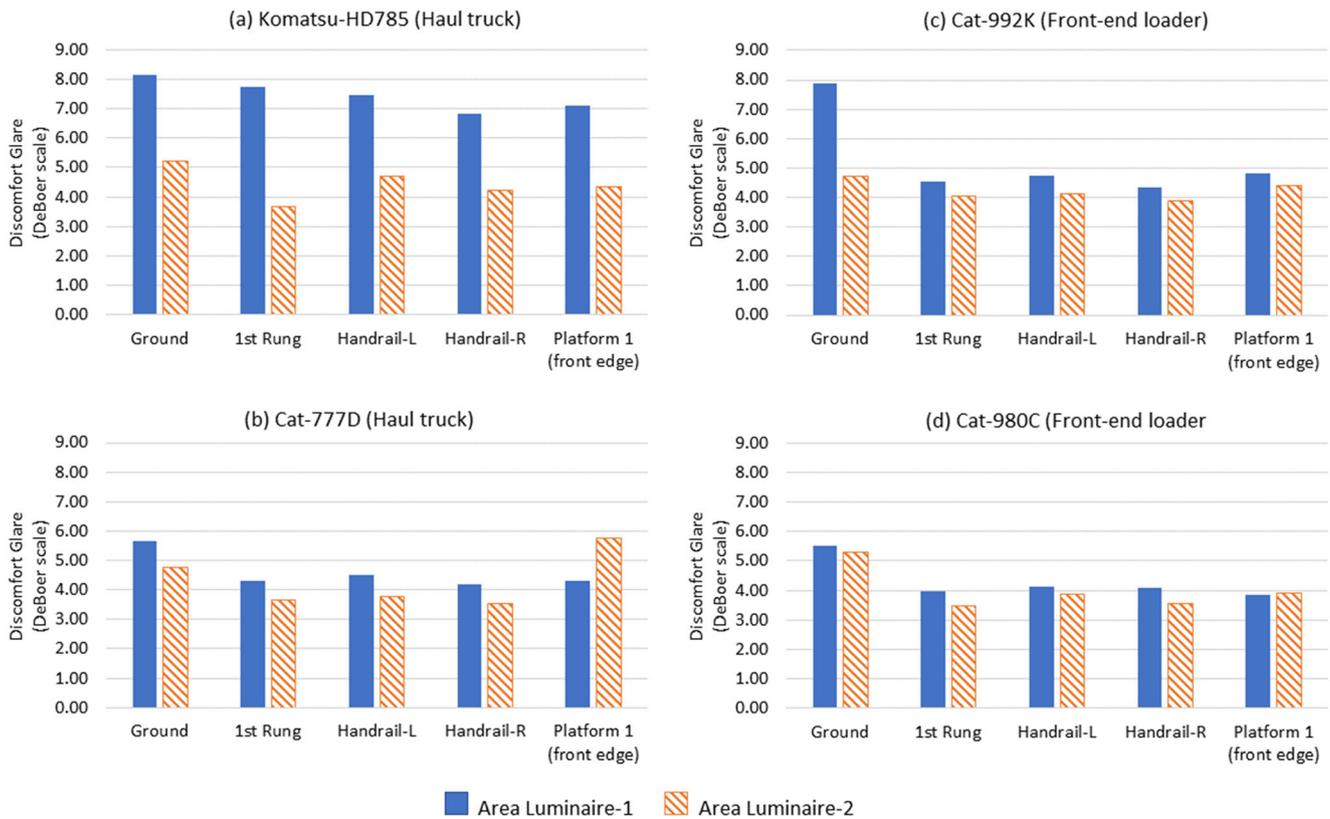
Fig. 9 Comparison of discomfort glare ratings for area luminaire-1 and area luminaire-2 ingress/egress tasks. The larger value is the better rating. L indicates left handrail and R indicates right handrail when facing the equipment

Figure 9 displays the results for the ingress/egress visual tasks for all four machines. Considering the newer Komatsu haul truck (Fig. 9a), the De Boer ratings for area luminaire-1 show better results for all eight tasks and lower glare compared with area luminaire-2. The ratings for area luminaire-2 varied from a low of 4 to a high of 5, in contrast to area luminaire-1 ratings, which show a low of 6 and a high greater than 8. Figure 10a

Regarding the results (Fig. 9c) for the CAT 992 K wheel loader, the ingress/egress tasks showed slightly better values again for area luminaire-1, with a median value of 6 (one unit between satisfactory and just permissible) versus 5 (just permissible) for area luminaire-2. The walkaround tasks (Fig. 10c) showed dramatically lower glare (higher values) for area luminaire-1, ranging from between just noticeable and satisfactory to 7 units above just noticeable. This contrasted with area luminaire-2, which showed values ranging from just permissible to satisfactory. Similarly, the CAT 980C wheel loader results (Fig. 9d) for ingress/egress tasks showed only slightly better values again for area luminaire-1 versus area luminaire-2 for the front driver's side tire location and the midpoint between the front and rear tires. Other task location values were the same, with a median value of 4, which is between just permissible and disturbing. On the other hand, the walkaround tasks (Fig. 10d) showed dramatically lower glare (higher values) for area luminaire-1 ranging from 8 to 10, one to three units above satisfactory, versus 7, satisfactory, for area luminaire-2.

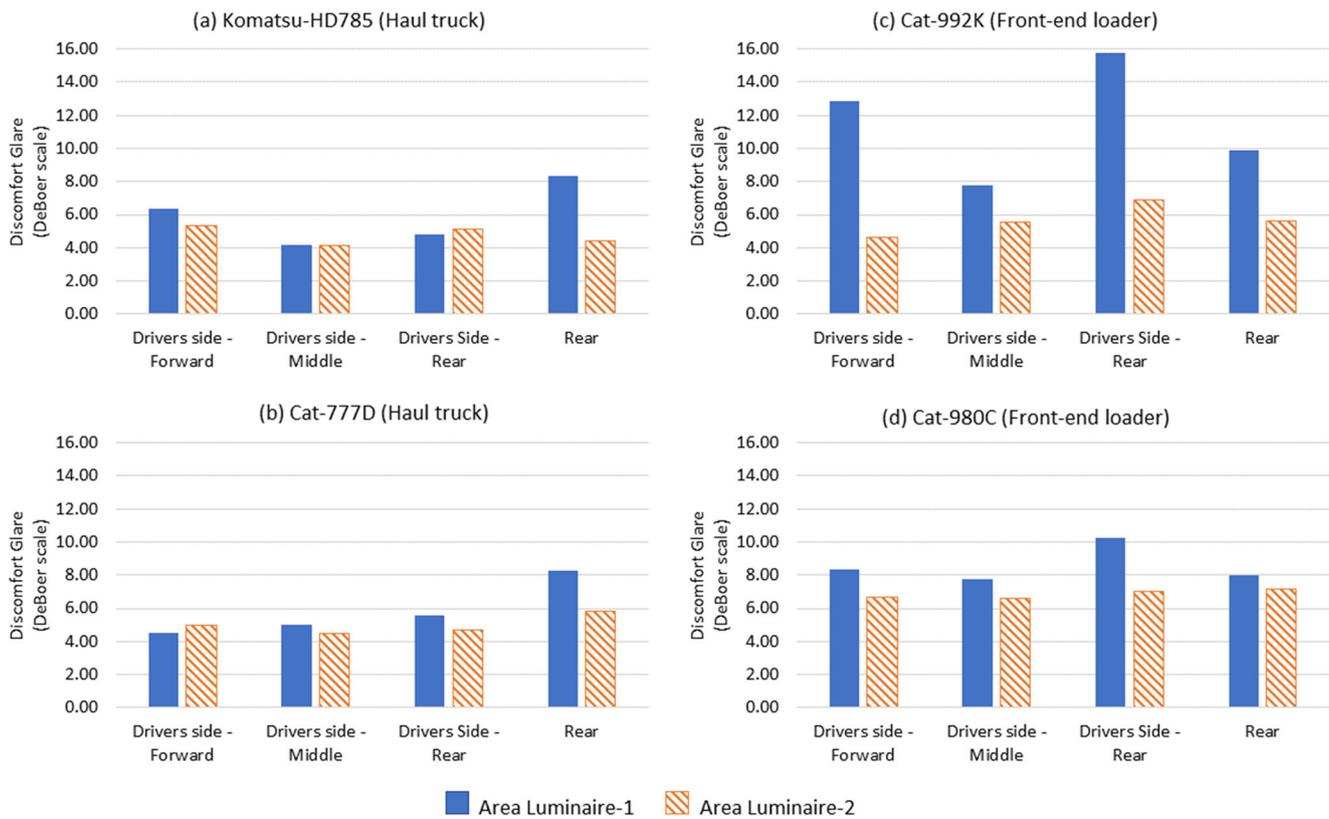
Fig. 10 Comparison of discomfort glare ratings for area luminaire-1 and area luminaire-2 during pre-shift walkaround tasks. The larger value is the better rating

displays the predicted De Boer ratings for pre-shift walkaround tasks for the newer Komatsu haul truck. Area luminaire-1 results indicate lower discomfort glare values relative to area luminaire-2 at the driver's side and rear areas for the pre-shift walkaround visual tasks. In Figs. 9b and 10b, glare values for the 777D haul truck show little difference between the two area luminaires for the ingress/egress tasks, and slightly better values for area luminaire-1 in the walkaround tasks.

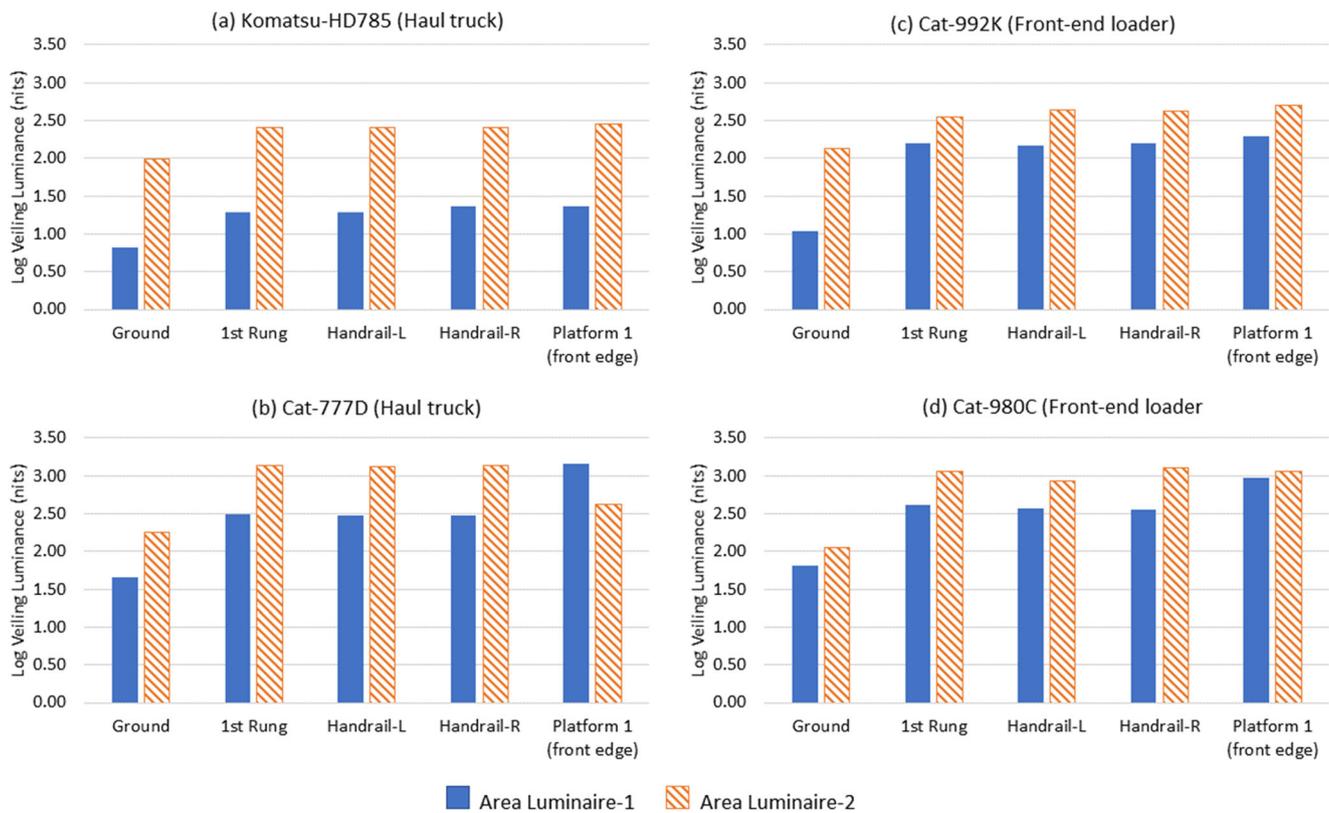
Fig. 11 Comparison of disability glare (veiling luminance) for area luminaire-1 and area luminaire-2 for all the equipment during ingress/egress tasks. The lower values reflect better levels of veiling luminance. L indicates the left handrail, and R indicates the right handrail when facing the equipment

showed area luminaire-1 with lower levels of veiling luminance or overall better performance. There were three instances where area luminaire-1 did not show better veiling luminance. One was at the driver's side rear tire for the Komatsu HD785 (Fig. 12a). The other two were platform 1 (Fig. 11b) and the driver's side forward tire for the CAT 777D

luminance values with standard deviations were 75 ± 138 nits for area luminaire-1 and 178 ± 203 nits for area luminaire-2. Figures 11 and 12 illustrate differences in log veiling luminance for the two area luminaires and all four machines during ingress/egress tasks and during pre-shift walkaround tasks, respectively.

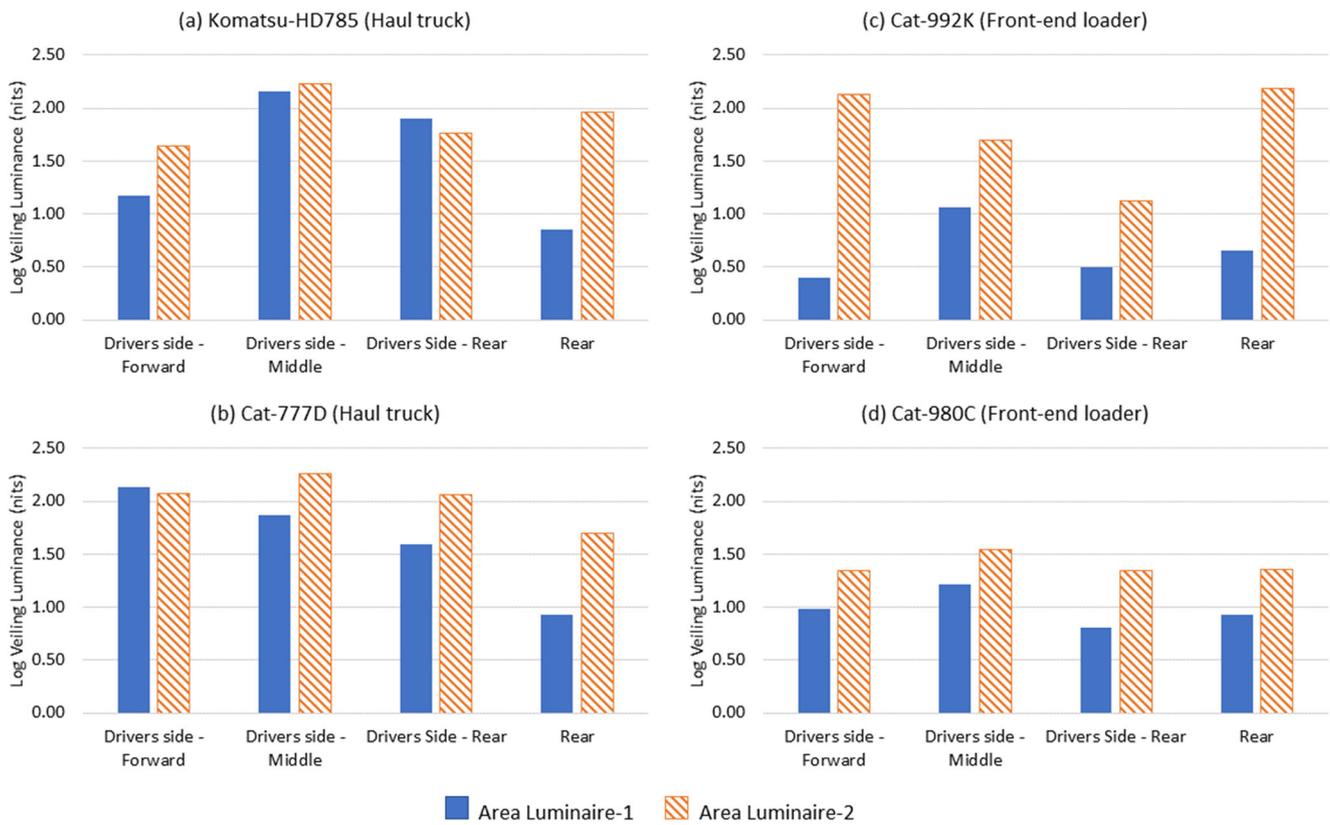
Fig. 12 Comparison of disability glare (veiling luminance) for area luminaire-1 and area luminaire-2 for all the equipment during pre-shift walkaround tasks. The lower values reflect better levels of veiling luminance.

(Fig. 12b). Moreover, we observed instances where veiling reflections occurred during measurements of the handrails. Veiling luminance values varied from about 1 nit to 643 nits for area luminaire-1 versus 4 nits to 616 nits for area luminaire-2; the median values for the same luminaires were 14 nits and 80 nits, respectively. The average veiling

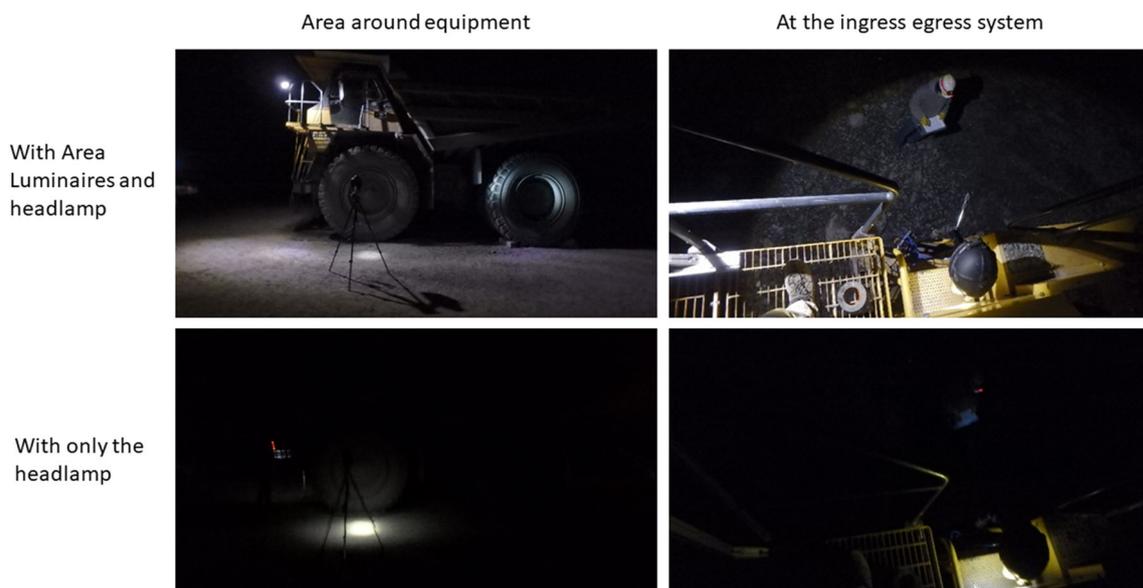
Fig. 13 Comparison of the area illuminated using the LED area lighting plus the headlamp (top left and right images) versus the headlamp only (bottom left and right images). The scenes depicted are at ground level on

the driver's side of the equipment (left images) and at the top platform of the ingress/egress system (right images)
