NIOSH

ALERT

Preventing Falls and Electrocutions During Tree Trimming

DHHS (NIOSH) Publication No. 92-106

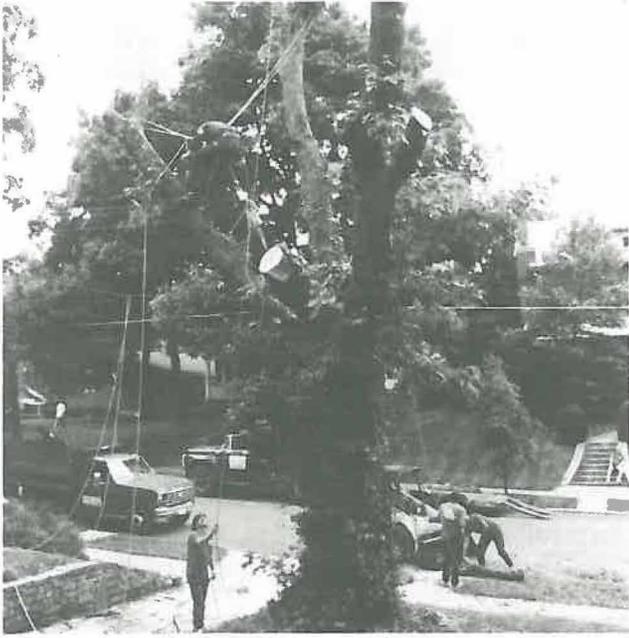
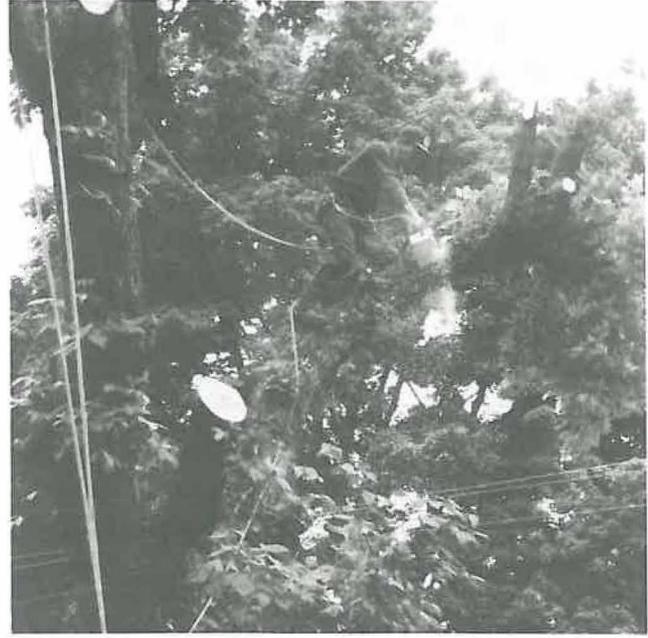
Figure 1. Tree trimmers at risk of falls and electrocutions.

The recommendations in this Alert should be followed by all employers, managers, supervisors, and workers in companies that perform tree trimming and cutting. NIOSH requests that editors of trade journals, safety and health officials, electric utilities, and telephone and cable television companies bring this Alert to the attention of workers who are at risk (Figure 1).

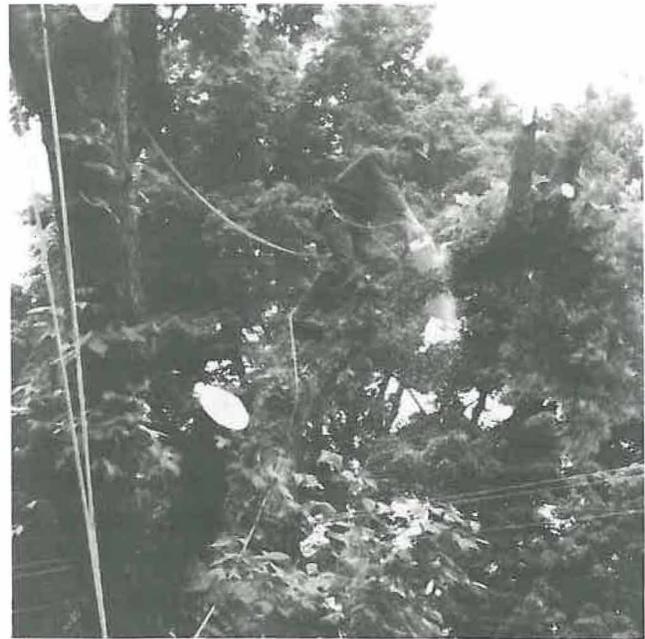
Tree trimmer at risk of falls and electrocution.
