RETREAT MINING WITH MOBILE ROOF SUPPORTS

By Frank E. Chase,¹ Allen McComas,² Christopher Mark, Ph.D.,³ and Chester D. Goble⁴

Information Circular 9446

Proceedings: New Technology for Ground Control in Retreat Mining

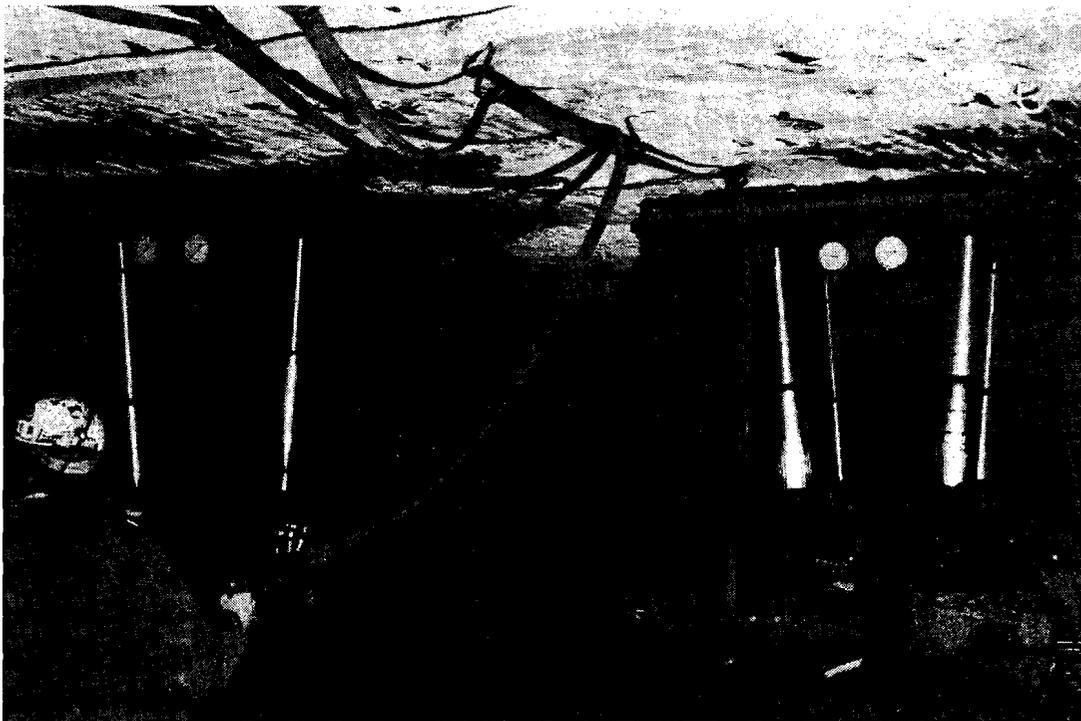
Mobile roof supports (MRS's) are shield-type support units mounted on crawler tracks (figure 1). MRS technology was pioneered by the former U.S. Bureau of Mines during the 1980's [Thompson and Frederick 1986]. Commercial units are currently manufactured by J. H. Fletcher and Co., Huntington, WV, and Voest-Alpine Mining and Tunneling, Pittsburgh, PA. Fletcher refers to its units as "Fletcher Mobile Roof Supports" (FMRS). Voest-Alpine has designated its units as "Alpine Breaker Line Supports" (ABLS). For the purposes of this paper, the generic term "MRS," or "mobile," is used to identify both manufacturers' units. In 1988, the Donaldson Mine in Kanawha County, WV, was the first U.S. operation to use mobiles. Since then, approximately 40 U.S. mines in 5 States have utilized mobiles. These States include Illinois, Kentucky, Pennsylvania, Virginia, and West Virginia. Mobiles have been employed in more than 15 different U.S. coalbeds ranging from 1.7 to 4 m (5.5 to 13 ft) thick. MRS units are primarily used in coalbeds thicker than 2.4 m (8 ft). Currently, there are approximately 100 units in use in the United States. Mobiles have been used primarily during full and partial pillar recovery

Figure 1.—Full pillar extraction using mobile roof supports.

Two pressure gauges are mounted on each mobile (figure 1). These gauges are visually monitored by operating personnel to determine loads and rates of loading on the units. Since the first fatality on an MRS section, considerable emphasis has been placed on the size of gauges. Some mobile operators have mentioned that it is necessary to stand close to the mobiles to read standard gauges. Other operators expressed that even the 10-cm (4-in) diameter gauges are of adequate size and can be read easily from 9 m (30 ft) away. Gauges are constantly monitored to determine loads and load development rates on the mobiles. Common sense modifications, which have made gauges easier to read, include the mounting of flood lights to illuminate the gauges and/or the adherence of reflective tape on the gauges' glass covers to mark a critical load threshold. At one operation, the positioning of the reflective tape depends on the roof rock type being mined under. The Spokane Research Center, MRS manufacturers, and others are currently working to develop lighting systems that can be seen from farther distances. Green, yellow, and red pulsating lights will indicate different total load levels or stages of loading. Additionally, a light-emitting diode bar graph will indicate rates of loading on

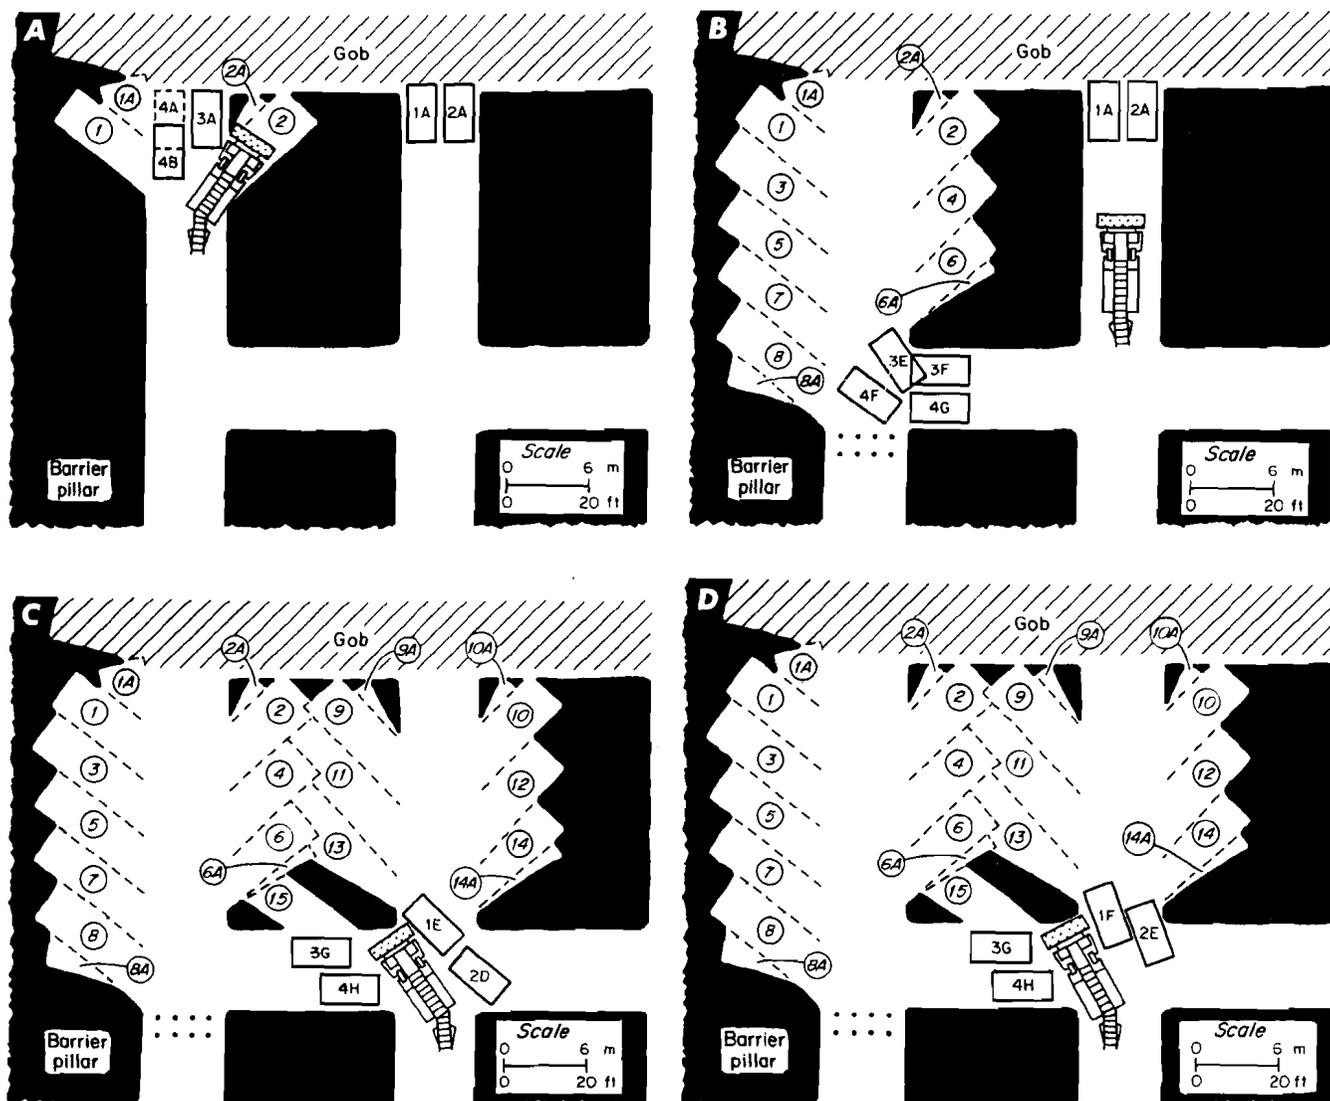
The "Christmas tree" method (also called left-right, fishbone, or treetopping) is the most commonly used full pillar extraction method with MRS's (see figures 2A through D). This method is generally employed under deep cover when pillars on 18- or 24-m (60- or 80-ft) centers are required to maintain necessary pillar stability factors. Figures 2A through D depict a common sequence in which lifts are extracted during barrier and production pillar extraction. As shown in figure 2A, mobile unit 4 is trammed approximately 2.1 m (7 ft) outby and pressurized prior to mining lift 2. Prior to mining lift 3 (figure 2B), unit 3 is trammed 4.3 m (14 ft) outby and pressurized. This process continues until the breakers are set, as indicated in figure 2B. After the breakers are set, unit 3 is moved to position F and unit 4 is trammed to position G. When referring to a particular

mobile, units 1 through 4 are designated as shown in figure 2B by convention. After mining the barrier pillar, the mobiles trammed down the entry are referred to as the "No. 1" (left side) and "No. 2" (right side) units. Mobiles maneuvered through the crosscut are designated as the "No. 3" (pillar line side) and "No. 4" (solid pillar side) units.

The size and shape of the pillar remnants, back wing, and pushout stump (figures 2C and D) can vary from pillar to pillar. The riskiest process during pillar extraction is pushout removal. Some operators routinely try to extract 60% or more of the pushout, conditions permitting; others do not attempt to remove the pushout. This decision is based on mining conditions, past experiences with equipment entrapments, and safety considerations. In general, the more competent the roof, the more likely the pushout is removed. Operators who typically remove the push will abandon it if the stump shows signs of excessive

Figure 2.—Christmas tree extraction method. A, lifts 1-2A. B, lifts 1-8A. C, lifts 1-push; pushout removal with units 1 and 2 in tandem. D, lifts 1-push; pushout removal with units 1 and 2 staggered.

the entry just inby the intersection during back wing and pushout removal. Significant roof deflection and higher roof bolt loads were monitored, compared with an adjacent instrumented intersection, where timbers were used to extract a pillar. Therefore, Hay et al. [1997] concluded that units 1 and 2 should be placed in the intersection as much as possible to protect miners and equipment. It is important to note that MRS units 1 and 2 were positioned inby the intersection when the 1995 fatality occurred in Mingo County, WV (figure 3). The fatal accident happened during the mining of the last lift in the pillar. To enhance intersection stability, some operators position mobiles 1 and 2 in tandem, as shown in figure 2C, prior

to pushout removal. Other operators stagger units 1 and 2 side by side in the intersection as much as possible (see figure 2D). In figures 2C and D, lift 11 is a 14-m (46-ft) extended cut. In certain MSHA districts, the length of an extended cut (measured from the rib-side column of bolts) cannot exceed 14.8 m (40 ft).

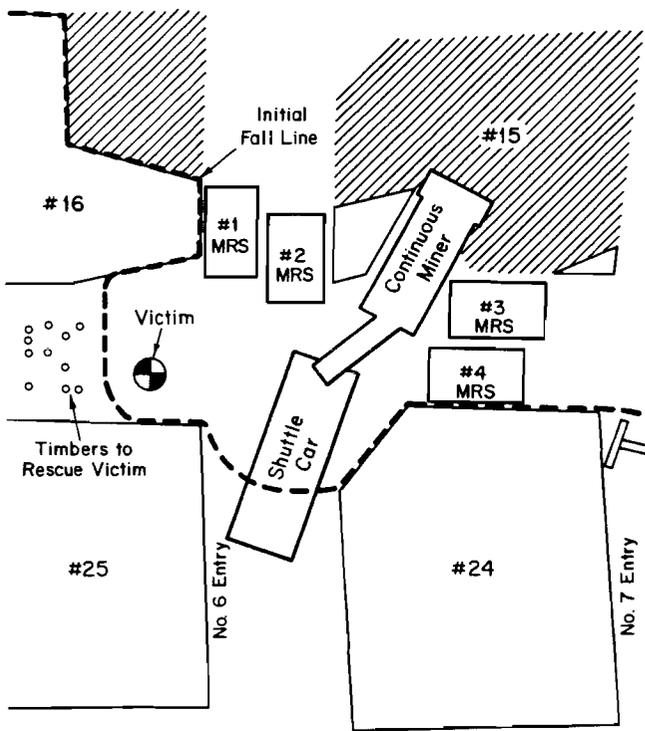
Figure 3.—MSHA drawing of fatal roof fall accident [Vance et al. 1995].

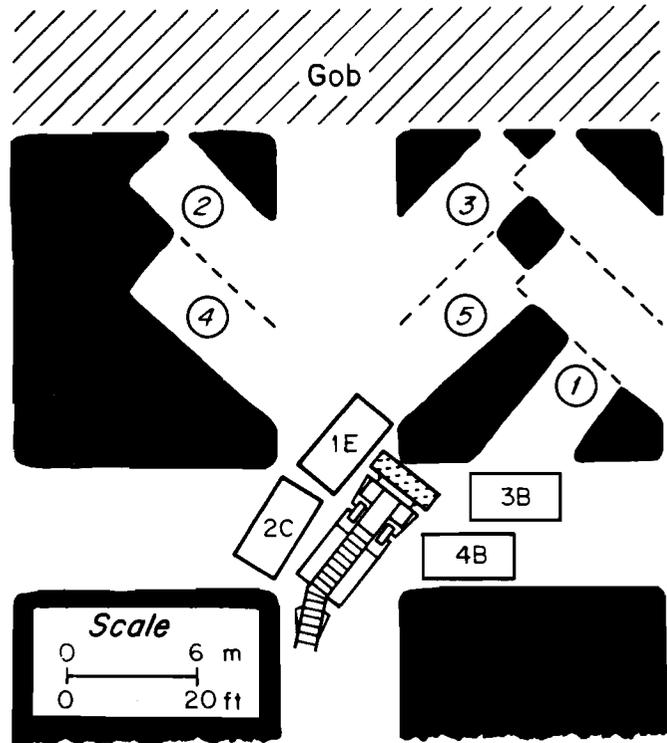
A variation of the usual Christmas tree lift sequence is illustrated in figure 4, where lift 1 is taken from the back wing (also called bottom of the block). Mobile units 3 and 4 are then moved to locations 3B and 4B and pressurized. Some operators indicated that this positioning enhances intersection stability prior to the mining of the left and right wings (lifts 2-5). However, some State and Federal roof control specialists expressed the concern that the removal of the back wing lift first actually reduces intersection stability, which is critical.

Figure 4.—Modified Christmas tree method.

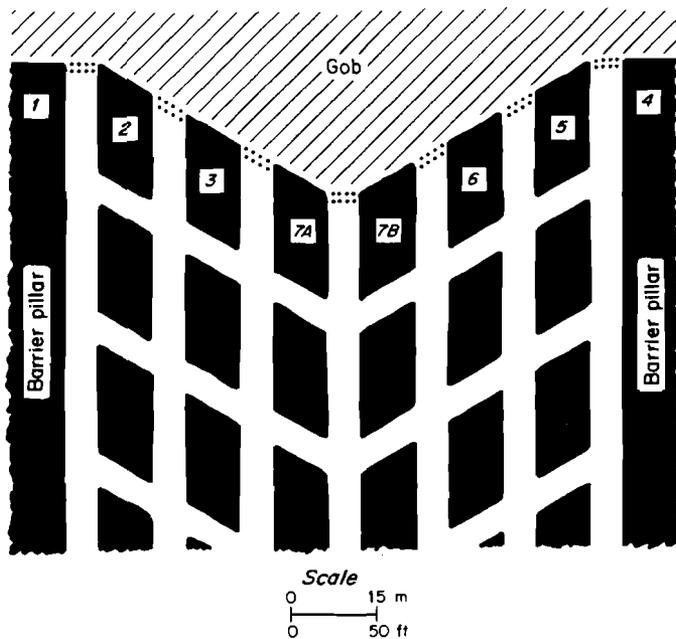
Figure 6.—Herringbone panel design.

The Christmas tree and outside lift methods have been used in combination to extract the parallelogram-shaped pillars (figure 6) that are developed using continuous haulage. Crosscuts are driven on approximately 60° angles to facilitate the movement of bridges and carriers. This panel configuration has been referred to as the "herringbone" or "turkey foot" design. Common entry centers range from 16 to 18 m (52 to 58 ft), with crosscuts on 25- to 27-m (81- to 90-ft) centers. Barrier and production pillars can be extracted as shown in figure 6, or pillars can be mined from right to left, then from left to right. After the mining of lifts 1 and 1A (figure 7A), unit 4 is trammed 2.1 m (7 ft) outby and pressurized. Lifts 2 and 2A are then removed from pillar 2. These lifts are removed to reduce the

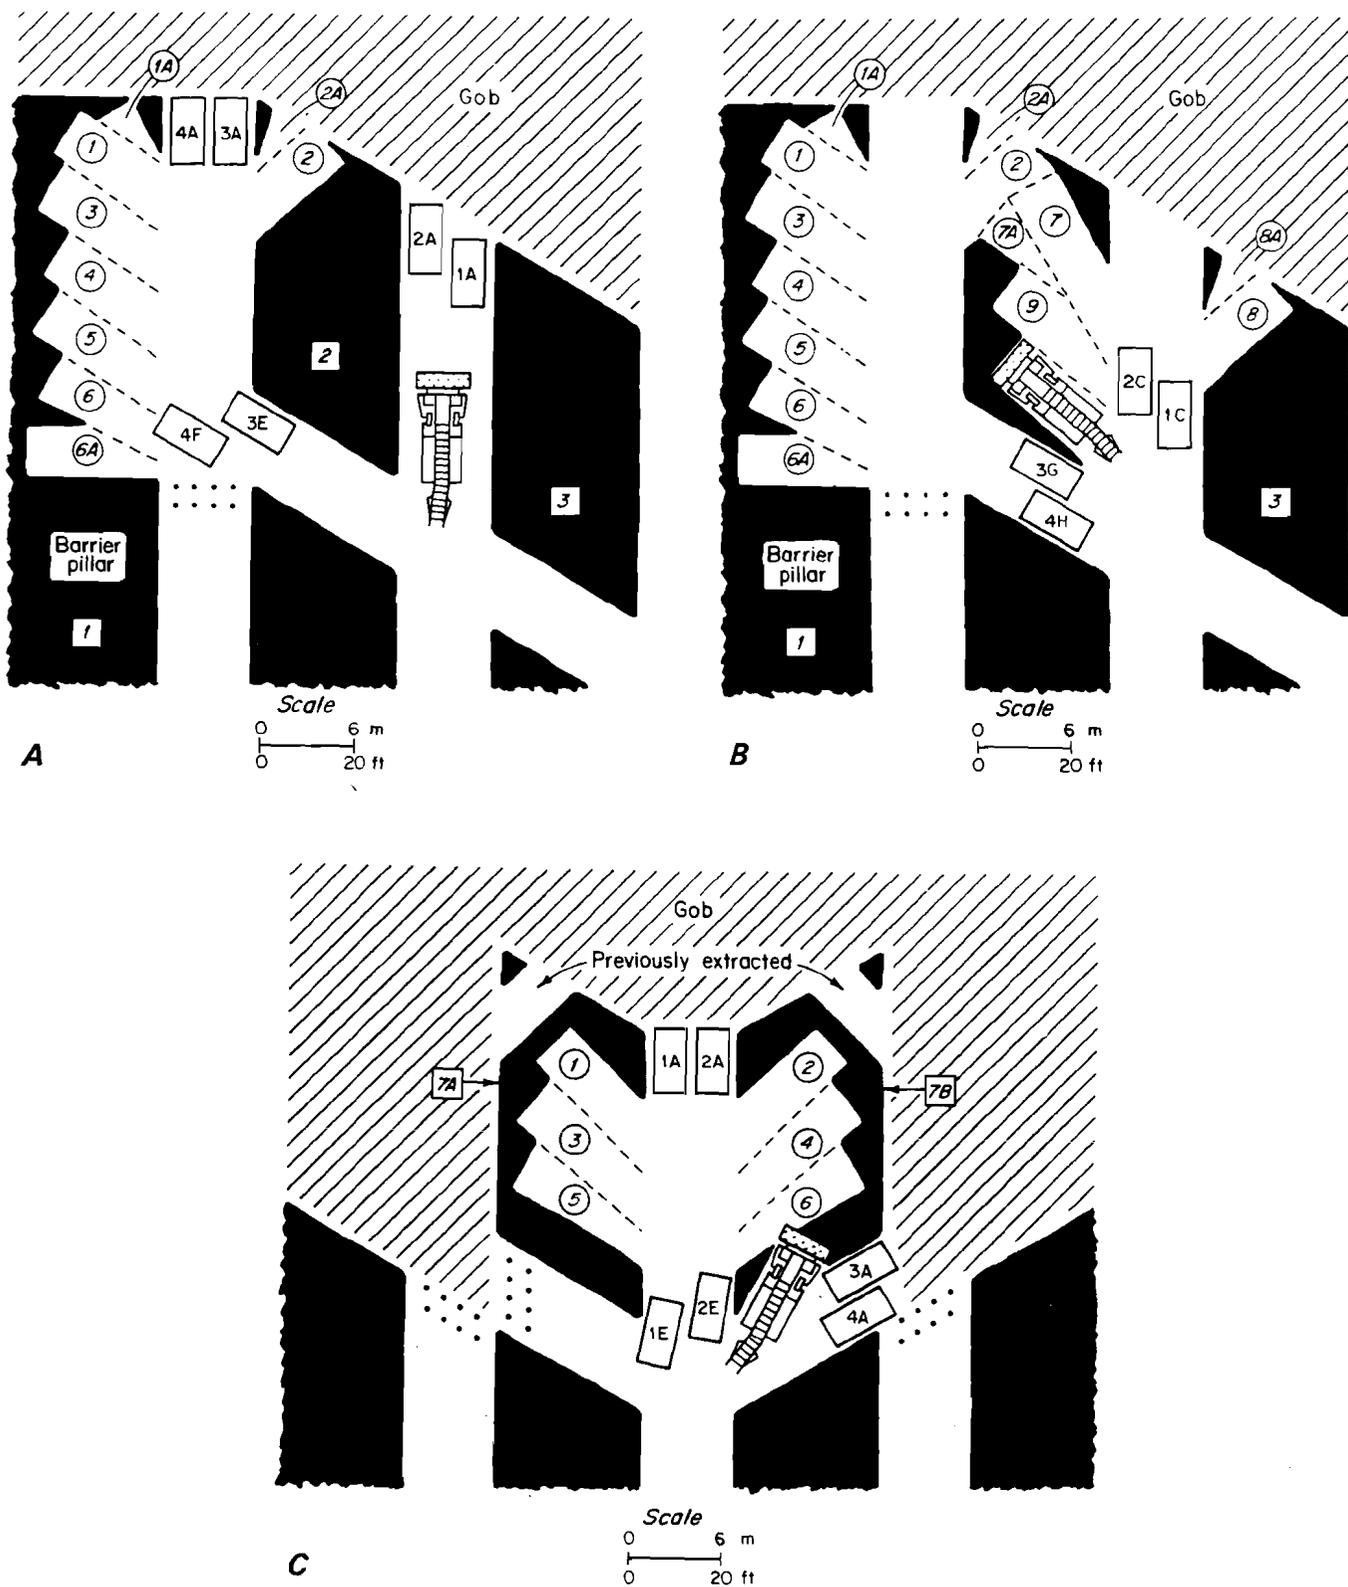
length of lift 7 shown in figure 7B. Mobile units 3 and 4 are positioned and pressurized at locations E and F, respectively, during breaker installation (figure 7A).

If poor ground conditions occur, they normally develop in the center or belt entry because the center pillars being mined are surrounded by gob on three sides, as shown in figure 7C. Figure 7C also displays mobile positioning during pushout removal in pillar 7B. A single pushout is usually removed from either pillar 7A or 7B. The push is taken from whichever fender is least loaded. The other fender (pillar 7A remnant) is left intact to function as a breaker during equipment removal. If both fenders exhibit severe loading, no pushout is taken. A laid-down version of this design has also been tried by one operator. A high incidence of roof falls in the belt entry prompted this operator to change to three-way belt entry intersections (figure 8). Three U.S. operators have employed mobiles in conjunction with continuous haulage. In one operation, shift production exceeded 5,400 t (6,000 st) during barrier pillar slabbing.

Figure 7.—Herringbone design: A, lift sequence for pillars 1 and 2; B, lift sequence for pillars 1-3; C, lift sequence for pillars 7A and 7B.

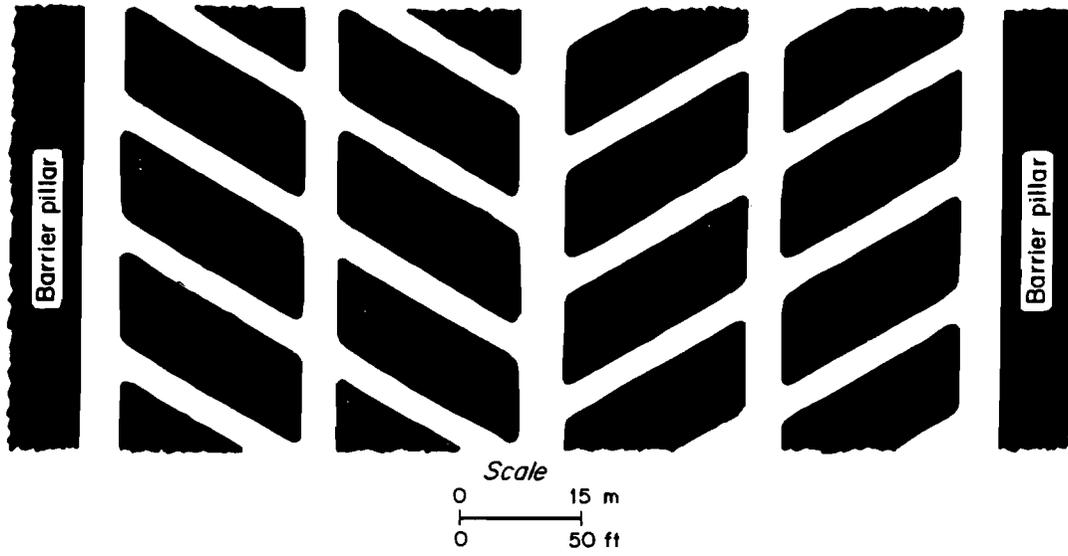
Figure 8.—Three-way intersection belt entry design.

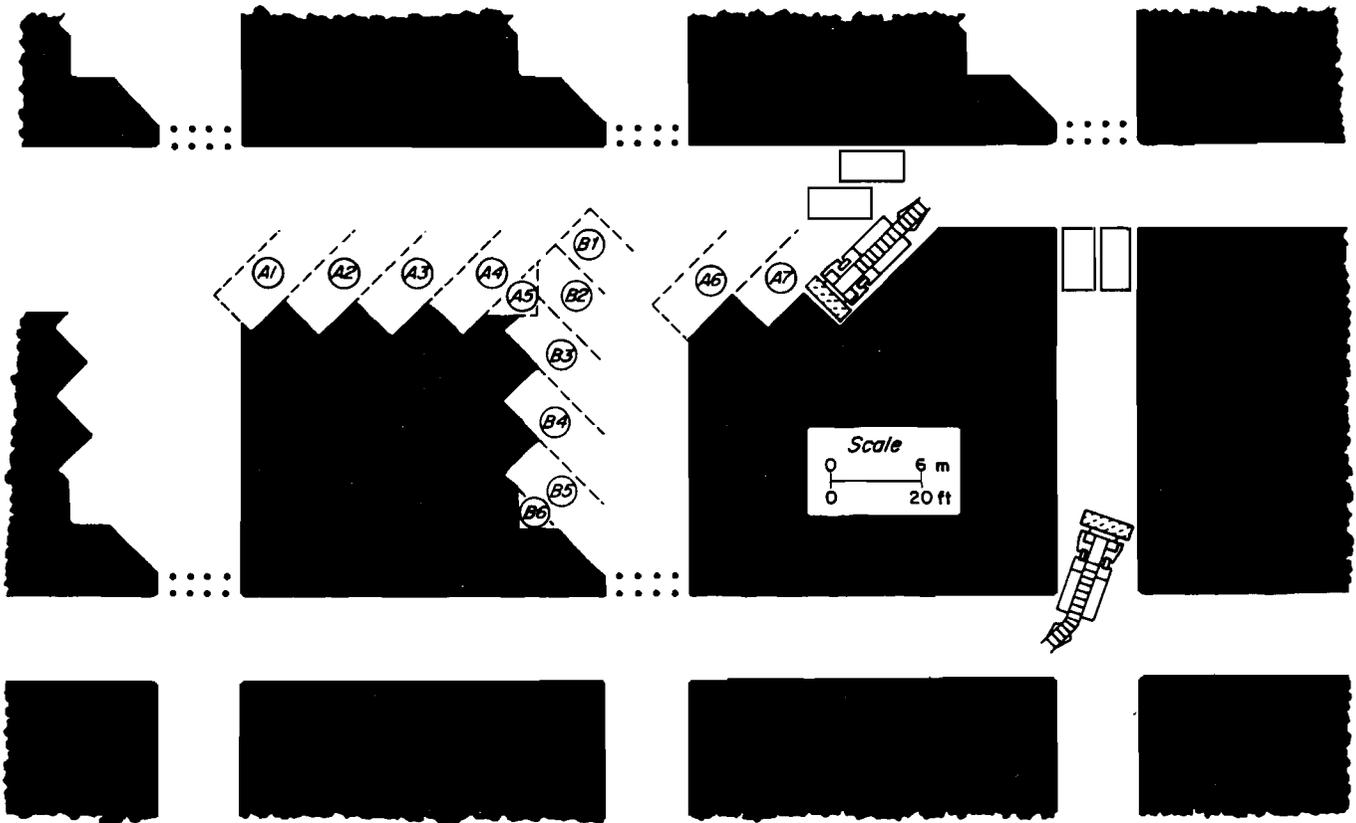
Figure 9.—Partial pillar extraction by slabbing.

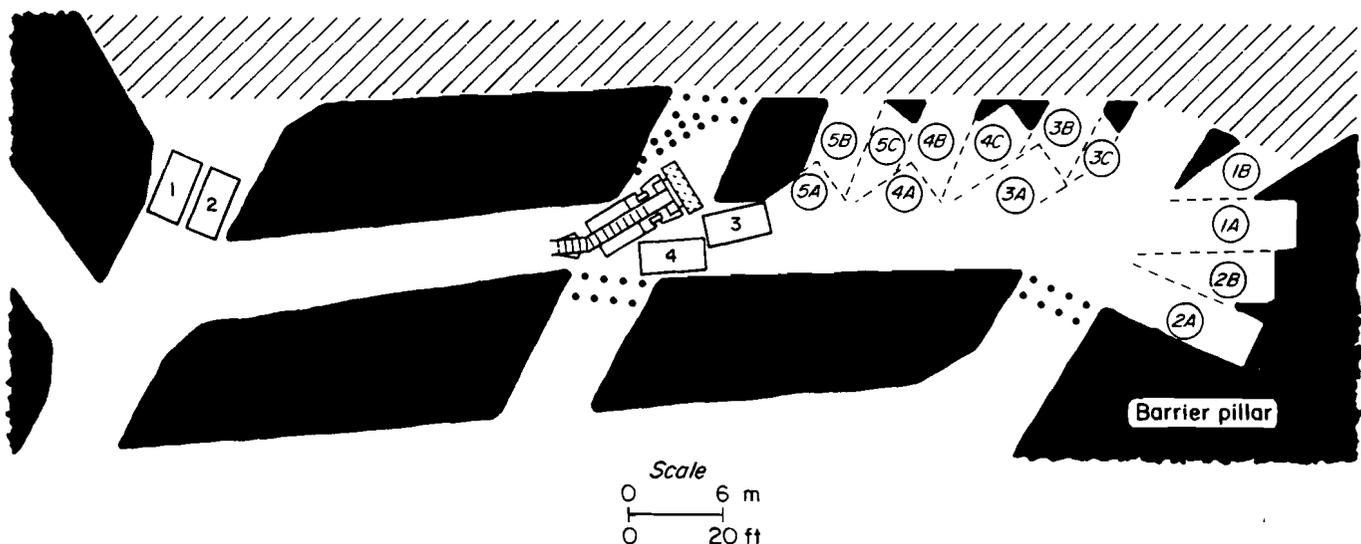
Figure 10.—Outside lift pillar extraction using temporary support fenders.

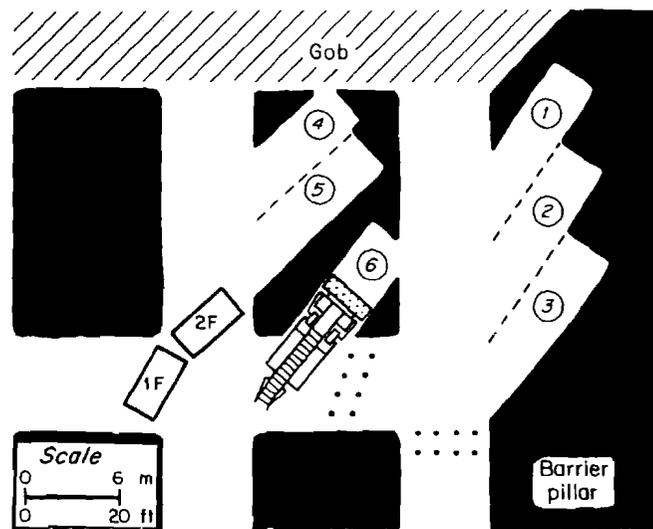
Figure 11.—Combination mobile/timber plan.
