## The Consequences of 'Leaky' Enclosures

David C. Byrne, National Institute for Occupational Safety and Health  
Pittsburgh, Pennsylvania

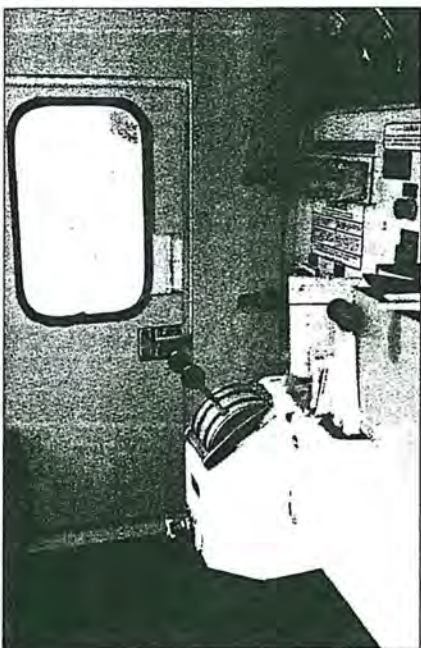
Figure 3. A well-designed operator cab.

Figure 3 shows an example of a well-designed operator cab. The doors and windows close securely. Also, a flexible barrier material or caulking was used to seal around all controls, allowing adequate movement of levers while maintaining the overall integrity of the enclosure. In other situations, equipment manufacturers employ electrical controls rather than mechanical ones to minimize the number of moving parts that must

pass through the enclosure wall into the cab.
