## 21<sup>st</sup> International Conference

## ANCHORAGE PULL TESTING FOR FULLY GROUTED ROOF BOLTS

Christopher Mark, *Rock Mechanics Team Leader*  
Craig S. Compton, *Engineering Technician*  
David C. Oyler, *Mechanical Engineer*  
Dennis R. Dolinar, *Mining Engineer*  
National Institute for Occupational Safety and Health  
Pittsburgh Research Laboratory  
Pittsburgh, Pennsylvania USA

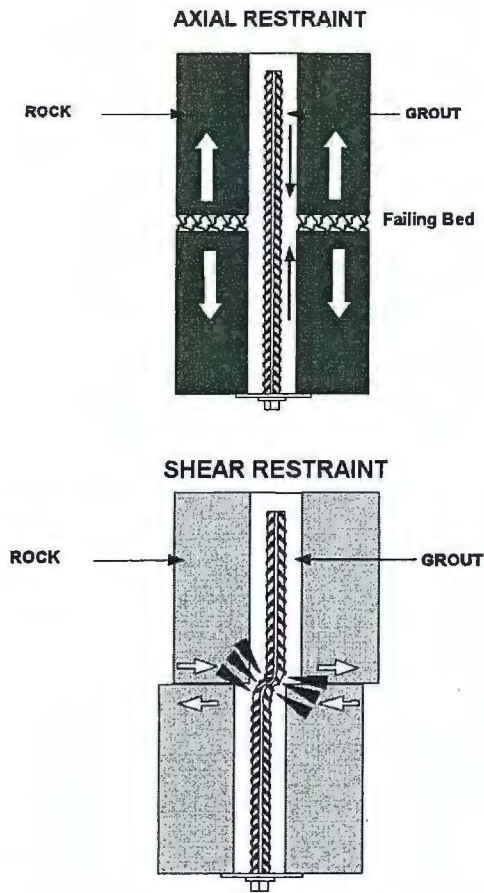
Figure 1. Loads in fully grouted roof bolts caused by roof movements. (Top) Tension resulting from bed dilation or bed separation; (Bottom) Tension and bending caused by slip on a bedding plane.

Fully grouted bolts are loaded by movement of the rock. The movement may be vertical sag, shear along a bedding plane, or dilation of a roof layer buckled by horizontal stress (figure 1). The movements cause tensile forces in the bolt, usually combined with bending stresses.

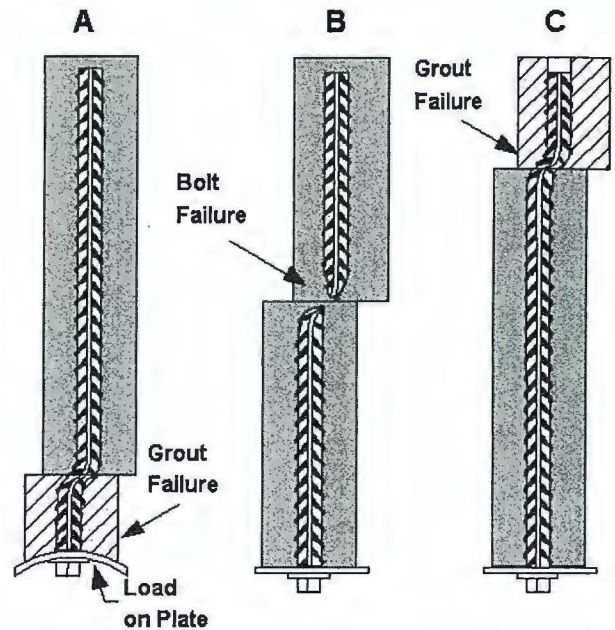
Figure 2. Failure mechanisms of a fully grouted roof bolt. (A) Roof movement near head; (B) Roof movement in central portion; (C) Roof movement in anchorage zone.

Depending on where the roof movements are concentrated, the bolts can fail in one of three ways, as shown in figure 2 (7, 8):<sup>1</sup>

- The head or the plate can fail;
- The rod may break, either in tension, or a combination of tension and bending; or
- The anchorage may fail.

The anchorage can fail when roof movement occurs near the top of the hole, as shown in figure 2c. If the load applied to the bolt exceeds the strength of the grout anchor, the top of the bolt will be pulled out of the hole. If the bolt had been suspending weak or failed lower roof from intact upper rock, a roof fall can follow.

Roof falls can sometimes provide clues as to the type of bolt failure that took place. If broken bolts can be seen, the anchorage was probably adequate, and the problem may have been that the capacity of the bolts was inadequate to resist the loads applied by the roof (as in figure 2b). But if the tops of resin bolts can be seen protruding from the top of the muck pile after a fall, then inadequate anchorage should be suspected (figure 2c and figure 3).

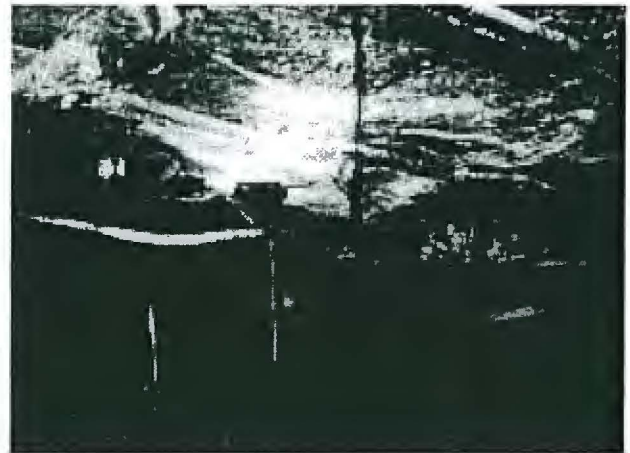
Figure 3. Photograph showing fully grouted bolts pulled from their holes in a roof fall.

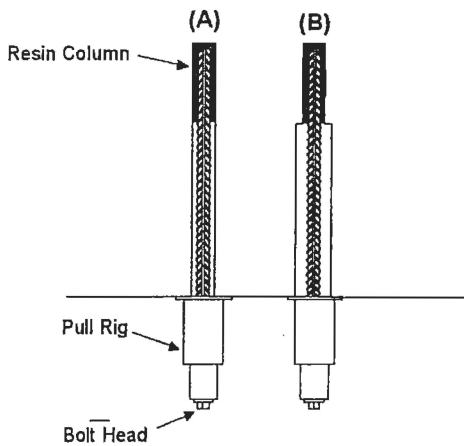
Figure 4. The Short Encapsulation Pull Test. (A) Normal hole; (B) Reamed hole.

The Grip Factor must be determined by loading the upper portion of the grouted bolt. This is accomplished with short encapsulation pull tests (SEPT), in which only the top 12 in of the bolt is grouted (figure 4). The Grip Factor (tons per inch) is calculated as:

- **Hole Reaming:** One method to ensure the correct encapsulation length is to ream the lower portion of the hole to a larger diameter (figure 4b). Then only the upper, unreamed portion of the hole is effectively grouted. This method is employed internationally, though an unreamed test is also allowed in the U.K. under certain conditions (10, 20). Reamed holes also make it possible to pull the bolt completely out, so that the resin anchor can be viewed.

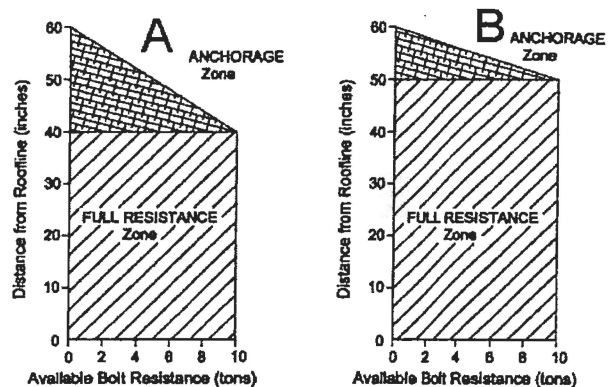
Figure 5. Effect of the Grip Factor on the resistance available from 10-ton roof bolts to react against roof loads. (A) Grip Factor = 0.5 tons/in; (B) Grip Factor = 1.0 ton/in.

Figure 5 illustrates the effect of the Grip Factor on bolt performance. Within the anchorage zone (the upper portion of the bolt), the bolt's available resistance to loading from rock movement may be considerably less than its nominal yield strength. The length of the anchor ( $L_{Anch}$ , in in) is the bolt's yield load ( $Y$ , in tons) divided by the Grip Factor (GF):

Obviously, a bolt with a larger Grip Factor will have more available resistance over a longer length, as shown in figure 5b. In fact, the "Full Resistance Length" ( $L_{FR}$ ) of a fully grouted bolt, which is the zone in which the force available to resist rock movement is at least equal to the yield strength of the bolt, is the total bolt length  $L$  minus the length of the anchor:

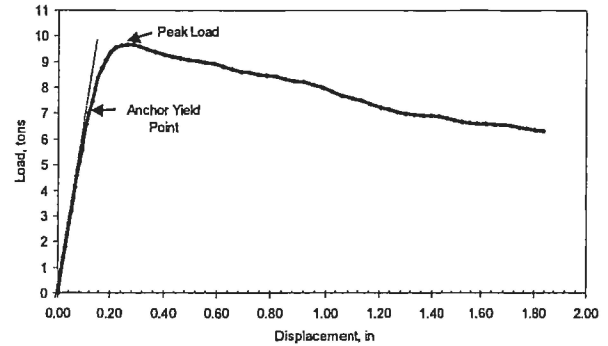
Figure 6. Load deformation curve for typical short encapsulation pull test.

Figure 6 shows a typical load deformation curve for a short encapsulation pull test in which the anchorage fails (and the rod does not yield). Initially the load deformation curve is linear. However, as the resin along the lower portion of the anchor begins to fail, the load deformation curve deviates from a straight line. As the applied load approaches and exceeds the peak anchor capacity, the anchor begins to slip. After the peak the anchor still carries on average about 70% of the peak load over 1.5-2.0 in of deformation.

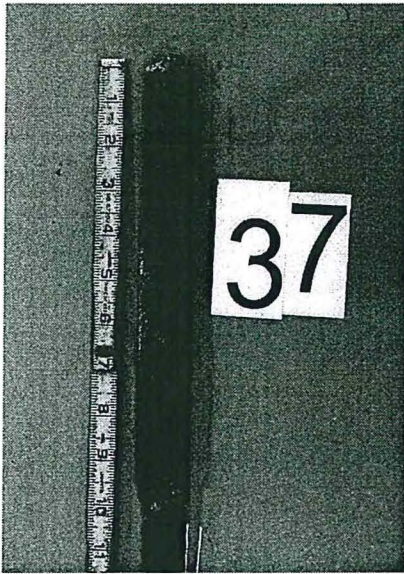
Figure 7. View of a short column grout anchor recovered from the roof.

As part of the tests, 32 of the anchors were recovered by pulling the bolts completely out of the reamed holes. Figure 7 shows a typical anchor that was pulled from the roof. Each anchor was examined for evidence of the length of the installed grout column while the length of the grout still attached to the rebar was measured. This confirmed that the specified grout length was achieved during the installation. Usually about a 7 to 10 in long solid length of anchor was still attached to the rebar after being pulled from the roof. About 2 to 4 in of the grout would break away from the lower portion of the anchor. This is the portion of the grout that failed during the pull test.

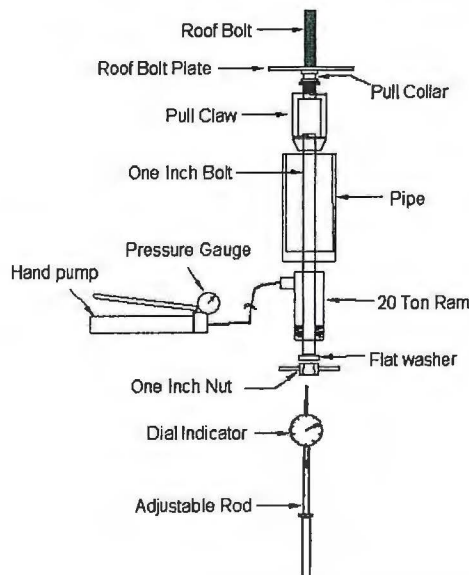
Figure A1. Exploded drawing of pull test apparatus.

Performing a short encapsulation pull test is basically the same as a standard pull test. The main difference is that the resin-rock anchorage of a specific horizon in the roof is being tested instead of overall bolt performance. The equipment needed is the standard pull gear (fig. A1), plastic tie wraps, and a resin keeper (an O-ring). The resin column may also be pulled out of the roof for examination. This requires items listed in fig. A2 and some additional time.

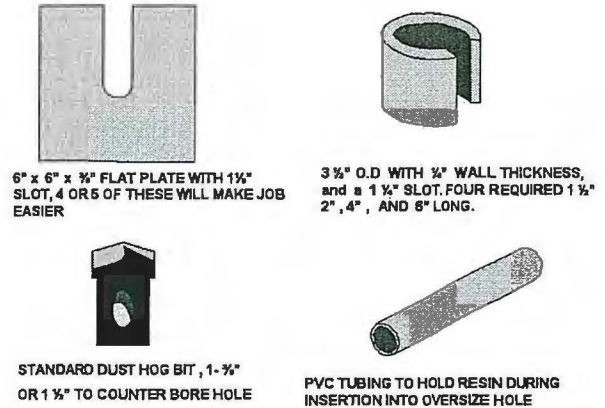
Figure A2. Additional material needed to ream hole and completely remove roof bolt.

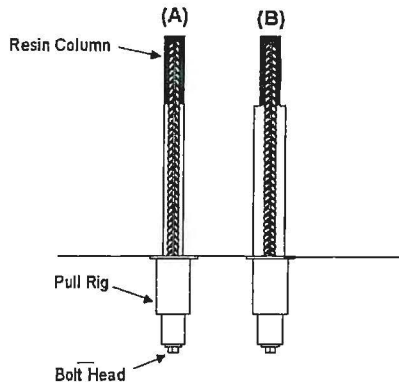
Figure A4. The Short Encapsulation Pull Test. (A) Normal hole; (B) Reamed hole.

5. Measure the hole length by assembling the bolt, pull collar, and flat roof bolt plate. The depth of the test hole is the distance from the plate to end of the roof bolt, plus one inch (fig. A4).

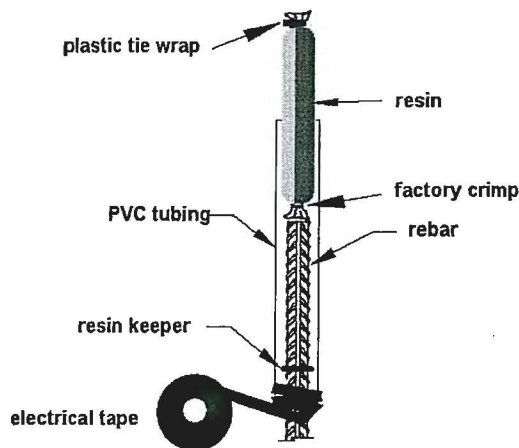
Figure A5. Using a short length of PVC tubing to insert the resin cartridge into the top of a reamed hole.

6. Use a new bit to drill the first hole, and measure periodically to ensure that there has not been excessive wear.
7. *(If a reamed hole is not desired then skip to step #8.)* Counter-bore the hole with a 1-3/8- to 1-1/2-in bit to within thirteen in of distance measured above. It is important not to go too deep with the counter-bore because it will compromise the effective length of resin column. A suggestion for keeping the resin in place while inserting a bolt through the oversized hole is shown in fig. A5.
