Ground Control Mining Research

21st International Conference

THE INTRODUCTION OF ROOF BOLTING TO U.S. UNDERGROUND COAL MINES (1948-1960): A CAUTIONARY TALE

Christopher Mark, Chief, Rock Mechanics Section
National Institute for Occupational Safety and Health
Pittsburgh Research Laboratory
Pittsburgh, Pennsylvania USA

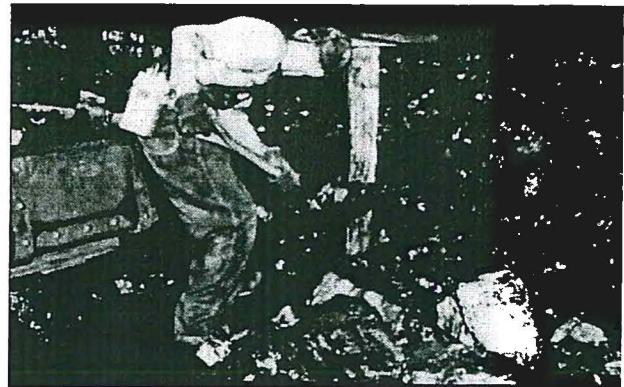
Figure 4. Hand loading with a safety post.

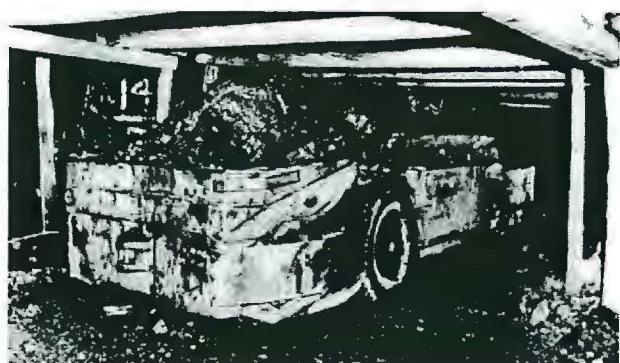
Figure 6. Shuttle car haulage with timbers.

The difficulties posed by traditional timber supports increased as the early track-mounted loading machines were replaced by crawler-mounted ones. When rubber-tired shuttle cars that carried coal away from the face were introduced in the late 1930's, "timbering resolved itself into setting cross-bars, because the machines required the full width of the place, leaving no room for posts."²¹ The maximum span without a post increased from the 9-10 ft over track to 15-20 ft and even more (figure 6). Intersections were particularly difficult, and mines with weak top that required narrow entries or close timbering had particular problems. In fact, during this time the Bureau maintained a separate category of fatalities from "roof falls due to car or machine knocking out post." In 1946, for example, 14 deaths were attributed to this cause.²²

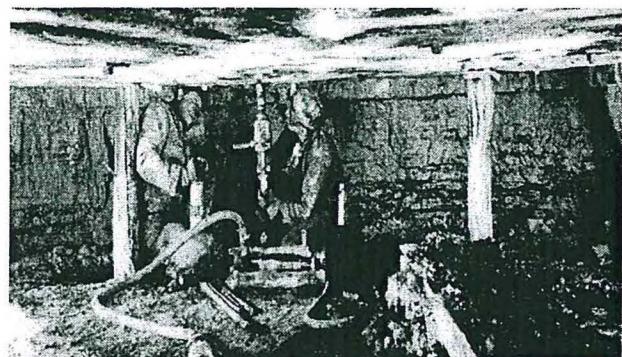
Figure 10. Installing roof bolts with a hand-held stoper drill.

The first roof bolts were installed in Mine No. 7 using hand-held stoper drills (figure 10). The anchors were expansion shells "similar to those used to support trolley wire", though slot-and-wedge type anchors like the ones "ordinarily used in the metal mines" were also employed. A section of channel iron was used as a plate. The DC air compressor was powered by a trailing cable and mounted on a truck. Two men constituted the bolting crew.³⁶

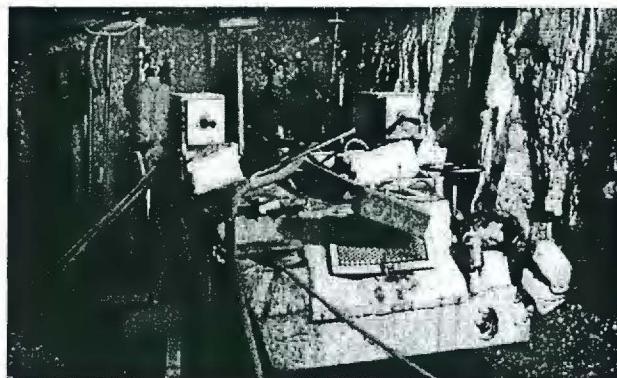
Figure 12. An early roof bolt machine.

The Bureau's campaign had to overcome two primary barriers to the new technology. The first was the cost and availability of the required equipment. The development of carbide alloy insert bits was essential because it made it possible to drill holes cheaply in hard rock.⁴⁶ Hand-held stoper drills were already available at most mines, but they now required a mobile source of compressed air. Many of the first mines to install roof bolts built their own cars to carry the drills, compressor, bolts, and other supplies from face to face (figure 12). In some cases, timbering machines were modified to double as roof bolters. The bolts themselves were not readily available either. In some cases, they were fabricated in the mine's own shop.

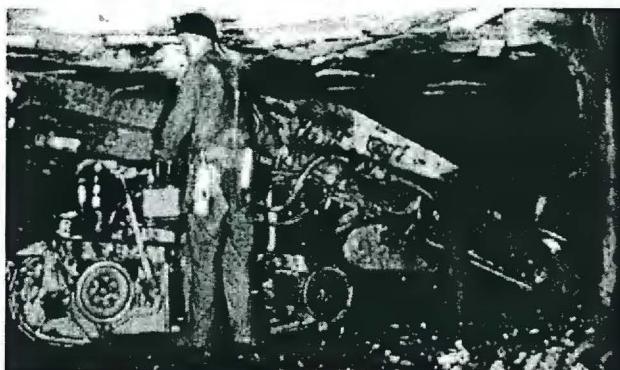
Figure 14. Machine loading with roof bolts.

Between 1949 and 1955, numerous case histories of the successful application of roof bolting from all over the coalfields were reported in the mining press (figures 13 and 14). An early article reported that three northern West Virginia mines of the Christopher
