## Preprint 03-138

### FIELD PERFORMANCE TESTING OF FULLY GROUTED ROOF BOLTS

C. Mark  
C. S. Compton  
D. R. Dolinar  
D. C. Oyler

Natl. Inst. for Occupatnl. Sfty. & Health  
Pittsburgh, PA

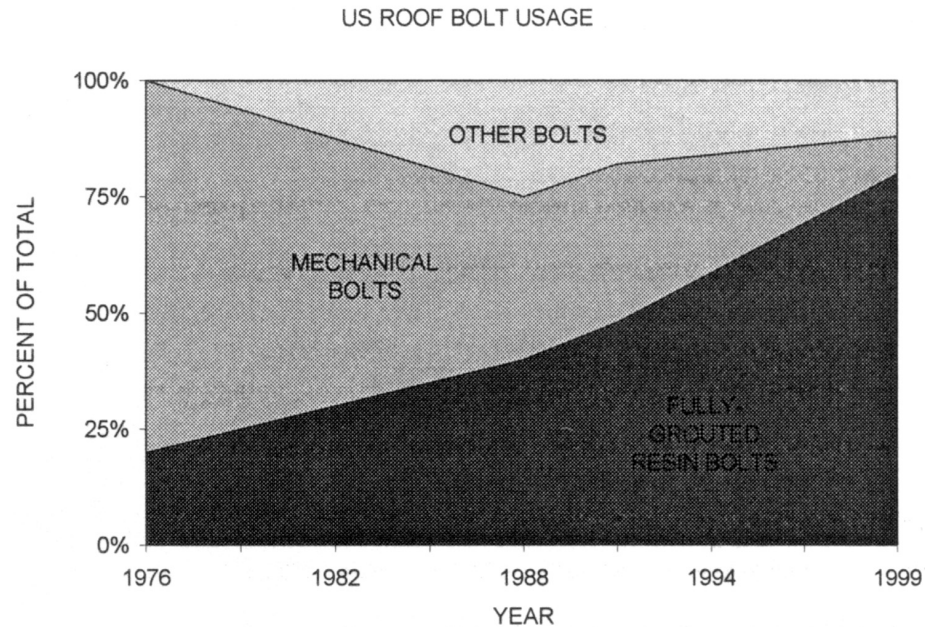
Figure 1. Trends in U.S. roof bolt usage (source: Dolinar and Bhatt, 2000).

Roof bolts have been the primary roof supports in U.S. coal mines since the late 1950's. Fully grouted resin bolts were introduced about a decade later. A survey conducted by NIOSH in 1999 (Dolinar and Bhatt, 2000) found that the coal mining industry used about 85 million roof bolts. Of these, approximately 80% were fully grouted. Figure 1 shows the historical trends in roof bolt usage in the U.S. For many years, the most common fully grouted bolt installation was a 19 mm (0.75 in) bolt in a 25 mm (1 in) hole. In recent years, however, 16 mm (5/8 in) bolts have become more popular. The 1999 survey found that about 80% of all fully grouted bolts were the smaller diameter.

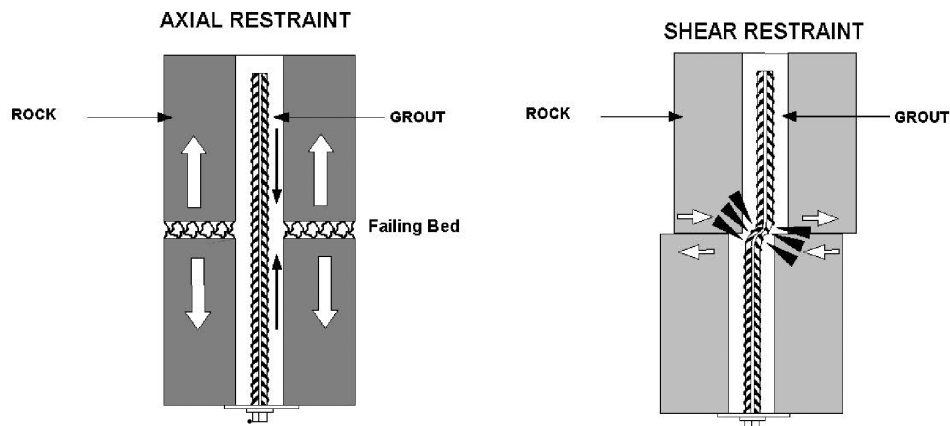
Figure 2. Loads in fully grouted roof bolts caused by roof movements. A) Tension resulting from bed dilation or bed separation; B) Tension and bending caused by slip on a bedding plane.

Fully grouted bolts are loaded by movement of the rock. As illustrated in figure 2, the movement may be vertical sag, shear along a bedding plane, or dilation of a roof layer buckled by horizontal stress (Signer, 2000; Fabjanczyk and Tarrant, 1992). The movements cause

tensile forces in the bolt, usually combined with bending stresses.

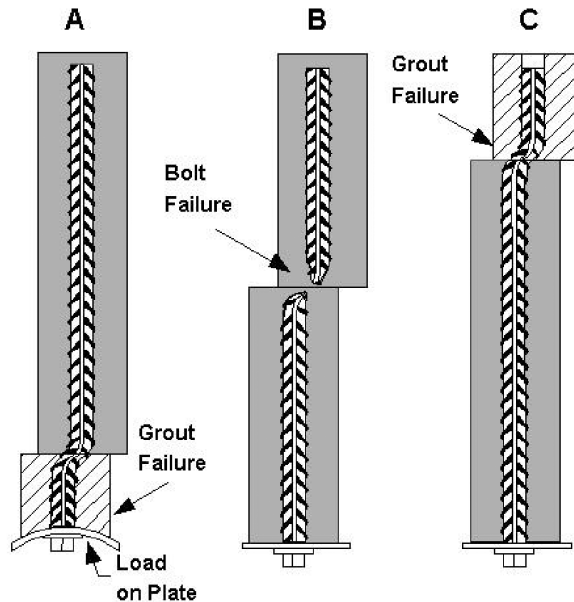
**Figure 3. Failure mechanisms of a fully grouted roof bolt. (A) Roof movement near head; (B) Roof movement in central portion; (C) Roof movement in anchorage zone.**

Depending on where the roof movements are concentrated, the bolts can fail in one of three ways, as shown in figure 3 (Serbousek and Signer, 1987; Mark, 2000):<sup>1</sup>

1. The head or the plate can fail;
2. The rod may break, either in tension, or a combination of tension and bending; or
3. The anchorage may fail.

The anchorage can fail when roof movement occurs near the top of the hole, as shown in figure 3c. If the load applied to the bolt exceeds the strength of the grout anchor, the top of the bolt will be pulled out of the hole. If the bolt had been suspending weak or failed lower roof from intact upper rock, a roof fall can follow.

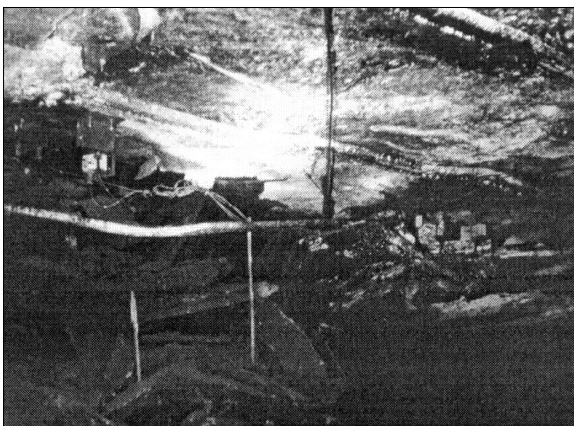
**Figure 4. Photograph showing fully grouted bolts pulled from their holes in a roof fall.**

Roof falls can sometimes provide clues as to the type of bolt failure that took place. If broken bolts can be seen, the anchorage was probably adequate, and the problem may have been that the capacity of the bolts was inadequate to resist the loads applied by the roof (as in figure 3b). But if the tops of resin bolts can be seen protruding from the top of the muck pile after a fall, then inadequate anchorage should be suspected (figure 3c and figure 4).

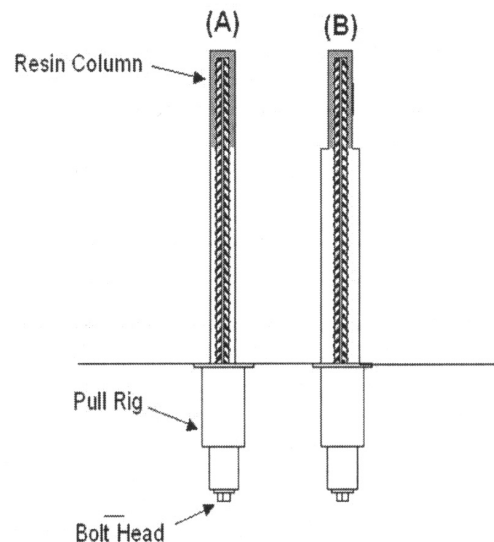
**Figure 5. The Short Encapsulation Pull Test. (A) Normal hole; (B) Reamed hole.**

The effectiveness of the interlock is measured by the "Grip Factor,"<sup>2</sup> which is defined as *the bolt's resistance to pullout per inch of bolt length*. The Grip Factor must be determined by loading the upper portion of the grouted bolt. This is accomplished with short encapsulation pull tests (SEPT), in which only the top 300 mm (12 in) of the bolt is grouted (figure 5). The Grip Factor (tons/in) is calculated as:

- Hole Reaming: One method to ensure the correct encapsulation length is to ream the lower portion of the hole to a larger diameter (figure 5b). Then only the upper, unreamed portion of the hole is effectively grouted. This method is employed internationally, though an unreamed test is also allowed in the UK under certain conditions (Health and Safety Executive, 1996; Wittenberg and Ruppel, 2000). Reamed holes also make it possible to pull the bolt completely out, so

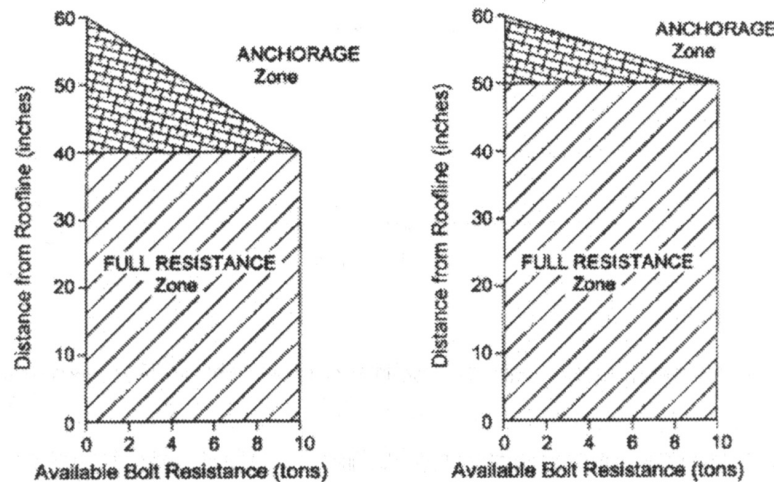
Figure 6. Effect of the Grip Factor on the resistance available from 10-ton roof bolts to react against roof loads. (A) Grip Factor = 0.5 tons/ch; (B) Grip Factor = 1.0 tons/in.

Figure 6 illustrates the effect of the Grip Factor on bolt performance. Within the anchorage zone (the upper portion of the bolt), the bolt's available resistance to loading from rock movement

may be considerably less than its nominal yield strength. The length of the anchor ( $L_{Anch}$ , in mm or inches) is the bolt's yield load ( $Y$ , in tonnes or tons) divided by the Grip Factor ( $GF$ ):

Obviously, a bolt with a larger Grip Factor will have more available resistance, as shown in figure 6b. In fact, the "Full Resistance Length" ( $L_{FR}$ ) of a fully grouted bolt, which is the zone in which the force available to resist rock movement is at least equal to the yield strength of the bolt, is the total bolt length  $L$  minus the length of the anchor:

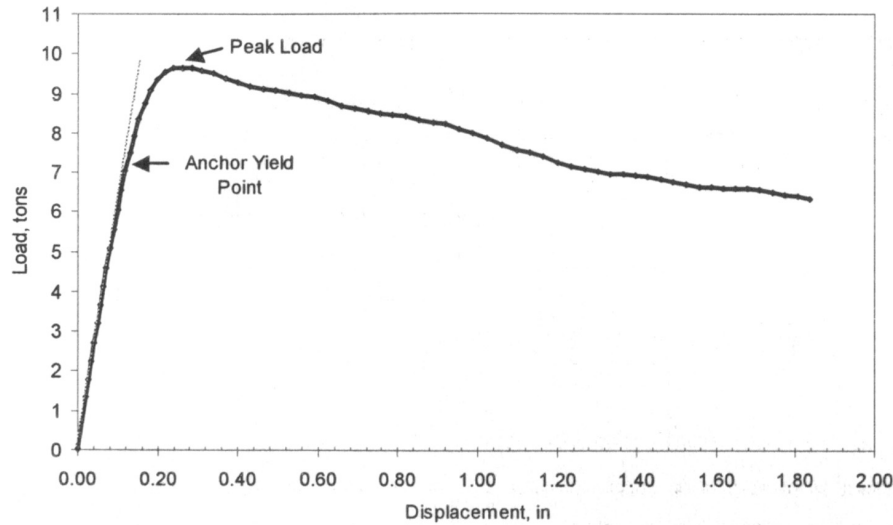
Figure 7. Load deformation curve for typical short encapsulation pull test.

Figure 7 shows a typical load deformation curve for a short encapsulation pull test in which the anchorage fails (and the rod does not yield). Initially the load deformation curve is linear. However, as the resin along the lower portion of the anchor begins to fail, the load deformation curve deviates from a straight line. As the applied load approaches and exceeds the peak anchor capacity, the anchor begins to slip. After the peak the anchor still carries on average about 70 pct of the peak load over 38-50 mm (1.5-2.0 in) of deformation.

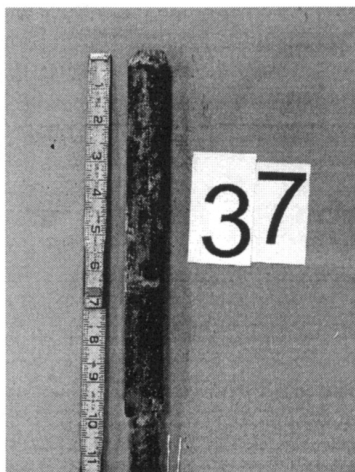
**Figure 8. View of a short column grout anchor recovered from the roof.**

As part of the tests, 32 of the anchors were recovered by pulling the bolts completely out of the reamed holes. Figure 8 shows a typical anchor that was pulled from the roof. Each anchor was examined for evidence of the length of the installed grout column while the length of the grout still attached to the rebar was measured. This confirmed that the specified grout length was achieved during the installation. Usually 70-80% of the installed length of anchor was still attached to the rebar after being pulled from the roof. The other 50-100 mm (2 to 4 in) of the grout usually broke away from the lower portion of the anchor. This is the portion of the grout that failed during the pull test.
