**DESIGN PARAMETERS OF ROOF SUPPORT SYSTEMS
FOR PRE-DRIVEN LONGWALL RECOVERY ROOMS**

S. C. Tadolini
T. M. Barczak
NIOSH
Pittsburgh, PA

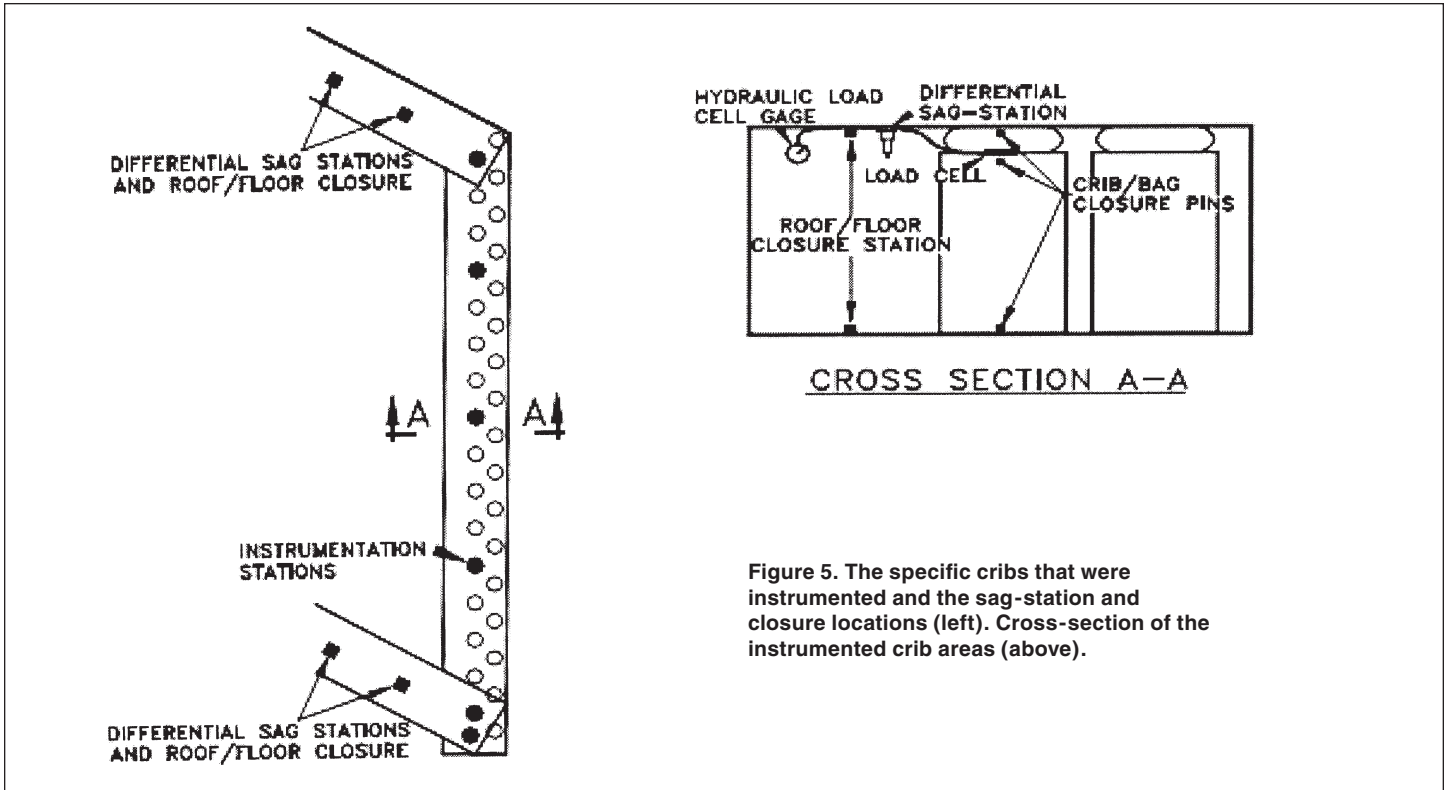
Figure 5. The specific cribs that were instrumented and the sag-station and closure locations (left). Cross-section of the instrumented crib areas (above).

An instrumentation package was selected that would help evaluate the performance of the cribs and the primary and secondary roof support systems. Ten differential sag-stations were installed across the room and in the recovery chutes to monitor roof deformation. The differential sag-station anchors were located at the 6-, 10-, and 15.5-ft depths into the mine roof. Roof-to-floor closure stations were established at the same locations so that the floor stability could be evaluated. Six cribs spaced along the length of the recovery room were fitted with flat-jack load cells placed between the top of the concrete crib and the bag so that actual crib loads could be measured. To complement the crib loading behavior, metal datum pins were driven into the concrete cribs and bags so that the actual crib displacements could be determined. The crib support stiffness, an indication of performance and a key component for evaluation, could be determined by measurement of the crib load and displacement. Figure 5 shows the specific cribs that were instrumented and the cross-section

A-A illustrates the approximate measurement configuration. Individual shield loading was also monitored from the on-board computer at the stage loader area. The loads were transmitted by the data acquisition system transducers installed on the longwall shield legs. The shields had a working capacity of 650 tons. Figure 6 shows a photograph of a small zone of completed ribs, roof reinforcement, and instrumentation.

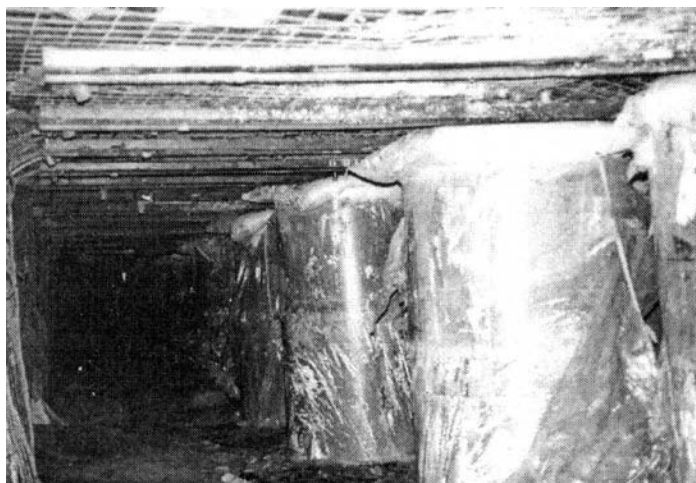
Figure 6. Photograph of completed cribs, roof supports, and instrumentation.

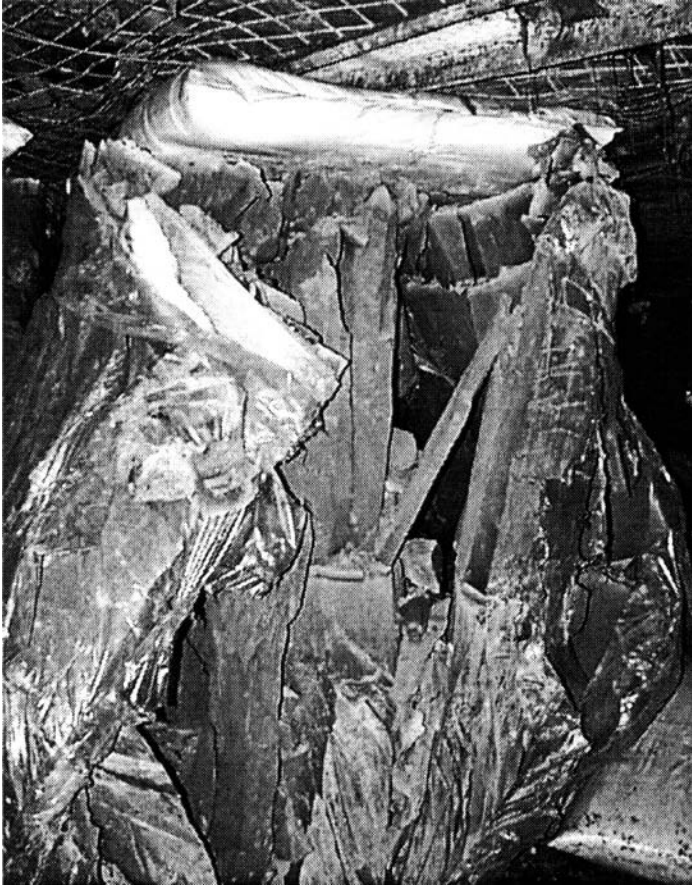
Figure 7. Brittle crib failure prior to the longwall entering the recovery room.

The greatest measured crib load was approximately 1,000,000 lbs. This load, coupled with the crib displacements, results in a stiffness calculation for the concrete crib and the bag of 1.69×10^6 lb/inch. This value is significant because it represents an indication of the resistance to load. While this stiffness helped minimize roof closure and movement, the stiff material properties may have caused the cribs to fail in a brittle mode as shown in Figure 7.
