DEMONSTRATION OF REMOTE MINE SEAL CONSTRUCTION

Thomas A. Gray
GAI Consultants, Inc.
Monroeville, PA

Michael A. Trevits
NIOSH
Pittsburgh, PA

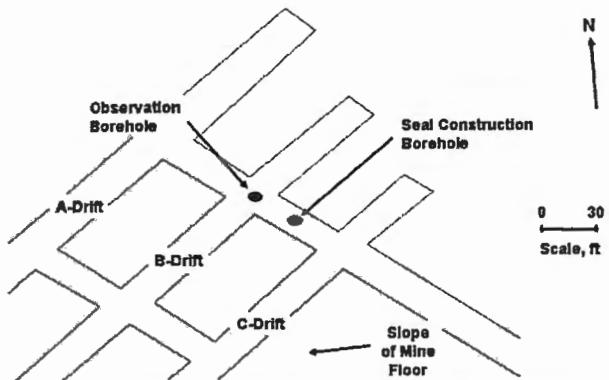
Figure 2. Underground layout of the seal construction site.

Previously, a 6-in diameter cased borehole was completed in the first cross-cut between the B and C Drifts of the experimental mine and it was determined that this borehole was suitable for the seal construction work (figure 2). The thickness of the overburden in the area of the borehole is about 200 ft. The cross-cut in the mine measured 19 ft wide, 40 ft long and 7 ft high. The floor sloped on the order of 1.13 percent gradient. A second borehole, located about 30 ft away, was available for viewing the mine seal installation through use of a downhole video camera. In-mine to surface communication was facilitated through the use of a mine pager phone system.

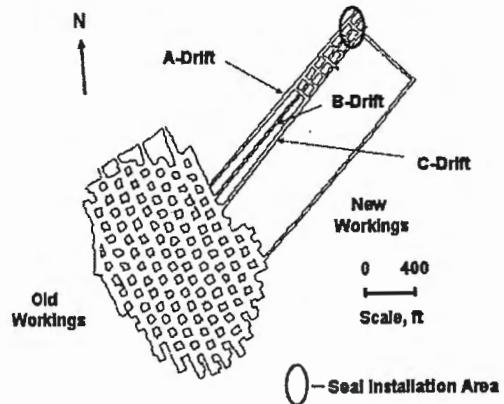
Figure 1. Layout of the Lake Lynn Laboratory Mine.

The work was conducted at LLL. The Lake Lynn Laboratory is a highly sophisticated underground and surface laboratory located about 60 miles southeast of Pittsburgh, PA, and 10 miles northeast of Morgantown, WV, where large-scale explosion trials, mine fire research and a myriad of other mine safety and health research programs are conducted. The underground workings are sized to match those of commercial mines, thus making them true, full-scale test galleries. Movable bulkheads permit the setup of single-entry, triple-entry, and longwall face configurations for experiments (NIOSH 1999) (figure 1).

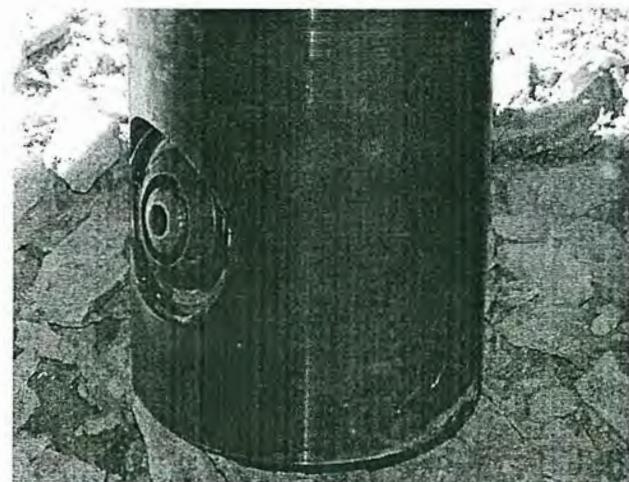
Figure 3. Spray nozzle.

The first process was designed to use a technique very similar to that used when placing bulk grout with a tremie pipe. The concept called for the bottom of the injection casing to be slotted to facilitate some directional control of the grout stream. The bulk grout material would be placed in separate lifts with time between lifts to allow the material to begin to stiffen. The second placement technique required the use of two strings of pipe (one inside of the other) to convey two streams of material to a spray nozzle. The spray nozzle permitted the blending of the two-part grout accelerator mix while allowing sufficient air velocity to transport the grout to the mine roof-and-rib areas. A spray nozzle was designed by GAI for this purpose (refer to figure 3). In both techniques, an on-site volumetric mixing plant was used to blend the grout mixture. The bulk grout was pumped to the borehole using a positive displacement pump and the sprayed grout was moved to the borehole using a conventional grout pump and compressed air.

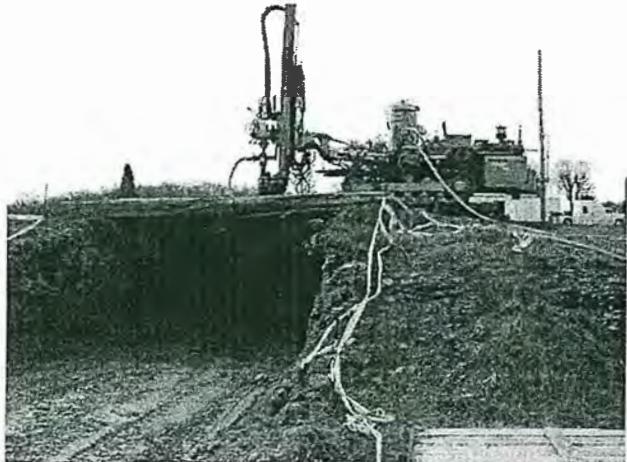
Figure 4. View of the model mine.

downhole nozzle and pumping equipment. The model mine opening consisted of a small excavation in a hillside (figure 4). The roof of the model mine was formed using crane mats so a drill rig could be located over the mine void to hold the pipe for the spray nozzle.

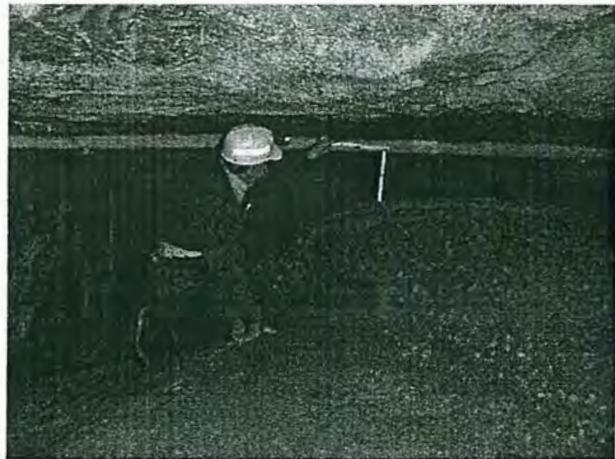
Figure 5. Underground view of bulk fill material for seal No. 1.

On July 22, 2002, placement of the bulk fill for seal No. 1 was initiated using a mixture composed of 2A crushed limestone aggregate, flyash and cement. This mixture was pumped into the mine opening using a string of casing. Bulk fill was pumped over different time intervals with a pause between intervals to allow the in-place grout to stiffen. This process was used in an attempt to control the extent of lateral material flow out of the mine cross-cut areas. The pumping time and the pause intervals were determined by visual observation via a downhole video camera and communication with the mine pager phone. Pumping was terminated after approximately 112 yd^3 of material had been placed into the cross-cut (figure 5). Underground examination revealed that the mine opening had not been completely sealed (open spaces were observed at the mine roof-and-rib areas) and some of the bulk fill material had flowed into the adjacent mine areas.

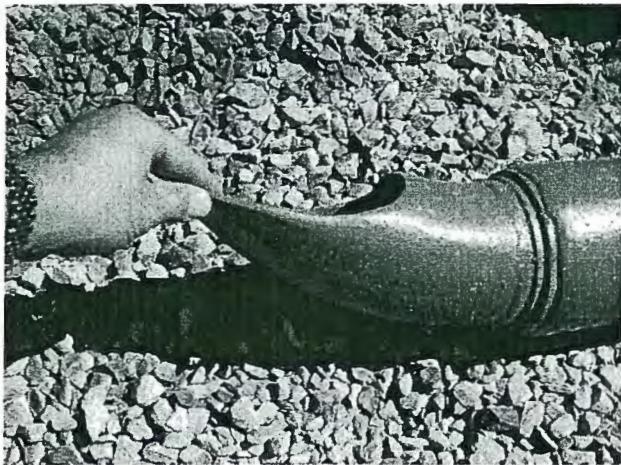
Figure 6. Elbow for bulk fill placement.

The disappointing results of the spray nozzle application indicated that additional work was needed to further refine the material mix components before the spray nozzle was used again. In the interim, after reviewing the progress made during the placement of the bulk fill, it was decided to fit the end of the casing string of pipe with an elbow to provide a means of directionally controlling the placement of grout material (figure 6). It was also thought that this elbow configuration could facilitate roof-rib closure with the bulk fill material.

On August 2, 2002, a newly designed elbow was lowered into the mine opening from the surface borehole. Once the elbow was positioned in the mine opening, pumping of the seal material began using a 2A limestone aggregate, flyash and cement mixture. Compressed air was added to the flow stream to facilitate movement of the material towards the mine rib areas. This material was pumped into select locations along the mine rib areas in an attempt to fill the mine opening (figure 7). Pumping was terminated after approximately 100 yd^3 of material had been placed into the cross-cut and after the elbow became plugged.

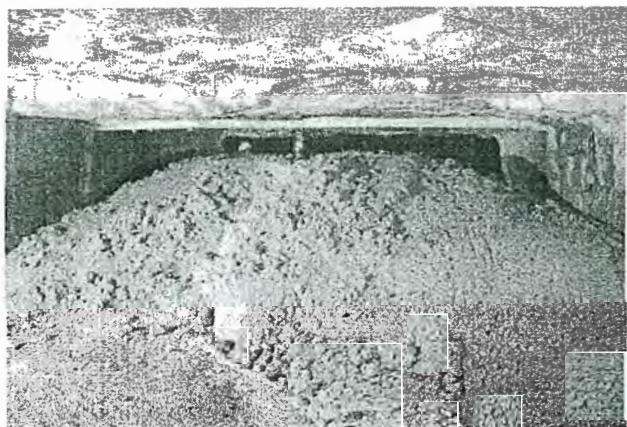
Figure 9. View of bulk fill placement for seal No. 2.

On October 8, 2003, the Howard/GAI team initiated the remote installation of mine seal No. 2 at LLL. Pumping of the first part of the remote seal (bulk material) began using a sand, fly ash and cement mixture. This material was pumped into the mine opening using the elbow. The bulk material was pumped in a series of lifts to fill the mine opening. Pumping was terminated after approximately 55 yd³ of material had been placed into the cross-cut. It should be noted that communication with underground personnel was required to orient the elbow and complete the construction of the base. Underground examination revealed that the mine opening had not been completely sealed, however the seal material was placed to within 1.5 ft of the mine roof below the borehole and within 2.5 to 3 ft of the mine roof near the rib areas (figure 9). It was decided to remove an additional 6 inches of material below the bottom of the borehole to allow sufficient room to test the capability of the spray nozzle.

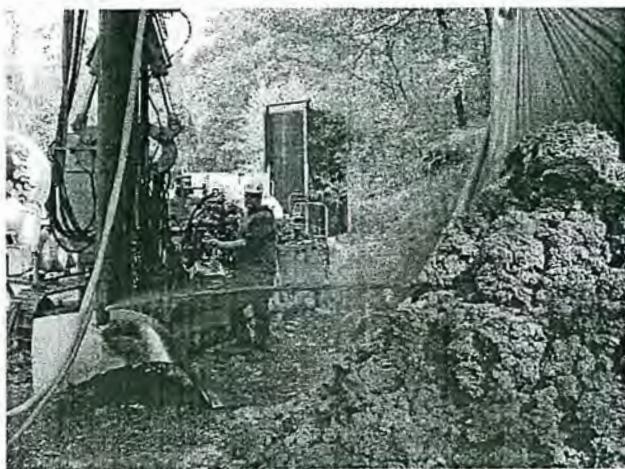
Figure 10. Surface test of spray grout system.

On October 14, 2003, a 10-yd 3 surface test of the final component of the seal mixture (flyash, cement and accelerators) was conducted at LLL (figure 10). The result of the test showed that the mixture would perform as required (little to no slump). A dual string of drill pipe and casing affixed with the spray nozzle was then placed into the 6-in diameter borehole in preparation for the second part of the seal construction.
