Role of fault slip on mechanisms of rock burst damage, Lucky Friday Mine, Idaho, USA

B. G. WHITE & J. K. WHYATT

Spokane Research Laboratory, National Institute for Occupational Safety and Health, Spokane, WA, USA

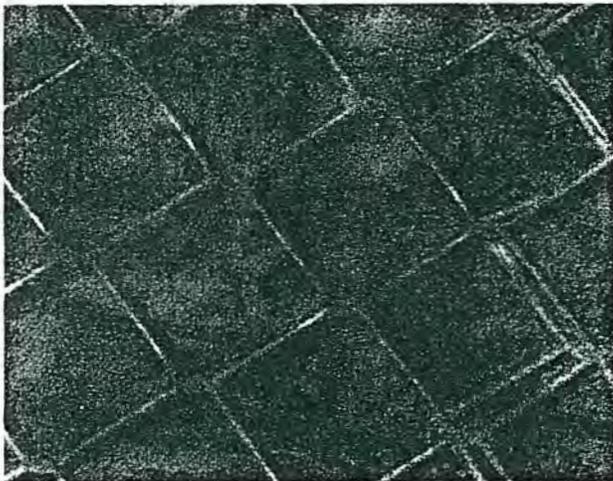
Figure 5. Mining-induced extension fractures in stope walls.

Flat-dipping extension fractures are common in the stope walls and in the advancing stope face (Figure 5). Concentration of these fractures in the upper one-third of mining faces and their persistence up to 10 m into the ribs confirm that they are caused by mining and that they form in the immediate abutment. These fractures are sometimes densely concentrated within zones 5 to 10 cm thick. Thin, tabular rock layers within these zones are occasionally broken, rotated, and disrupted (Figure 6). Evidence of slip has been established by offsets of veins up to several tens of centimeters. Thus, these extension-fracture zones may evolve into flat-dipping thrust faults.
