## 24th International Conference on Ground Control in Mining

### Investigation of Fully Grouted Roof Bolts Installed Under In Situ Conditions

*Craig Compton*, Engineering Technician  
*David Oyler*, Mechanical Engineer  
NIOSH-Pittsburgh Research Laboratory  
Pittsburgh, PA

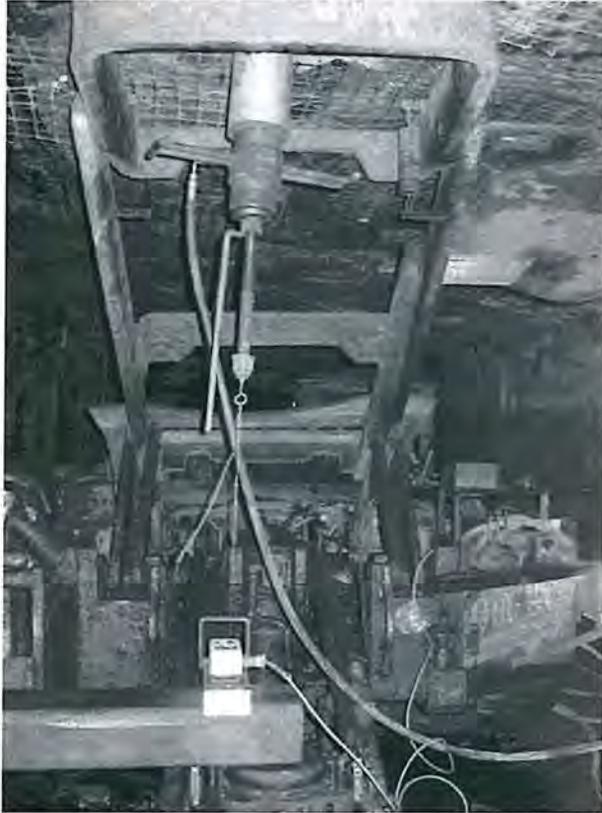
Figure 2. Pull test equipment showing reaction fixture, 20 ton hydraulic ram, 1-inch thread bar and string pot displacement sensor.

pipe used to simulate roof bolt holes, to measure bolt installation pressures. A datalogger and a laptop computer were used to collect and display the data during the tests. The pull equipment, including reaction fixture, pull claw, 20 ton hydraulic ram and 1-inch thread bar, is shown in Figure 2. The bolts were loaded using a hand pump.

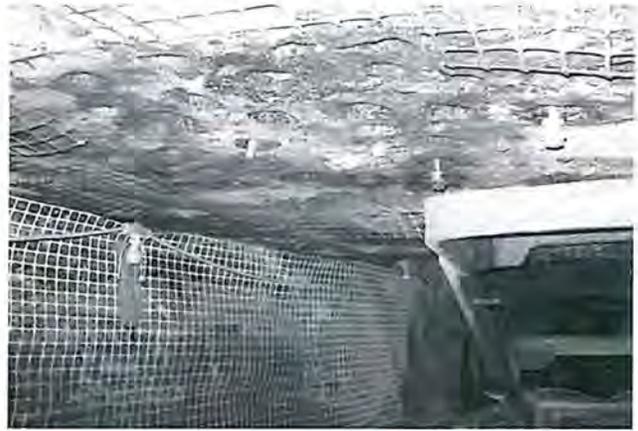
Figure 5. Bolt installation site in NIOSH Safety Research Coal Mine (SRCM), showing the 3 inch diameter holes from overcored bolts and several previously pulled bolts which were not removed from the roof
