Assessment of potential asbestos exposures from jet engine overhaul work

S.P. Mlynarek^a, D.R. Van Orden^{b,*}

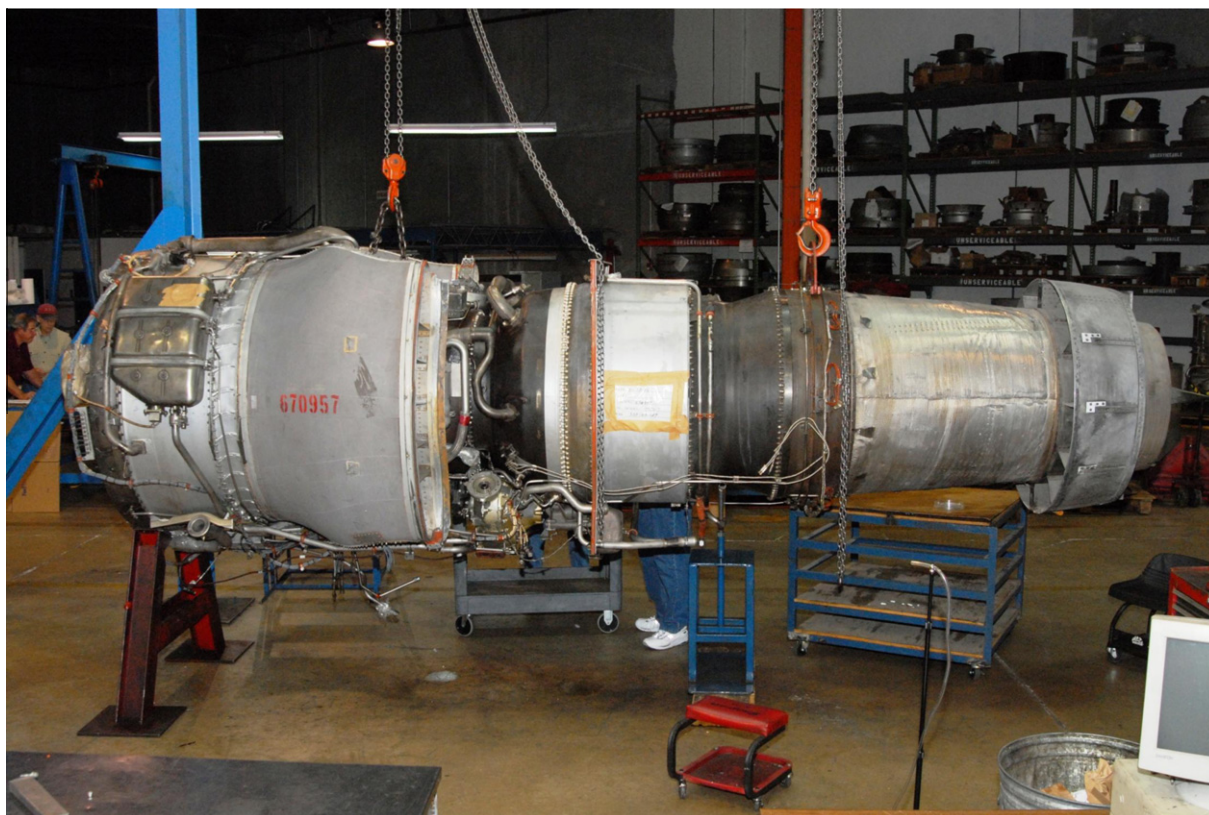
Fig. 1. Pratt & Whitney JT3D-7 engine used in the present study.

The engine is approximately 137 inches long by 53 inches in diameter and weighs 4340 lb. Parts are made from steel, aluminum, titanium, magnesium, and nickel alloys. It also contains non-metallic parts such as gaskets, thermal and electrical insulation and cushioned clamps that hold the external stainless steel plumbing and wiring. The engine has a large external magnesium gearbox that drives most accessory components.

The jet engine used for this study was a Pratt & Whitney model JT3D, a dual shaft turbofan engine derived from the JT3 turbojet of the late 1950s. The first three stages of the JT3 low pressure compressor were replaced by a much larger diameter two stage fan, along with an additional low pressure turbine stage, which improved both thrust and fuel efficiency significantly. The JT3 is called the J57 and the JT3D is called the TF33 in military applications. A photograph of the JT3D engine used in this study is shown in Fig. 1.
