Paper presented at The Third International Fishing Industry Safety and Health Conference (IFISH 3), February 1-4, 2006, Mamallapuram, Tamil Nadu, India

DEVELOPMENT OF AN EMERGENCY STOP SYSTEM FOR A HYDRAULIC DECK WINCH

Robert W. McKibbin, PE
Chelsea C. Woodward
Spokane Research Laboratory
National Institute for Occupational Safety and Health
Spokane, Washington
USA

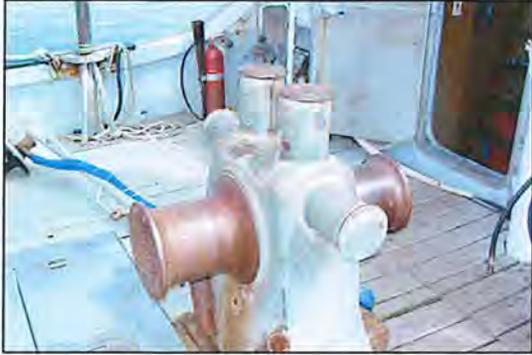
Fig. 1 – Capstan deck winch

The primary task of this project was to design and test a system which has the potential to reduce entanglement injuries in the capstan deck winch typically found on purse seining vessels. This type of winch requires easy access to the rotating winding drums (gypsies) from all angles, and requires workers to stand near it during operation. Fishermen who lose their balance or are

inattentive can be quickly entangled in the purse line as it is winding onto the gypsy drum. Crushing injuries to the hand or arm (and in some cases fatalities if the head or torso is caught) are the inevitable result. SRL staff considered a wide range of potential technologies for preventing entanglement or stopping the winch in the event someone became entangled. These included: pressure mats or pedals on the deck near the winch, activated either by the fisherman stepping onto or off the mat/pedal; guard rails or cables around the gypsies, with or without kill switches; and, various types of e-stops such as light curtains, buttons, or tensioned cables. Each of these options could function either by disconnecting power to only the winch or by disengaging the engine clutch driving the hydraulic pump or generator.

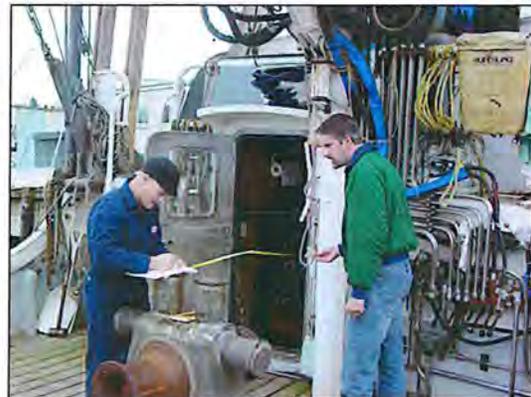
Fig. 4 – Measuring deck layout

The F/V Lake Bay was built in the early 1970's at Delta Marine in Seattle, Washington, and is equipped with a Kolstrand 5N capstan deck winch, manufactured in Seattle. Hydraulics are driven by a pump connected through a pneumatic-actuated clutch to the vessel's main engine. The winch directional control valve is mounted on the rear bulkhead adjacent to the mast, approximately 1.5 meters forward of the winch. The vessel's electrics are 32-volt dc. SRL staff traveled to Seattle in March, 2005 to obtain the necessary measurements that would allow for detailed engineering design of the prototype e-stop system. These included: layout of equipment on the working deck; placement, size and manufacturer of the various hydraulic components; location of electrical panels and wiring runs; and, the mounting and internal construction of the deck winch (Fig. 4).

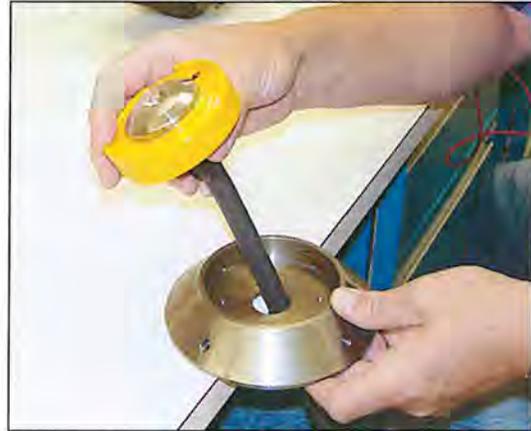
Fig. 5 – Button, steel ring, and cable

1. the momentary-contact button, manufactured by Polara Engineering. This button is typically used as an actuator for pedestrian crosswalk signals and, as such, is waterproof and can withstand severe impacts. The button is recessed into a machined steel ring (Fig. 5) that is in turn welded to the top winch horn. The conical-shaped ring permits lines to slip over the button without actuating it as the winch is being used, but still allows for a fisherman to depress the button. The ring also lessens the chance that a tensioned line could shear the button off the horn. The wire connecting the button to the control box is a marine-grade, non-wicking, wire-shielded cable fastened to the terminals of the button and sealed with an electrical potting epoxy;

Another recommendation is that the momentary-contact button's housing be re-designed. As manufactured by Polara Engineering, the button housing has straight sides, necessitating the addition of the custom-machined tapered ring to prevent lines from catching or activating the button. Elimination of the machined ring could be accomplished with a tapered-side button housing, which would save in machining and installation costs. Again, this would be an important improvement if the e-stop system is commercialized.

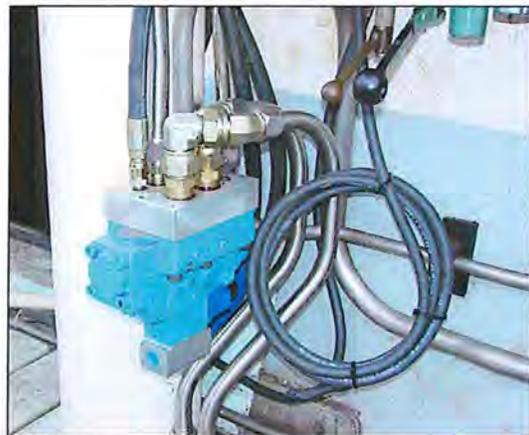
Fig. 6 – Solenoid-actuated hydraulic valve

5. and, a Vickers electro-hydraulic solenoid valve (Fig. 6). This valve was plumbed between the vessel's existing winch directional control valve and the winch drive motor. When the latching relay is energized, power is sent to the 12-volt solenoid, thus actuating the valve, shutting off the flow of oil to and from the winch motor, and locking the winch gypsies in place. The valve was plumbed using hard tubing.

The solenoid valve was first mounted on a bracket welded to the vessel's mast. Once in place, this allowed the hydraulic contractor to precisely measure for, and install, the stainless steel tubing runs between the solenoid valve, the winch directional control valve, and the winch motor -- a total of four new tubes. Finally, the cable from the control box was connected to the solenoid and sealed.

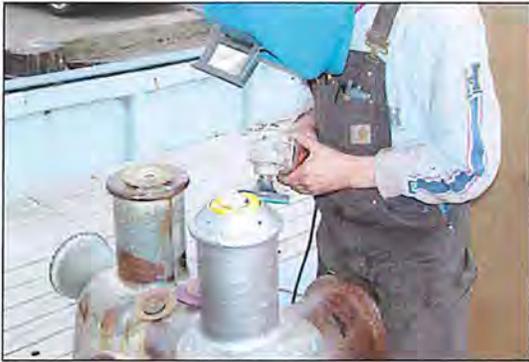
Fig. 7 – Grinding the welded ring smooth

Installation of the prototype e-stop system occurred in June, 2005, just prior to the beginning of the southeast Alaska salmon fishing season. The first step was to weld the tapered steel ring to the top of the winch horn, and drill the holes through the horn and bottom of the winch case for the electrical cable. The weld was ground smooth (Fig. 7), the hole in the winch horn was chamfered to prevent chafing of the cable, and the hole in the bottom of the winch was tapped to receive a threaded strain relief fitting. After securing the button to the steel ring with four mounting screws, the cable was routed to the control box through the winch via the drilled holes (with appropriate strain reliefs and marine-grade waterproofing sealant), and then under the vessel's false deck. Routing in this manner eliminates the chance of lines or equipment snagging and tearing out the cable ends.

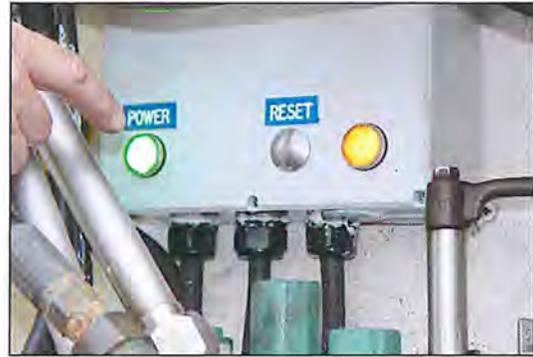
Fig. 8 – Control box mounted on bulkhead

4. a latching relay that is energized when the winch e-stop button is pushed. It remains latched until the 'reset' button, mounted on the control box, is depressed. Pilot lights (green to indicate power on, and yellow to indicate 'tripped') complete the control box circuitry. These components are housed in a waterproof enclosure mounted to the rear bulkhead, with strain reliefs for the cables and marine sealant as needed;

The waterproof box housing the electrical control components was mounted to the vessels rear bulkhead (Fig. 8), directly above the bank of valves which control the deck winch, power block and other mast winches. Three cables enter the box: 32-volt dc power from the circuit breaker in the engine room; the cable from the button on the winch; and, the cable connecting the solenoid valve. All entry points have strain reliefs and marine sealant. The box lid has a full gasket, which allows the lid to be easily removed for inspection or service of the internal components.
