# EXTREME MULTIPLE-SEAM MINING IN THE CENTRAL APPALACHIAN COALFIELDS

By Christopher Mark, Ph.D., P.E.<sup>1</sup>

# Proceedings: New Technology for Ground Control in Multiple-seam Mining

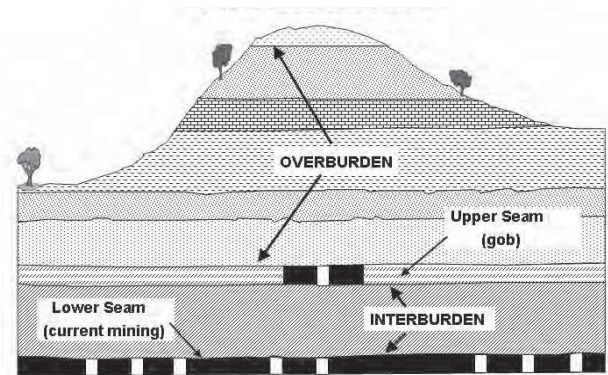
Figure 1.—Undermining.

In making future mine projections, mine planners must evaluate the potential impacts of these multiple-seam interactions. When undermining (mining beneath old workings), the new developments may be subjected to excessive load transfer (Figure 1). In the overmining situation (Figure 2), load transfer can also occur and, in addition, the ground may have been damaged by subsidence. In some cases, multiple-seam interactions can be so severe and hazardous that mining is impossible. In others, it may be possible to develop pillars, but not recover them.
