Demonstration of remote mine seal construction

T.A. Gray

M.A. Trevits

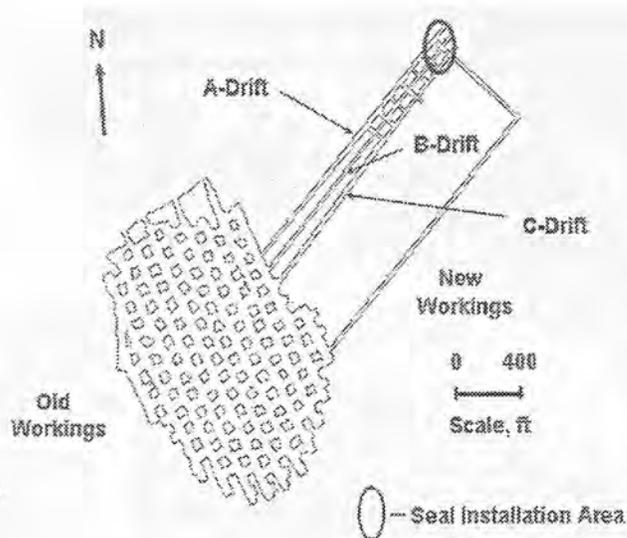
Figure 1 — Layout of the Lake Lynn Laboratory Mine.

The work was conducted at LLL. The Lake Lynn Laboratory is a highly sophisticated underground and surface laboratory located about 100 km (60 miles) southeast of Pittsburgh, Pennsylvania, and 16 km (10 miles) northeast of Morgantown, West Virginia, where large-scale explosion trials, mine fire research and a myriad of other mine safety and health research programs are conducted. The underground workings are sized to match those of commercial mines, thus making them true, full-scale test galleries. Movable bulkheads permit the setup of single-entry, triple-entry and longwall face configurations for experiments (NIOSH, 1999) (Fig. 1).

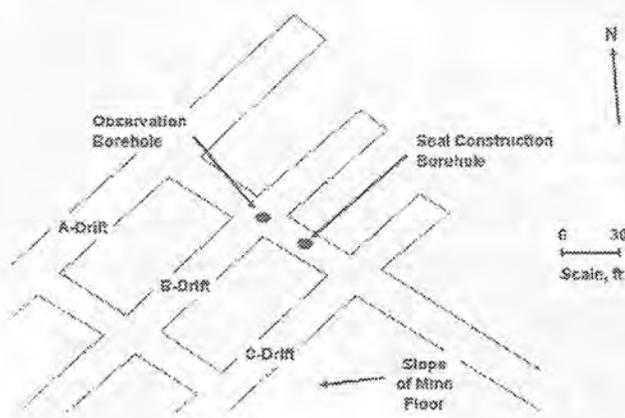
Figure 2 — Underground layout of the seal construction site.

Previously, a 152.4-mm- (6-in.-) diameter cased borehole was completed in the first crosscut between the B and C Drifts of the experimental mine, and it was determined that this borehole was suitable for the seal construction work (Fig. 2). The thickness of the overburden in the area of the borehole is about 60 m (200 ft). The crosscut in the mine measured 5.8 m (19 ft) wide, 12.2 m (40 ft) long and 2.1 m (7 ft) high. The floor sloped on the order of a 1.13% gradient. A second borehole, located about 9 m (30 ft) away, was available for viewing the mine seal installation through use of a downhole video camera. In-mine to surface communication was facilitated through the use of a mine pager phone system.

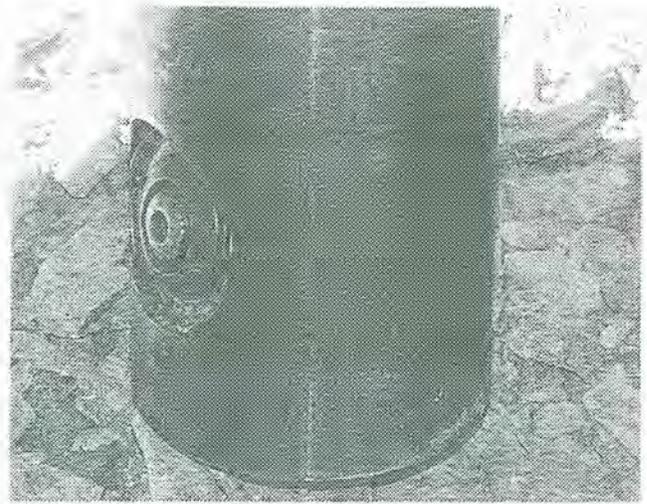
Figure 3 — Spray nozzle.

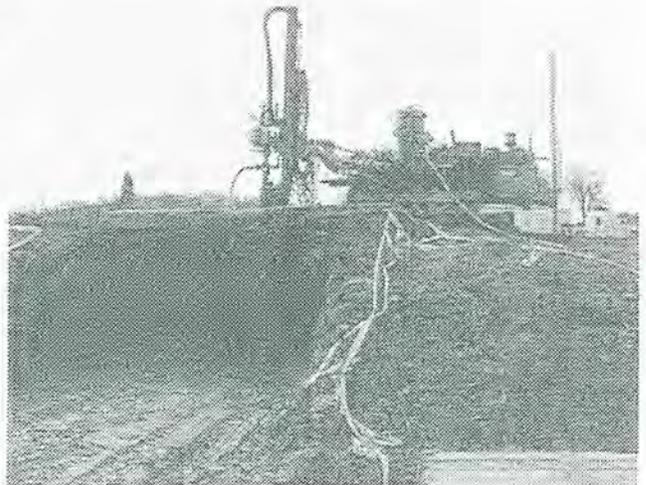
Figure 4 — View of the model mine.

small excavation in a hillside (Fig. 4). The roof of the model mine was formed using crane mats so a drill rig could be located over the mine void to hold the pipe for the spray nozzle.

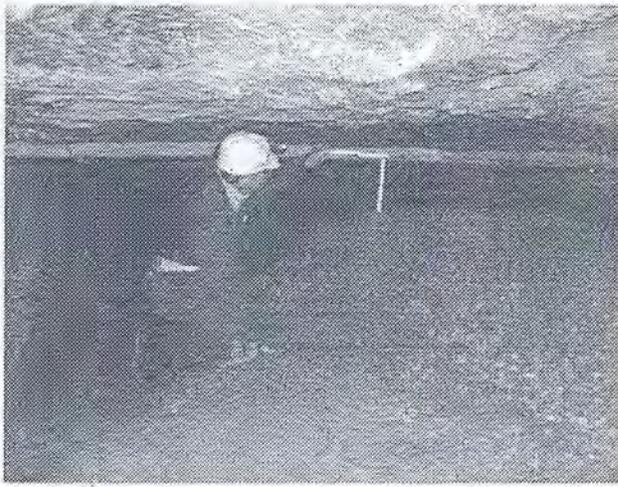
Figure 5 — Underground view of bulk fill material for seal No. 1.

the pause intervals were determined by visual observation via a downhole video camera and communication with the mine pager phone. Pumping was terminated after approximately 86 m³ (112 cu yd) of material had been placed into the crosscut (Fig. 5). Underground examination revealed that the mine opening had not been completely sealed (open spaces were observed at the mine roof-and-rib areas), and some of the bulk fill material had flowed into the adjacent mine areas.

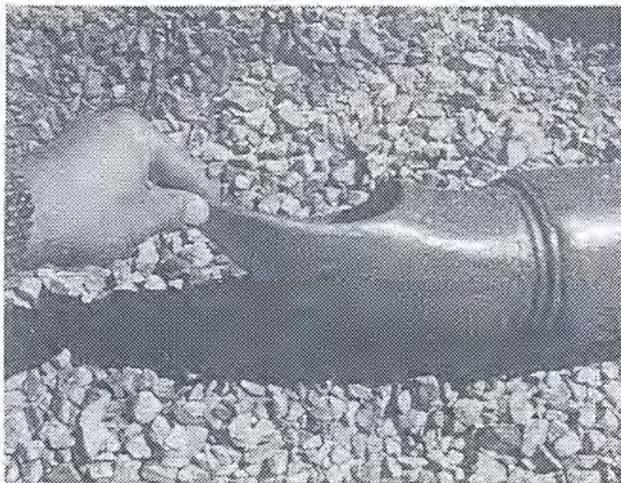
Figure 6 — Elbow for bulk fill placement.

The disappointing results of the spray nozzle application indicated that additional work was needed to further refine the material mix components before the spray nozzle was used again. In the interim, after reviewing the progress made during the placement of the bulk fill, it was decided to fit the end of the casing string of pipe with an elbow to provide a means of directionally controlling the placement of grout material (Fig. 6). It was also thought that this elbow configuration could facilitate roof-rib closure with the bulk fill material.

On August 2, 2002, a newly designed elbow was lowered into the mine opening from the surface borehole. Once the elbow was positioned in the mine opening, pumping of the seal material began using a 2A limestone aggregate, fly ash and cement mixture. Compressed air was added to the flow stream to facilitate movement of the material towards the mine rib areas. This material was pumped into select locations along the mine rib areas in an attempt to fill the mine opening (Fig. 7). Pumping was terminated after approximately 75 m³ (100 cu yd) of material had been placed into the crosscut and after the elbow became plugged.

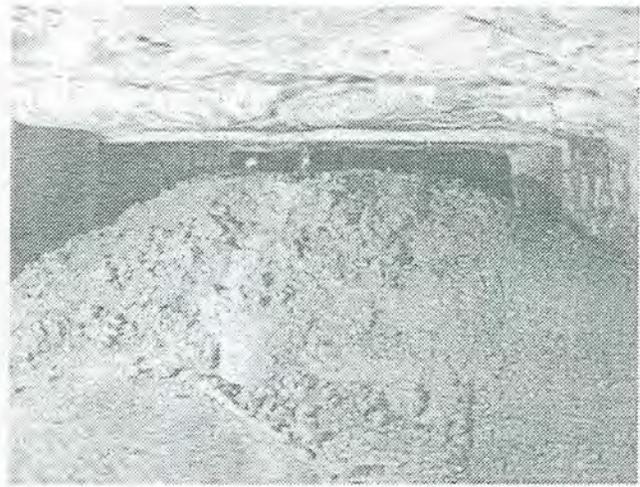
Figure 9 — View of bulk fill placement for seal No. 2.

Underground examination revealed that the mine opening had not been completely sealed. However, the seal material was placed to within 0.46 m (1.5 ft) of the mine roof below the borehole and within 0.76 to 0.9 m (2.5 to 3 ft) of the mine roof near the rib areas (Fig. 9). It was decided to remove an additional 152 mm (6 in.) of material below the bottom of the

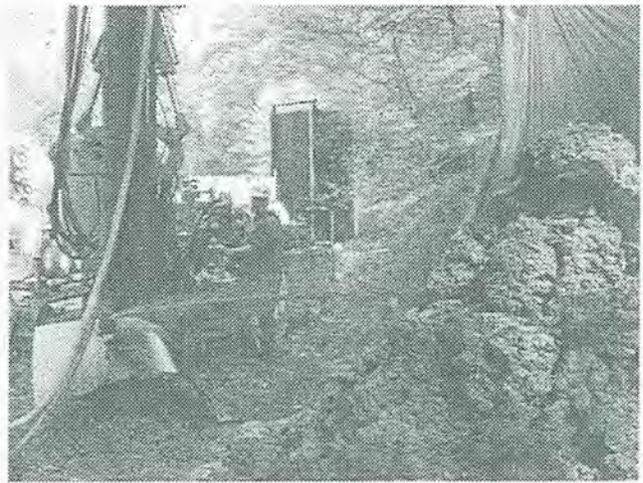
Figure 10 — Surface test of spray grout system.

On October 14, 2003, a 7.6-m³ (10-cu yd) surface test of the final component of the seal mixture (fly ash, cement and accelerators) was conducted at LLL (Fig. 10). The result of the test showed that the mixture would perform as required (little to no slump). A dual string of drill pipe and casing affixed with the spray nozzle was then placed into the 152.4-mm- (6-in.-) diameter borehole in preparation for the second part of the seal construction.

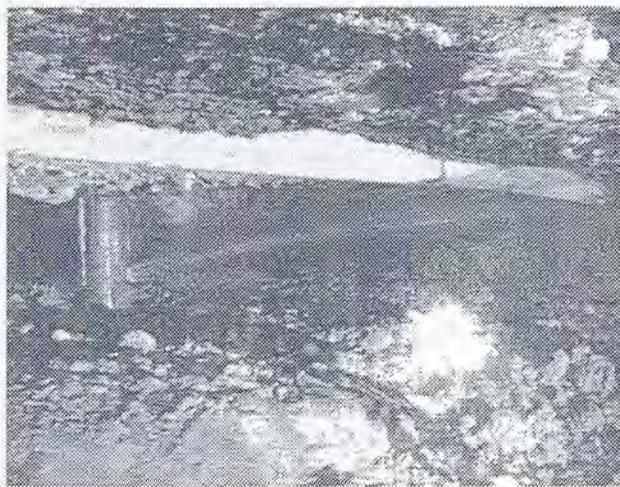
Figure 11 — Underground view of spray nozzle during seal No. 2 construction.

On October 15, 2003, the second part of the mine seal was installed using the spray nozzle. The material was sprayed in a back-and-forth motion along the mine rib areas to fill in the gaps. Interaction between observers underground and engineers on the surface ensured that the nozzle was aimed in the proper direction. Good mine roof-and-rib contact was made with the sprayed material. The problematic corner areas at the mine roof-rib intersection were filled before the grout began to build up and migrate towards the spray nozzle (Fig. 11).
