Overview of coal mine ground control issues in the Illinois Basin

G.M. Molinda, C. Mark, D.M. Pappas and T.M. Klemetti

Gerologist, mining engineer, civil engineer and mining engineer, respectively,
National Institute for Occupational Safety and Health (NIOSH), Pittsburgh, Pennsylvania

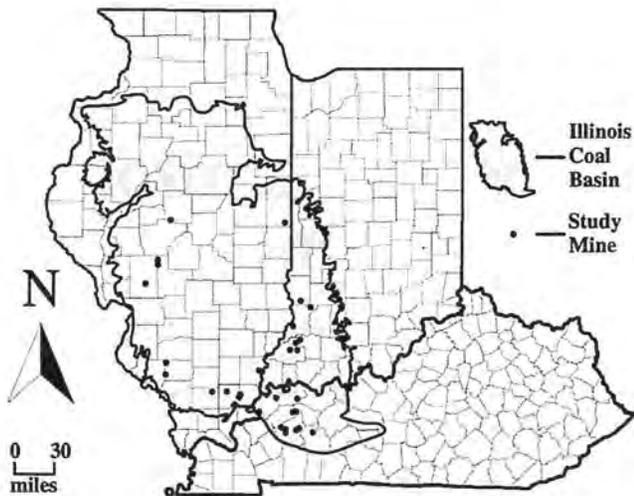
Figure 1 — Underground mines in the Illinois Basin (2007).

The Illinois Basin is a major coal-producing basin in the United States, with more than 86 Mt (95 million st) of coal mined in 2006 (MSHA, 2006). Of this total, 9 Mt (10 million st) of coal were mined by longwall methods, 47 Mt (52 million st) were mined by room and pillar methods and 30 Mt (33 million st) were surface mined. The basin includes Illinois, southwestern Indiana and western Kentucky (Fig. 1).

More than 75 individual coal seams have been identified in the basin, of which 20 have been mined (Archer, 1975). The primary producing coal seams in the basin, the Herrin #6 and the Springfield-Harrisburg #5, are middle Pennsylvanian in age. There are now 30 underground coal mines operating in the basin (Fig. 1). Twenty-seven of the mines are room and pillar operations and three are longwalls. (Two additional longwall mines are permitted but are not yet operating.) Annual produc-

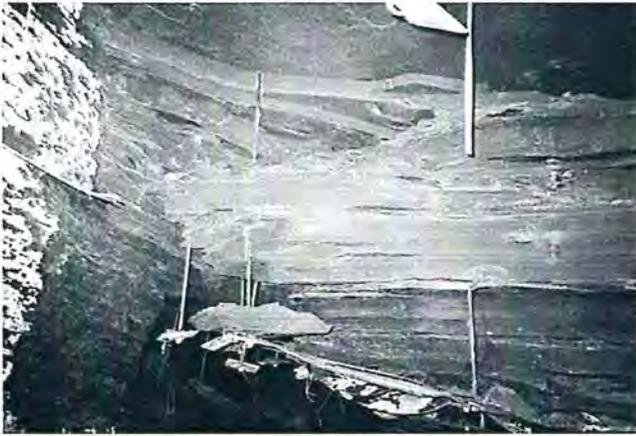
Figure 6 — Roof fall in moisture sensitive roof.

Moisture sensitivity of roof rocks. Roof rocks that absorb humidity and swell can deteriorate over time causing skin control problems and roof falls (Molinda et al., 2006). Fourteen of 30 operating mines report problems with slaking roof. These problems range from thin skin flaking to chandeliered bolts to severe guttering requiring supplemental support (Fig. 6). Roof falls in the Illinois Basin spike in August and September, indicating that high humidity in intake air plays a role in roof instability (Fig. 4). NIOSH has tested roof rock for moisture sensitivity and found extremely moisture sensitive roof rock in a number of Illinois Basin mines (Table 1).

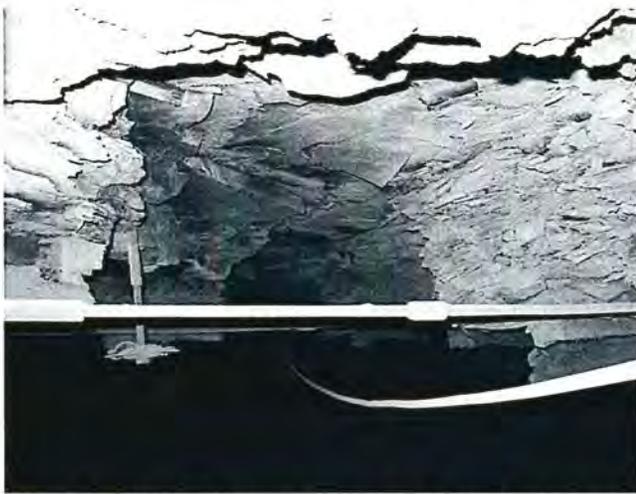
Figure 7 — Gray shale weathers badly after protective black shale is removed.

moisture sensitive gray shale from moisture, preserving it. NIOSH has documented poor roof conditions directly related to the lack of a protective black shale layer. At one western Kentucky mine, the immediate black shale roof was removed to increase the roof height. The exposed gray shale weathered quickly in contrast to the flat roof in the adjacent crosscut (Fig. 7). Black shale provides a natural barrier to humidity exposure, but spray-on roof sealants have also been effective in stopping moisture infiltration (Molinda, 2007). In extreme cases, weathering around roof bolts can compromise roof bolts. “Ker-Thobs” or other tensioning devices are used to reestablish rock contact and restore plate loads (Fig. 8). The Ker-Thob¹ is a pipe extension inserted between the loose roof bolt plate and the roof that allows reestablishment of roof/plate contact.

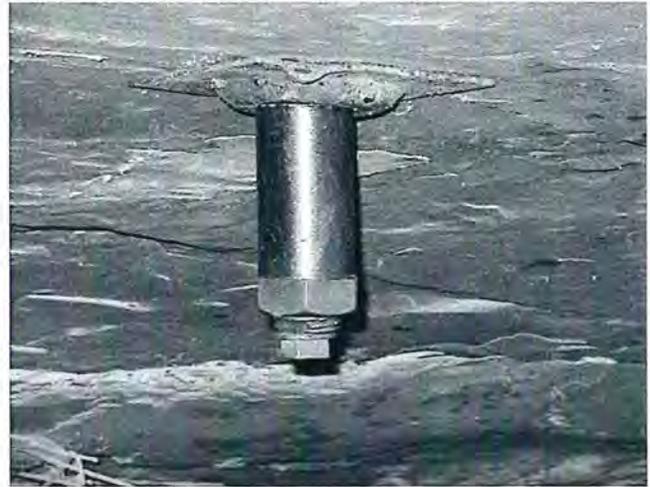
Figure 8 — A “Ker-Thob” is used to reestablish plate contact with the roof and maintain roof bolt integrity.

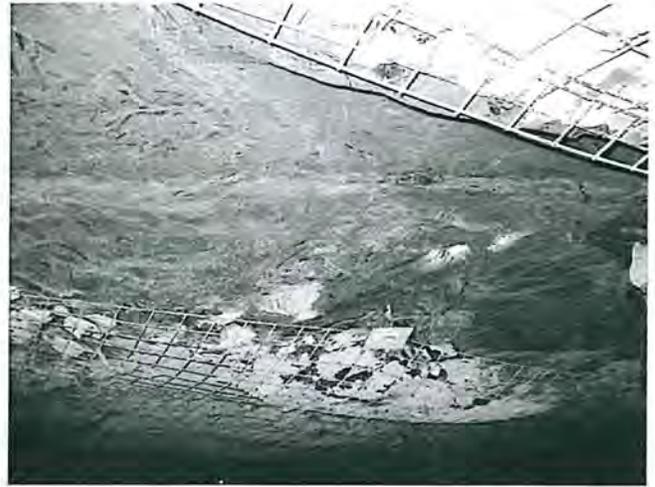
Figure 14 — Gaps left in roof screen coverage have resulted in injuries.

Operators should be alert to several hazards that may occur during the screen installation. As the roof bolter is installing bolts and moving towards the face, it may become impossible to install the last screen without having extra screen hanging down from the roof. The continuous miner would tear up this screen as it advanced the next cut. As a result, some operators may finish bolting the place without installing the last screen. This leaves a gap in the roof coverage when screen installation is resumed after the next cut. Injuries have occurred from rock falling through this gap (Fig. 14). It is better to double bolt the last row when starting to bolt and screen the next cut in order to anchor the next screen. This practice will ensure no screen gaps are left.
