Preprint 09-151

TESTING AND EVALUATION OF AN INFLATABLE TEMPORARY VENTILATION CONTROL DEVICE

**SME Annual Meeting
Feb. 22-25, 2009, Denver, CO**

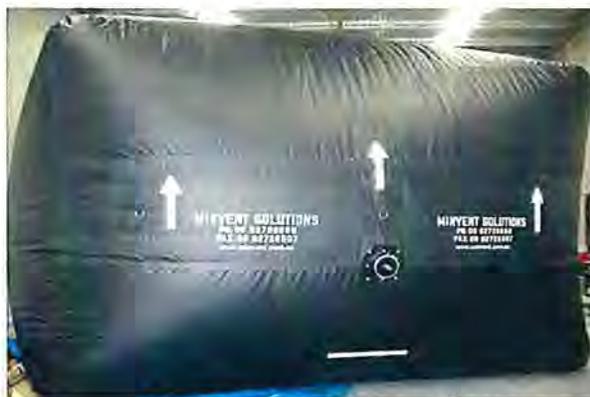
Figure 1. Photo of Ventstop®¹

Ventstop®¹ is a multi-purpose, inflatable device that is produced by Minvent Solutions and is available world wide for use in the metal and nonmetal mining industry (figure 1). Ventstop®¹ is used as an emergency temporary ventilation control device, for controlling ventilation in breakthrough situations, to combat radiation dust, thermal heating return vent, blast fumes and fires. The device can be quickly deployed, is reusable and can be placed in horizontal and vertical mine voids.

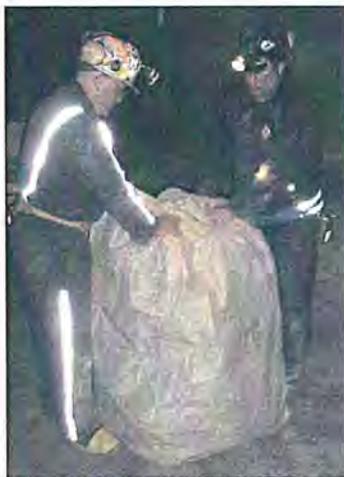
Figure 5 – Carry bag for transporting the Ventsop[®] unit.

The Ventstop[®] unit used in this study was a prototype constructed of the fire-retardant and anti-static fabric. The unit measured 10 ft in diameter and was 20 ft long and weighed 150 lbs. The Ventstop[®] unit was installed by two persons several times in the mine opening to determine how long it would take to fully deploy the unit. The unit was inflated using mine air and a venturi. On average it took approximately 7.5 minutes to install the unit from the carry bag to full inflation in the mine opening (5.5 minutes to inflate the unit only) (figures 5-6). Deflation of the unit, folding and

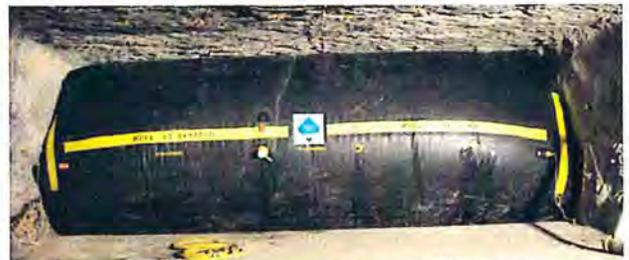
Figure 7. Fully deployed Ventsop[®] unit as viewed from the C-Drift side.

During deployment, adjustments were made to position the unit correctly in the mine opening and to remove wrinkles in the fabric. These adjustments were made by holding the fabric (either at the hold down loop or by clutching the fabric) and moving it to the desired position. This task was relatively easy provided it was done before the unit was fully inflated. If a problem area (such as a wrinkle) was observed after the unit was fully inflated, the problem could be easily corrected by partially deflating the unit, making the adjustments in the fabric and re-inflating the unit. Figures 7 and 8 shows the unit fully inflated in mine opening.

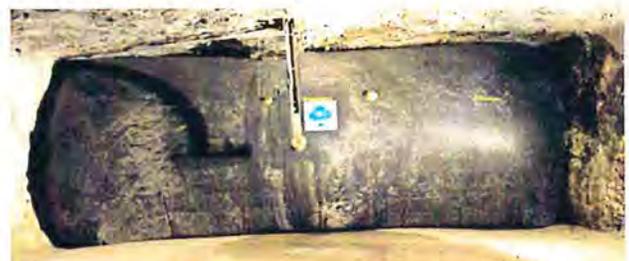
Figure 8. Fully deployed Ventsop[®] unit as viewed from the B-Drift side.

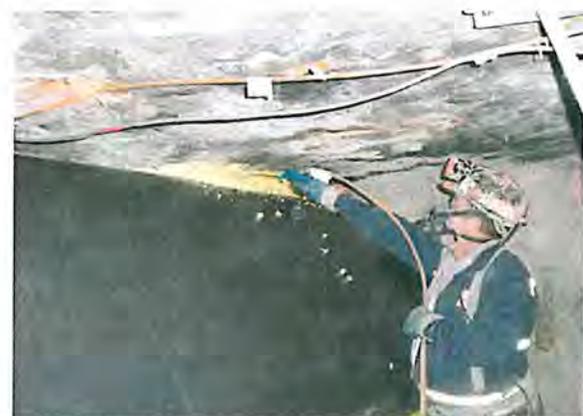
Figure 10. Application of PUR to the perimeter of the Ventstop[®] unit.

Figure 10 shows the application of a PUR sealant to the upwind side of the Ventstop[®] unit as a supplemental means of minimizing mine air leakage. The PUR sealant was sprayed along the entire perimeter at the interface between the Ventstop[®] unit and the mine opening. The expanded thickness of the applied sealant was about 5 in and tapered in thickness to 1/8 in at a depth of about of 18 in using the standard spray head provided with the PUR material.
