CURRENT TRENDS IN REDUCING GROUND FALL ACCIDENTS IN U.S. COAL MINES

C. Mark, NIOSH, Pittsburgh, PA
D. M. Pappas, NIOSH, Pittsburgh, PA
T. M. Barczak, NIOSH, Pittsburgh, PA

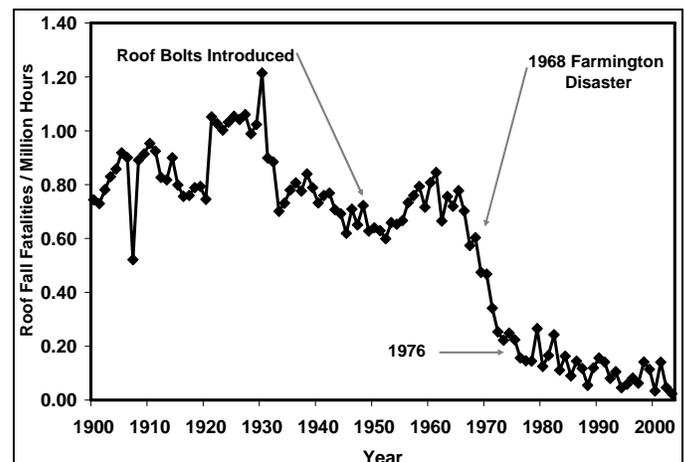
Figure 1. Roof fall fatality rates per million employee hours for underground bituminous coal mines, 1900-2005.

A close look at the ground fall fatal incident rate during the last century underlines the importance of the safety culture.¹ Between 1900 and 1968, the incident rate was relatively constant, fluctuating between about 0.6 and 1.0 fatalities per million employee hours (Figure 1). Over the next eight years, following the passage of the 1969 Coal Mine Health and Safety Act, the rate fell to about 0.15, an unprecedented 75% reduction. Careful analysis indicated that this reduction was not due primarily to new technology, but rather to widespread application of technologies that were already available. In particular, much of the improvement can be attributed to the requirement that essentially all roofs be supported according to a mandated roof control plan (Mark, 2002).

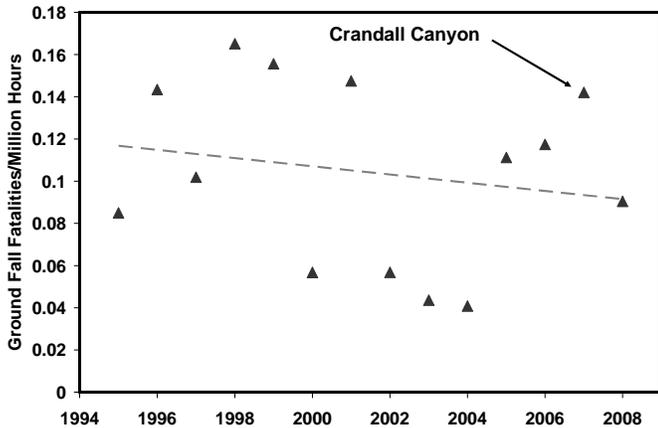
Figure 2. Ground fall (roof and rib) fatality rates per million employee hours for underground coal mines, 1995-2008. The trendline was determined for the data set excluding the Crandall Canyon incident.

In 1995, MSHA started creating electronic versions of their fatality reports, and these are available on their website, WWW.MSHA.gov. A total of 112 bituminous underground coal miners have been killed in groundfalls since 1995. Figure 2 shows that if Crandall Canyon is excluded, there has been a slight downward trend in the ground fall incident rate during this period. The r-squared for the trend is only 0.21, however, indicating that it has little statistical significance.

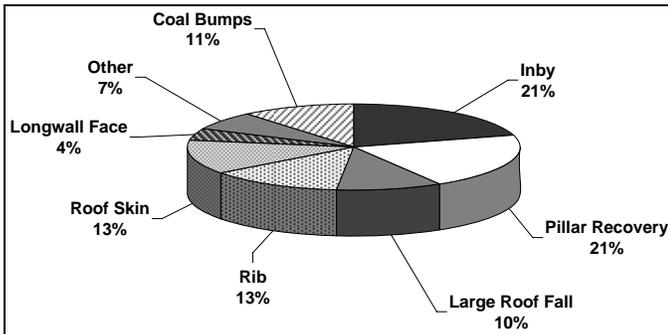
Figure 3. Classification of ground fall fatalities, 1995-2008. The total number of fatalities for the period is 112.

For this paper, each of the fatality reports was analyzed in detail. In figure 3, the fatalities are categorized by the type of the ground fall hazard. The remainder of this paper will be devoted to evaluating each of the five largest categories, which together account for 78% of all the fatalities during the period:

- Fatalities occurring inby support (21%);
- Fatalities during retreat mining (21%);
- Rib falls (13%);
- Rock falls from between or around supports, (13%) and ;
- Major roof falls (not associated with retreat mining) (10%)

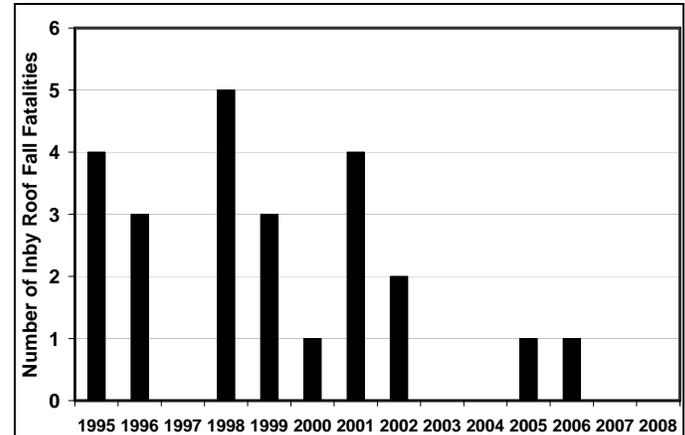
Figure 4. Number of roof fall fatalities occurring inby roof support during entry development, 1995-2008 (August).

One clear success story told by the ground fall statistics is the reduction in the number of fatalities occurring inby support. Although traveling inby for any reason has been illegal since the 1969 Act, throughout the 70’s and 80’s approximately half of all ground fall fatalities were attributed to this cause (Peters, 1992). Figure 4 shows that as late as 2002, there were still two or three fatalities occurring

inby each year. During the past six years, however, there have been just two incidents in bituminous coal mines.

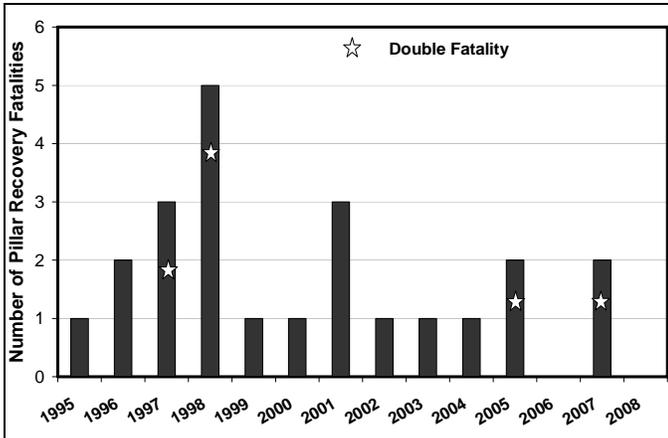
Figure 5. Number of roof fall fatalities occurring during pillar recovery operations, 1995-2008 (August).

Pillar recovery accounts for no more than 10% of the coal mined underground, yet it has historically been associated with more than 25% of all ground fall fatalities (Mark et al., 2003). However, the statistics do seem to indicate that some progress is being made. Prior to 2002, an average of two fatal incidents occurred each year during pillar recovery operations. During the past six years there have been just four incidents, though unfortunately two of those resulted in double-fatalities (figure 5). Moreover, the nature of the incidents has changed. Most incidents prior to 2002 occurred during the mining of final stump, while posts were being set, or because of insufficient roof bolt support. In many of these cases, the miners were following their roof control plan, but the plan itself proved to be inadequate (Mark et al., 2003). In contrast, in most of the recent incidents, the fatalities occurred when the victims were unnecessarily in unsafe locations and in violation of their roof control plans.

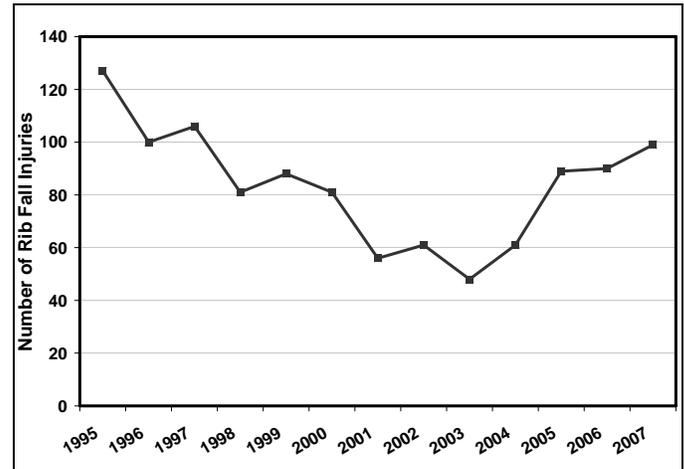
Figure 6. Number of rib fall injuries in underground coal mining (excluding bumps), 1995-2007.

Falls of coal and/or rock from the sidewalls of coal mines or pillar ribs injure approximately 100 coal miners annually. As figure 6 indicates, the number has actually been trending upward in recent years. In addition, rib falls have killed 15 mineworkers since 1995.

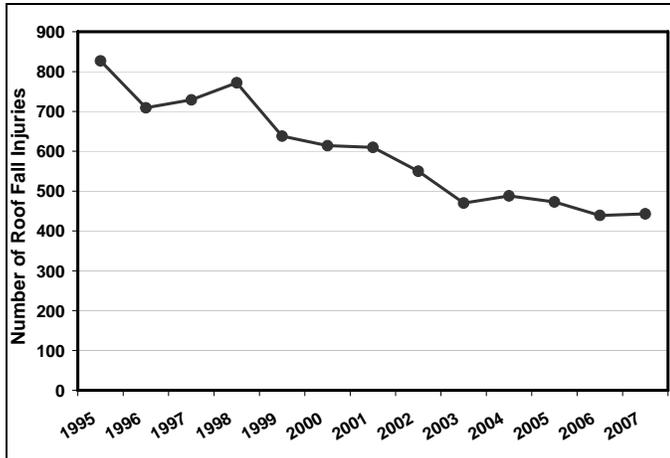
Figure 7. Number of injuries caused by rock falls in underground coal mining, 1995-2007.

Since the 1969 Act, any roof that coal miners work under is required to be supported. Yet, as figure 7 shows, more than 400 coal miners are injured each year by rock falls while they are beneath supported roof. Another 11 miners have been killed by these rock falls so far this decade.

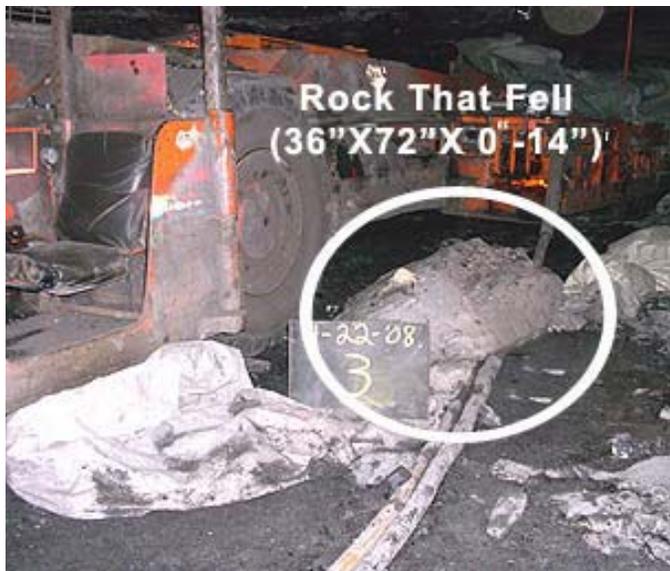
Figure 8. Photograph of a rock that fell from between roof bolts and fatally injured a mineworker (photo from MSHA).

The problem is that roof supports, like bolts or ATRS, are designed primarily to prevent large rock falls and major roof collapses. They do not protect miners from smaller pieces of rock that fall from between or around the supports. Figure 8 shows the size of a rock that fell between roof bolts and killed one miner in 2008.

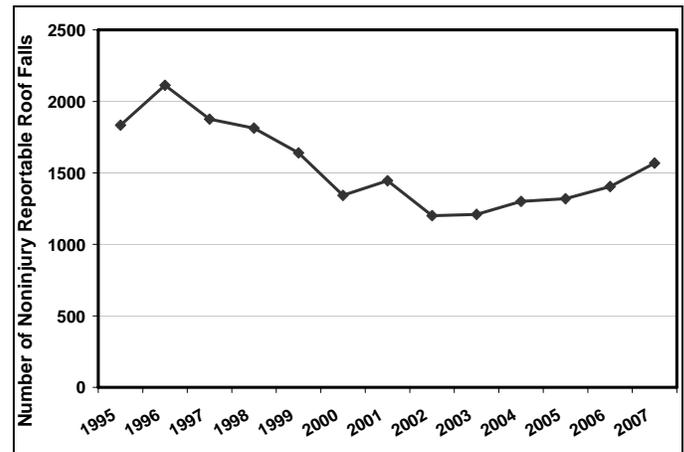
Figure 9. Number of non-injury roof falls reported to MSHA, 1995-2007.

Massive roof falls are those that extend higher into the roof than the anchorage horizon of the roof bolts. Such roof falls must be reported to MSHA if they occur in actively traveled parts of the mine, even if they do not result in an injury. Approximately 1,500 reportable “non-injury” roof falls occur each year, and the number has been trending upward (figure 9). These roof falls can threaten miners, damage equipment, disrupt ventilation, and block critical emergency escape routes. Roof collapses also helped trigger the 2001 mine disaster in Alabama which took 13 lives (MSHA, 2004).
