Roof Span Design for Underground Stone Mines

NIOSH Ground Control Branch

29th International Conference on Ground Control in Mining

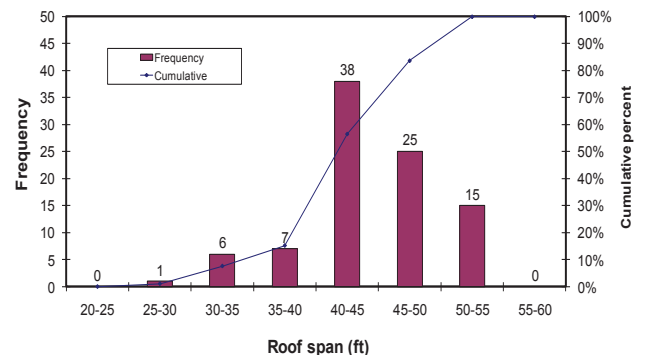
Figure 1. Distribution of roof span dimensions measured at 34 different underground stone mines.

Observations were carried out at 34 operating stone mines to identify the factors that contribute to roof instability. Data were collected on rock strength, jointing and other geological structures, room and pillar dimensions, roof stability, and pillar performance (Esterhuizen et al., 2007). Two to five data sets were collected at various locations at each mine site. A data set describes the stability of the roof and pillars in an area of approximately 100 x 100 m (300 x 300 ft). The range of roof spans observed is shown in Figure 1, which shows that the 92% of the mine openings are more than 10 m (33 ft) wide. Of the mines visited, 41% were installing support in a regular pattern, while the remaining 59% did not install any roof support, or only rarely installed spot bolting if required.

The majority of roof spans in operating mines fall within a narrow range of 10 m to 17 m (35 ft to 55 ft) and are related to the space needed to effectively operate large loaders and haul trucks. A small number of mines used roof spans wider than 15 m (50 ft), so it is not clear whether the stability limit is approached at 17 m (55 ft) or whether it simply satisfies the practical requirements for equipment operation. Given that a large proportion of the mines

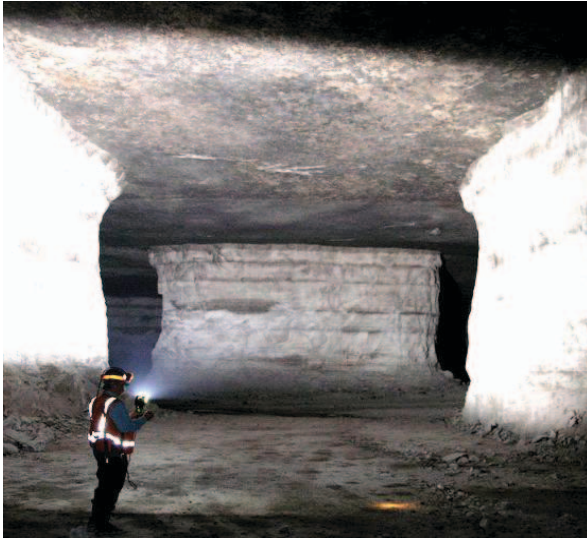
Figure 2. Naturally stable 44-ft (13-m) wide roof span in a stone mine.

Figure 2 shows an example of a 13-m (43-ft) wide, naturally stable excavation with excellent roof conditions. Most of the smaller scale instabilities are addressed by scaling, rockbolting, or screen installation as part of the normal support and rehabilitation activities.

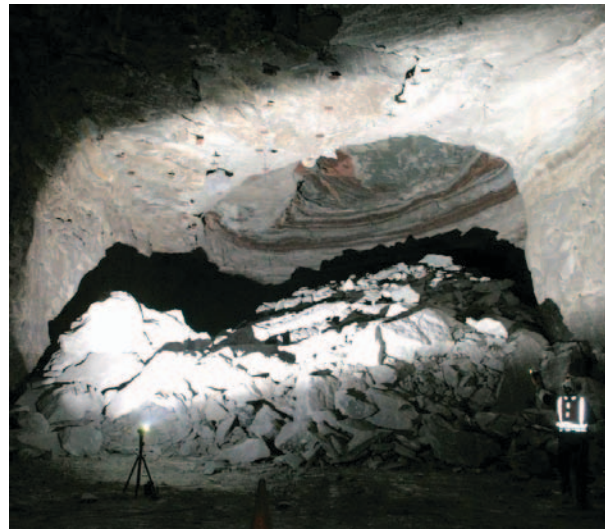
Figure 3. Example of a large elliptical-shaped roof fall that was related to high horizontal stress in the roof.

- Stress: High horizontal stress was assessed to be the main contributing factor in 36% of all large roof falls observed. These falls are equally likely to occur in shallow or deep cover. A roof fall related to stress-induced damage was observed at a depth of as little as 50 m (160 ft) in one case. The characteristics of stress-related roof falls are described in Iannacchione et al. (2003) and Esterhuizen et al. (2007). Figure 3 shows a typical ellipsoidal stress-related fall, and Figure 4 shows an example of how such a fall progressed through the mine workings in a direction perpendicular to the major horizontal stress.

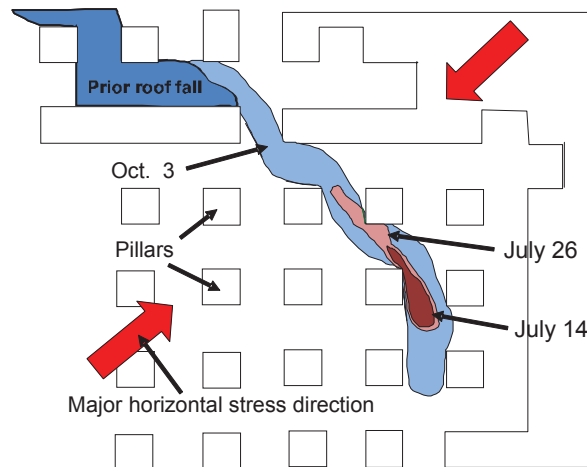
Figure 4. Plan view showing the development of a stress-related roof fall in the direction perpendicular to the direction of the major horizontal stress, after Iannacchione et al. (2003).

Once a stress-induced roof fall has occurred, it can be costly and difficult to arrest the extension of the fall into adjacent areas. Avoidance of these falls through layout modifications has proved to be very successful in several operating mines (Iannacchione et al., 2003). It is first necessary to establish the direction of the major horizontal stress, which can be determined by various stress measurement techniques or can be inferred from stress-related roof failures (Mark and Mucho, 1994). The layout is then modified so that the main development direction is parallel to the maximum horizontal stress and the amount of unfavorably oriented cross-cut development is minimized (Parker, 1973). A further modification that has proved to be successful is offsetting the cross-cuts and increasing the length of the pillars, so that a continuous path does not exist along which a roof fall can progress across the layout. Modifying a layout in this manner will not necessarily eradicate

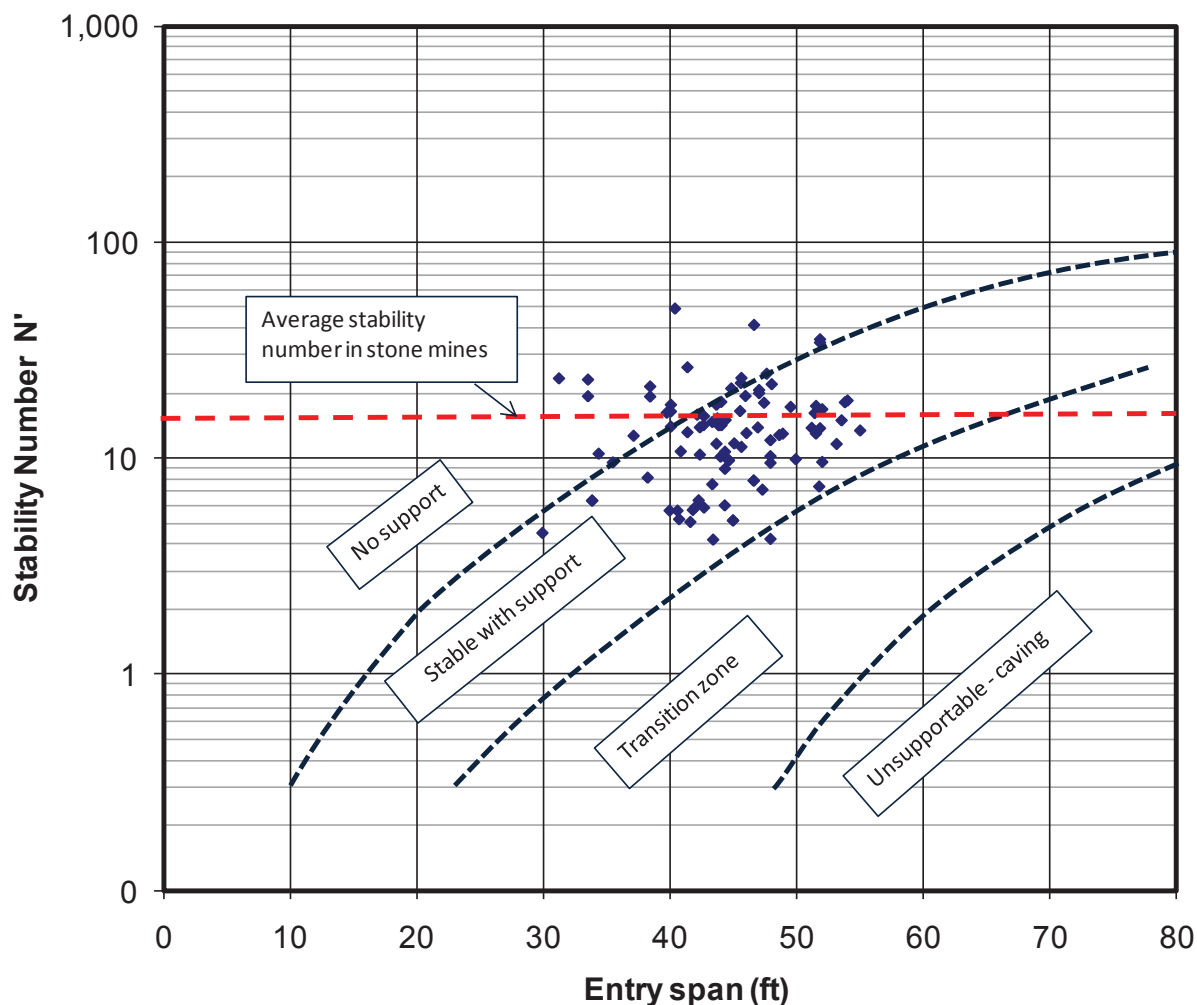
Figure 5. Stability chart showing stone mine case histories and stability zones, modified after Matthews et al. (1980), Potvin (1988), Nickson (1992), and Hutchinson and Diederichs (1996).

The stability number for each stone mine case history was calculated using the procedure described by Hutchinson and Diederichs (1996) and was based on the rock classification data collected at each site. Figure 5 shows the Stability Chart with the stone mine case histories and stability categories. In this chart, the actual heading width is shown instead of the “hydraulic radius” which is customarily used. The hydraulic radius, in this context, is the ratio of the area to the circumference of the roof of the excavation. For a parallel-sided excavation, the hydraulic radius is 50% of the excavation width. It was assumed that the headings in stone mines are parallel-sided excavations. The chart also indicates the average Stability Number of the stone mine case histories as a horizontal dashed line.

It can be seen that the majority of stone mine case histories plot in the region of “stable” to “stable with support,” and only one is located in the transition zone. This agrees reasonably well with the observed stability and support usage in stone mines, although stone mines have been able to achieve stability with light support compared to cable bolting used in the hard rock mine case histories. Based on the average Stability Number for stone mines, it would appear that stable, supported excavations can reliably be achieved with spans of up to about 20 m (65 ft) using cable bolt supports. Cable bolt lengths in the hard rock mines are typically greater than half the excavation span, which would imply 10-m (33-ft) long or longer cable bolts to achieve stability in a 20-m (65-ft) wide stone mine entry. Unsupportable and caving conditions are indicated when the span increases to about 27 m (90 ft). These results are in line with current experience. It appears that stone mines are working near the span limit that can reliably be achieved using rock bolts as the support system. Increasing the spans beyond the 15–17 m (50–55 ft) range is likely to incur considerable cost and productivity implications as cable bolting would become necessary.

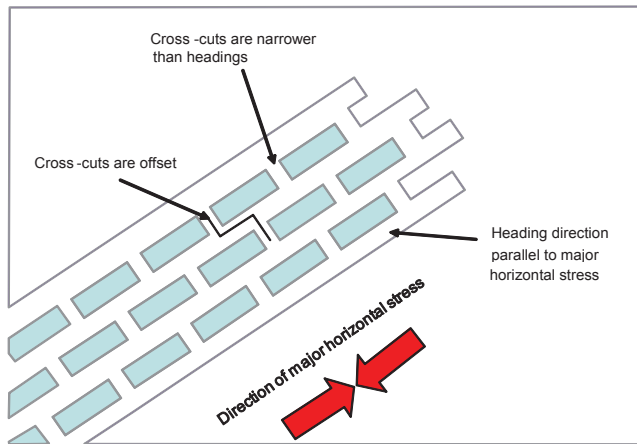
Figure 6. Diagram showing room and pillar layout modified to minimize the potential impact of horizontal stress related damage.

Figure 6 shows a mine layout that has been optimized for high horizontal stress. The main heading direction is parallel to the maximum horizontal stress; pillars are elongated so that unfavorably oriented cross-cuts are minimized; the cross-cuts are narrower than the headings; and the cross-cuts are off-set so that potential stress related roof falls will abut against solid pillar ribs, rather than snake through the layout.

4. **Modification of pillar layout:** A simple square pillar layout with headings and cross-cuts of equal width is sufficient in most cases. However, if horizontal-stress-related instability is expected, the pillar layout can be modified to improve the likelihood of success. Possible layout modifications were shown in Figure 6.
