FILTERED AIR SUPPLY SYSTEM REDUCES ROOF BOLTER OPERATORS' EXPOSURE TO RESPIRABLE DUST

J. M. Listak, NIOSH, Pittsburgh PA
T. W. Beck, NIOSH, Pittsburgh PA

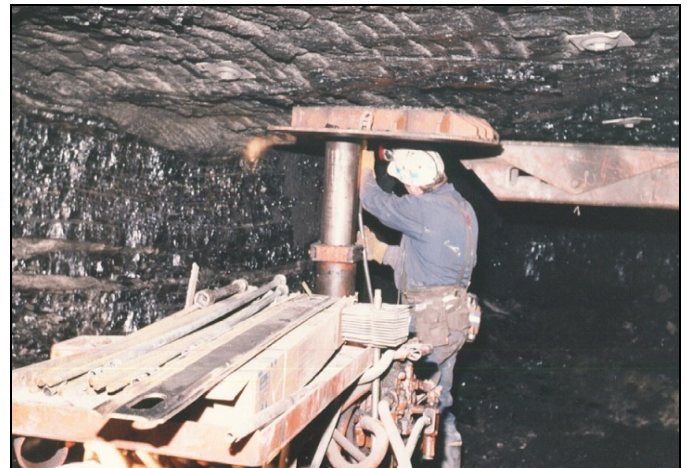
The roof bolting procedure requires the operator to stand under a support canopy for protection from loose roof rock as holes are drilled into the mine roof for the installation of roof bolts (Figure 1).

Figure 1. Roof bolter operator under roof canopy during roof drilling.

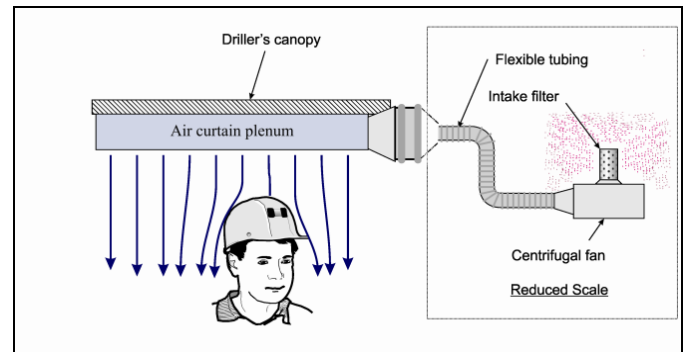
fresh air for a zone of protection from the contaminated air around the bolter, regardless of the dust source (Figure 2).

Figure 2. Roof bolter operator protected by clean airflow provided by canopy air curtain.

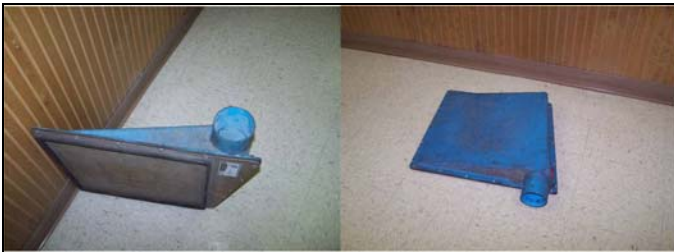
cm (17 by 17 in.). Figure 3 shows the Donaldson air curtain design. Field testing of the air curtain in continuous miner cabs showed reductions in dust exposure from 30 to 75% depending upon the amount of time the operator spent in the protected zone.

Figure 3. Original square air curtain design, by Donaldson Company, Inc.

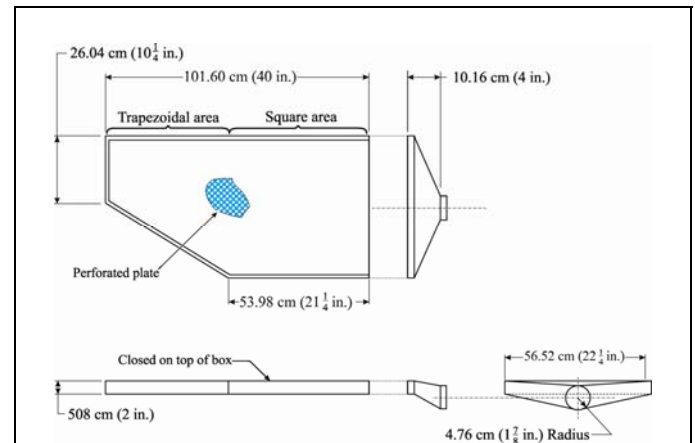
coal seam heights up to 1.83 m (6ft) are 101.6 by 50.8 cm (40 by 20 in.). The dimensions also include a tapered angle reducing the outermost dimension to 25.4 cm (10 in.). These dimensions were used to define the geometry of a newly developed plenum. A height restriction of 5.1 cm (2.0 in.) was required to provide head clearance for operators beneath the canopy. The remaining components consisted of a centrifugal fan (American Fan, model AF-10), sized for delivering air to the plenum, and a filter. The fan used in laboratory testing provided 0.165 m³ at 0.25 kPa (350 CFM at 1 in WC). A filter (P12-3990, Donaldson Co., Inc., Minneapolis, MN) was used to clean the air before it passes through the fan. Tubing with a diameter of 10.2 cm (4 in.) connected the fan/filter assembly to the plenum. As with the Donaldson design, the success of the system depends on a uniform distribution of air flowing over the operator to provide a protected area beneath the entire canopy. Therefore, the initial plenum design was based upon the Donaldson units. A perforated plate with a 13% open area, backed by 180-micron (80-mesh) screen, was used as the outflow air diffuser, covering the entire underside of the plenum. The inlet portal shape and location had to be changed to allow for canopy movement and to conform to the mast location on the roof bolting machine. Figure 4 shows the first prototype unit. The figure shows two distinct areas which will be referenced throughout the paper, the trapezoidal area and the square area. Although these regions are contiguous, the distinction is shown in Figure 4 to better direct the reader when references are made to plenum performance.

Figure 4. Original air curtain designed for a roof bolter canopy.

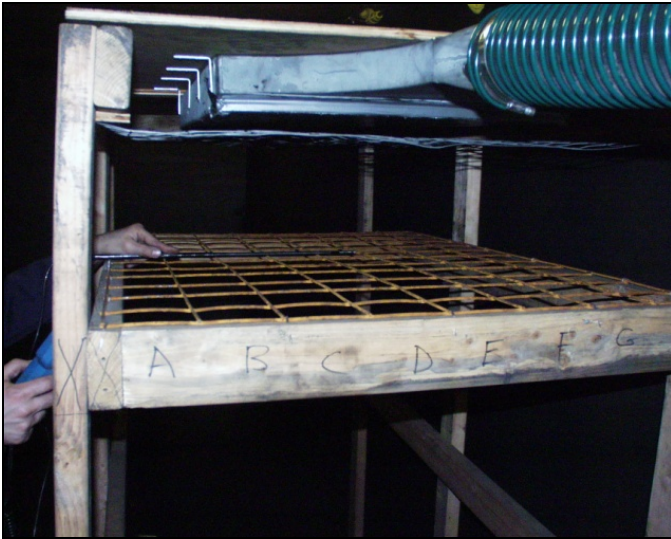
To evaluate the plenum design, air velocity exiting the diffuser was measured to determine airflow uniformity. A 10.2 by 10.2 cm (4 by 4 in.) grid was constructed and mounted beneath the plenum to perform repetitive velocity measurements of the new and subsequent designs. The grid was located 25.4 cm (10 in.) below the plenum which falls within the breathing zone range of a worker wearing a hardhat. The velocity measurements beneath the unit were taken using a hotwire anemometer (TSI Inc., Model 8346) as shown in Figure 5.

Figure 5. Velocity measurement grid 25.4 cm (10 in.) beneath the plenum.

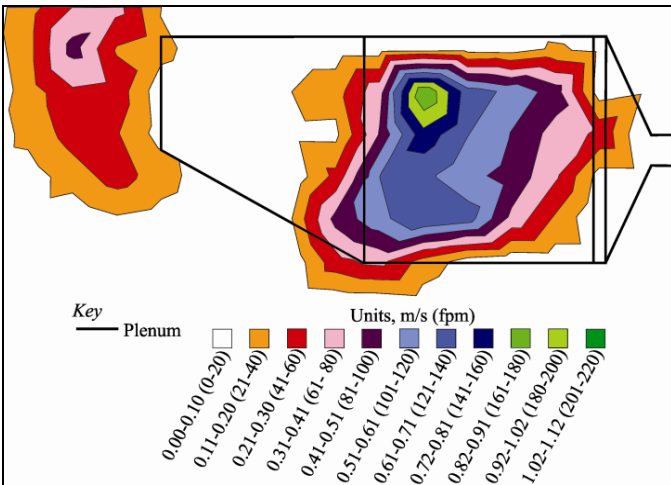
Using the 136 point velocity values from each grid traverse, velocity profiles were created to show the distribution of air exiting the plenum. On the early plenum designs, velocity profiles showed that the air flowing from the perforated plate was very uneven. As an example, Figure 6 shows the velocity profile of the original plenum design. As shown in the figure, most of the airflow was concentrated to the square area of the plenum. A maximum velocity of 1.12 m/s (220 fpm) was measured. In the trapezoidal area of the plenum the airflow exited on an angle out beyond the outer perimeter of the unit. Little to no flow was measured directly beneath the trapezoidal area of the plenum.

Figure 6. Velocity profile of original CAC design.

seen in Figure 6, the velocity contour area greater than 0.51 m/s (100 fpm) is limited to a small area under the plenum.

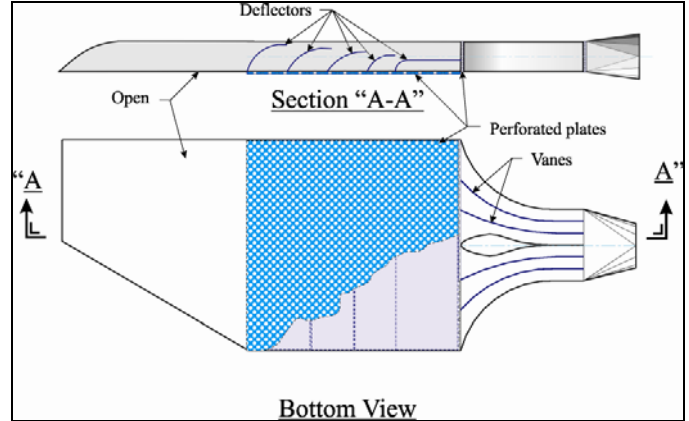
To try to improve airflow distribution, the unit was disassembled and various baffles, inflow vanes, and flow straighteners were added in attempts to direct the air through the device for better distribution. All initial modifications failed to produce uniform airflow. Therefore, to better determine the dynamics of the airflow within the plenum and make the necessary changes, the unit was assessed by a ventilation computer simulation company using computational fluid dynamics (CFD) evaluation. The initial CFD results showed deficiencies in the original design. Based on these results, CFD modifications were made to the prototype in an attempt to provide even flow from the unit. Several iterations were performed until the computer model showed that the modifications inside the plenum would provide the best flow from the unit. After the design changes were made (Figure 7), the unit was retested in the laboratory to determine the velocity profile beneath the unit. Although there was improvement over the original design, the distribution of air beneath some areas of the unit was still too low in velocity to be effective for protection against dust infiltration. To improve flow, CFD simulators suggested a design change to the unit that would increase the vertical height of the plenum. This change was not an acceptable modification due to the overhead clearance requirement for operator comfort.

Figure 7. Prototype modified based upon CFD analysis.

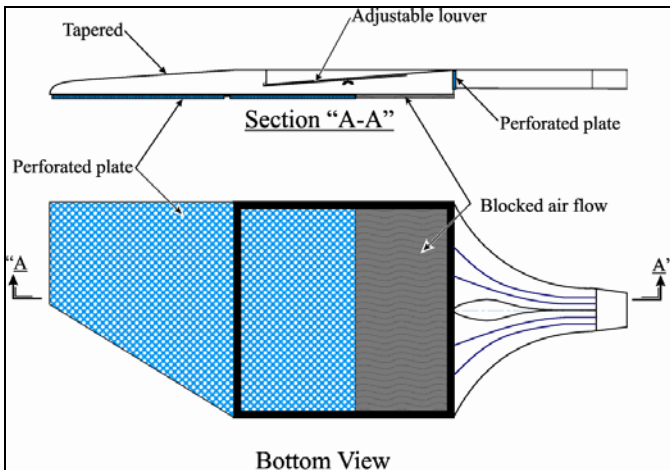
Figure 8. The final CAC design.

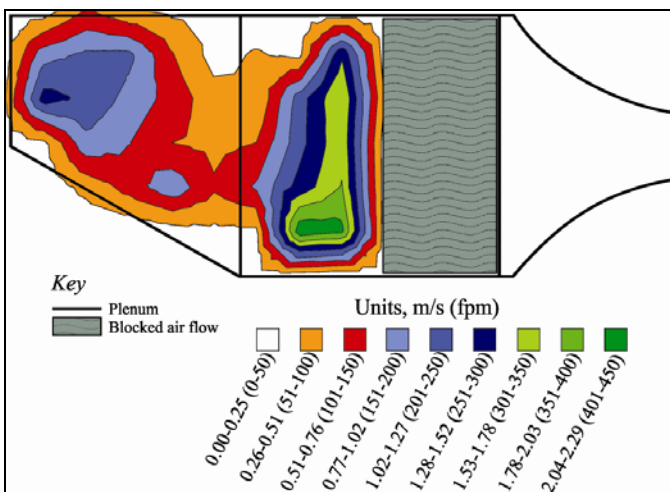
Figure 9. Velocity profile of the final design.

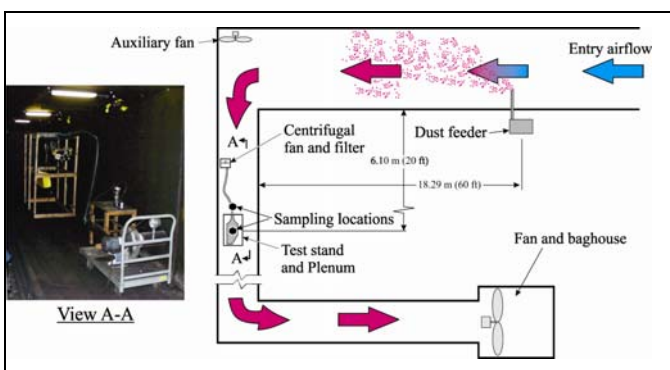
Figure 10. NIOSH mine gallery test setup configuration.

The frame was positioned in the return airway of the gallery approximately 24.4 m (80 ft) downwind of a vibratory dust feeder (Vibra Screw, Inc., Totowa, NJ). The respirable dust (Keystone Mineral Black, 325BA, Keystone Filler and Manufacturing Co., Muncy, PA) was fed into the airstream upwind of the test stand using the dust feeder. An auxiliary fan was also used in the entry to facilitate mixing of the dust before it reached the sampling instruments. A dust concentration of approximately 6 mg/m^3 was maintained for each test velocity. The use of this concentration was based upon a previous NIOSH study showing return concentrations of continuous miners using scrubbers (Listak et al. 2010). The test setup is shown in Figure 10.

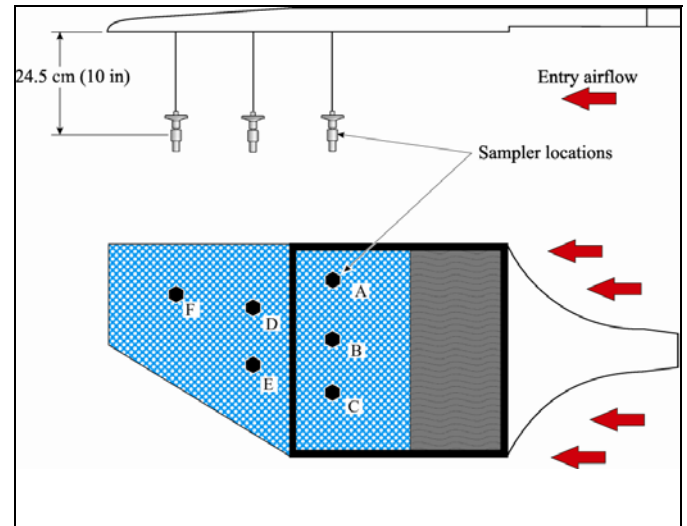
To measure dust levels beneath the canopy, six gravimetric samplers were positioned in spatial locations, 25.4 cm (10 in.) beneath the plenum. Physically, 25.4 cm (10 in.) is in the range of the typical breathing zone of an operator wearing a hardhat. The samplers were spaced laterally to measure dust at locations within an operator's range of motion while performing drilling duties (Figure 11).

Figure 11. Dust sampling instrument locations under plenum.

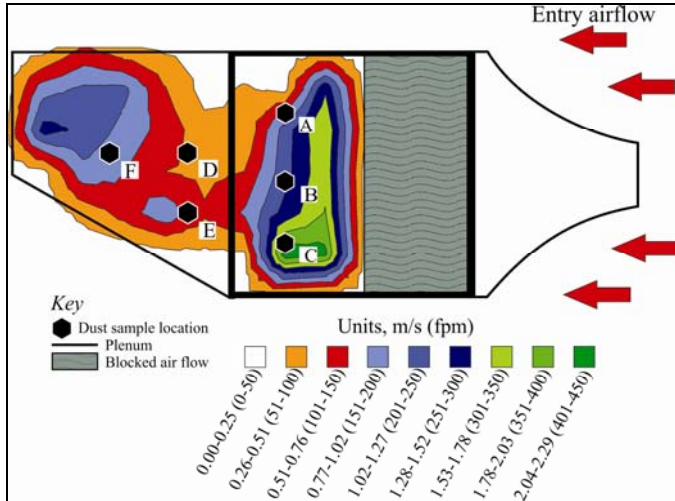
Figure 12 shows the sampler locations relative to the velocity contours. There is a distinct drop in velocity at the transition zone between the square and trapezoidal areas of the perforated plate. Samplers D and E were located in this area to measure dust concentrations. The dust measurements verified that this area provided less protection than the areas where the other samplers were located. For instance, for the test velocity of 0.61 m/s (120 fpm) the dust levels from samplers D and E were 4.5 times greater than those measured at samplers A through C. The authors believe this low-flow area was created partially by the metal seam in the perforated plate. Another cause may be the transition zone inside the plenum from the square to the trapezoidal region.

Figure 12. Dust samplers relative to air velocity under plenum.

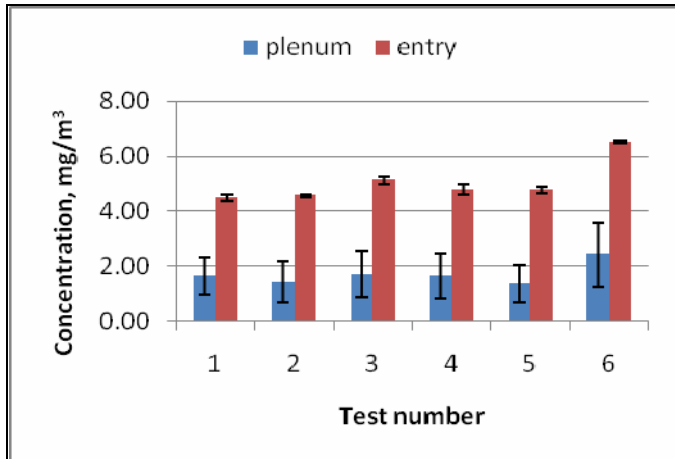
Figure 13 shows a graph of the average concentrations from the six test replications for the 0.30 m/s (60 fpm) velocity test from Table 1. To illustrate the degree of uncertainty between the tests, the graph is shown with standard error bars (standard error of the mean). As can be seen on the graph, the tests have low standard deviations from the mean in the entry measurements and higher variability under the plenum. The higher variability under the plenum is a result of the higher dust measurements at samplers D and E. The graph also visually shows a distinct difference in average dust concentrations at the plenum and entry sampling locations.

Figure 13. Relative dust concentrations, showing standard error bars—under the plenum versus outside the plenum (i.e., entry).

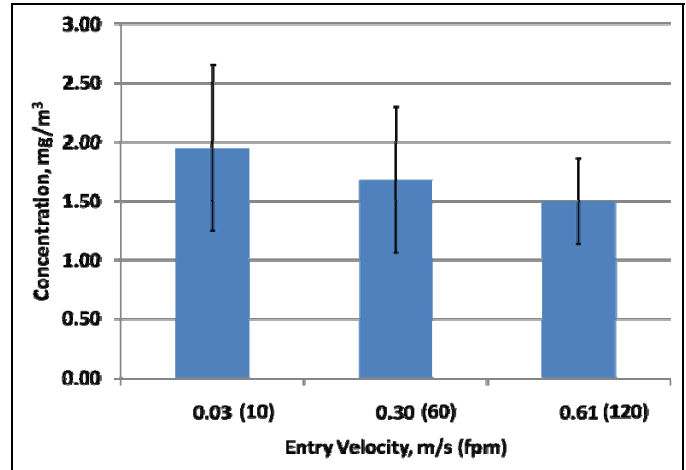
The data were also summarized to show dust concentration comparisons at each of the test velocities. The measured dust levels under and outside the plenum at the different test velocities are shown with associated dust reductions in Table 2. Statistical t-tests show that a significant difference in dust concentrations is measured for each test velocity when comparing levels under the plenum and in the entry. Figure 14 shows the three average dust concentrations (1.50 to 1.95 mg/m³) under the plenum at each velocity. Although dust reductions appear to be greater as entry velocity increases, the chart, shown with standard error bars from the six test measurements at each velocity, implies no significant difference related to change of velocity. Dust reductions were similar for all test velocities, and therefore the system is effective for reducing respirable dust concentrations for velocities common to roof bolting work areas.

Figure 14. Dust concentration averages for three test velocities showing standard error bars.

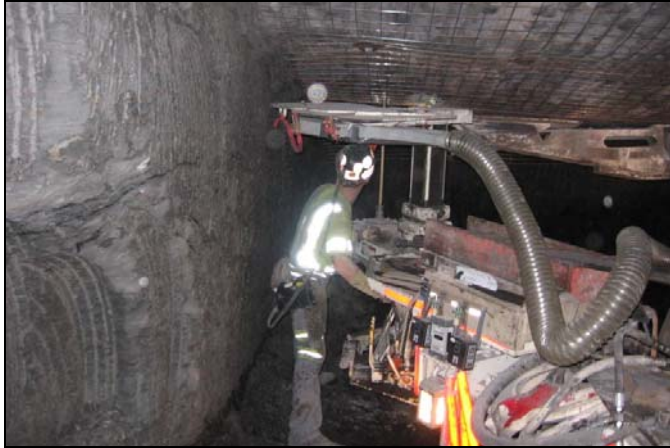
Field testing of the canopy air curtain system was attempted on two occasions to verify results obtained in the laboratory (Figure 15). For each field test, the system was delivered to the mine site in advance for installation on the roof bolting machine. However, due to operational problems (fan seal damage) while integrating the centrifugal fan into the hydraulic system of the roof bolter, both of these studies ended prematurely and provided limited data for analysis. Despite the problems encountered, the studies were beneficial in that they identified the need for a dedicated hydraulic stage on the roof bolter to independently operate and regulate the fan speed. The machine manufacturer has since added additional hydraulics on the roof bolter to test another air canopy design.

Figure 15. NIOSH-designed air canopy system on roof bolter in underground coal mine.

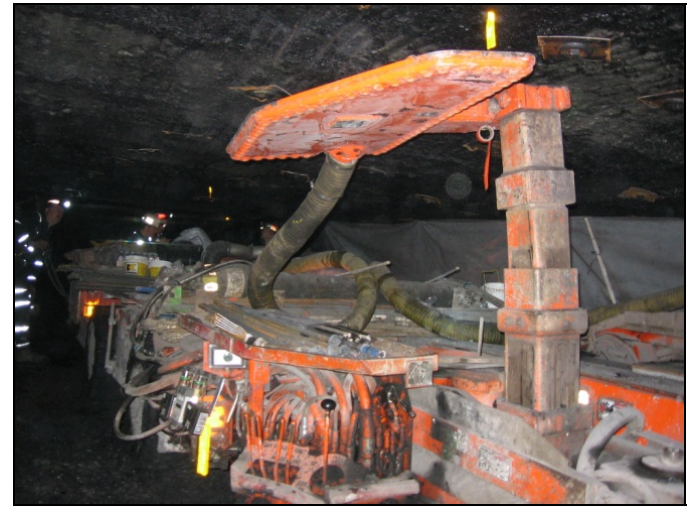
An equipment manufacturer is currently working with a mining company in Virginia to add air curtains on the mining company's roof bolter canopies (Figure 16). Another company in Kentucky is

Figure 16. Alternative designed air curtain based on mine/matrix collaboration.
