Evaluation of seismic potential in a longwall mine with massive sandstone roof under deep overburden

Mark A. Van Dyke ^{a,*}, Wen H. Su ^a, Joe Wickline ^b

^a Ground Control Branch, NIOSH, Pittsburgh, 15236 PA, USA

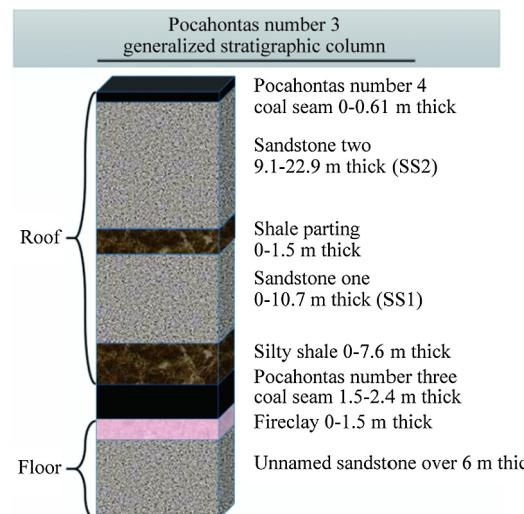
Fig. 1. Generalized stratigraphic column.

but have been referred to as Sandstone 1 (the first encountered sandstone above the Pocahontas No. 3 seam) and Sandstone 2 (the second sandstone unit encountered after small shale lenses above Sandstone 1 [5]). In limited areas, sandstone 1 is not present and is replaced by a larger interval of silty shale. The shale lens between Sandstone 1 and 2 that typically ranges 0.3–1.5 m can be absent, resulting in the two sandstones acting as one massive unit (Fig. 1).

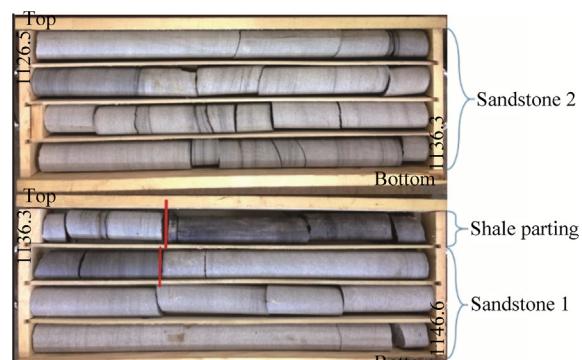
Fig. 2. Core from Sandstone 1, shale parting, and sandstone.

The sandstone units are typically medium to massively bedded, and fine to medium grained with few micaceous streaks, sparse coal debris, shale streaks, and iron nodules (Fig. 2). Where these sandstones become massive, potential longwall caving issues may be present [5]. Axial and diametral compressive strengths of the sandstone averaged 174.76 and 132.05 MPa, respectively, and the maximum strength was 241.31 MPa for axial tests and 218.56 MPa for diametral tests.

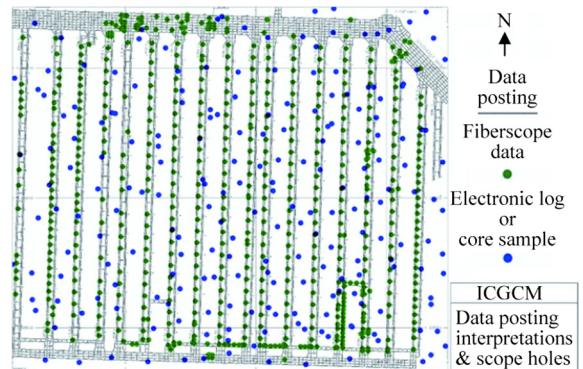
Fig. 4. Geological data points.

Mining hazard maps were created to combine four geologic criteria that showed geological variability that could affect longwall-induced stresses in the sandstone and abutment stresses in the gateroad pillars (Fig. 4). The geologic criteria in descending importance were overburden depth, longwall caving height, interval to sandstone above the Pocahontas No. 3 seam, Sandstone 1 thickness, and sandstone quality determined by fracturing. The caving height was calculated by a thorough and conservative geologic approach examining weaknesses in the strata, such as cracks, mica laminations, shale lenses, and coal streaks. The strata were examined by three methods: fiberscope, geophysical logs, and corehole information. Each geologic method searched for the first layer of weakness within 4.57 m of the immediate roof strata. If the weak layer of rock was below 4.57 m from the top of the roof, then it was considered poor caving because the amount of gob would not be enough to support the massive sandstone layers above [5].

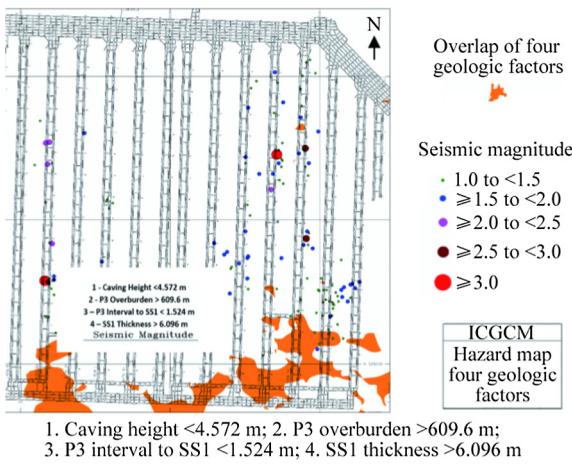
Fig. 5. Mining hazard map.

In July of 2016, a magnitude 3.7 M_L seismic event occurred in roof strata above the gob adjacent to the active longwall panel. The event caused no damage to the mine but was strong enough to be felt by the miners underground and local residents on the surface. After reviewing the original hazard maps, it was clear that the event was thousands of meters away from the nearest hazard area previously defined. The hazard map was intended to highlight areas that could cause problems to mining operations at the longwall face rather than to track potentially seismic zones of interest. Only 8 of the total 181 events that occurred from 2009 through October 2016 were within the mining hazard map boundary.

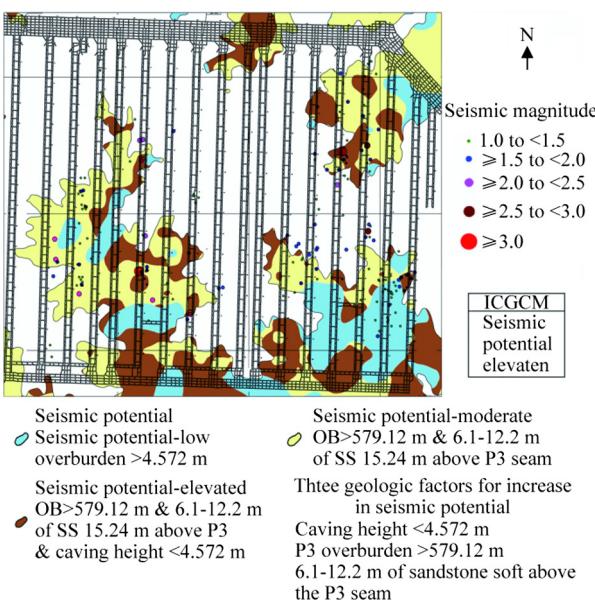
Fig. 6. Seismic potential map.

cally active locations [5]. Over the history of the total 181 events that were $1.0 M_L$ or greater since July 2016, only 47 (26%) occurred under overburdens of less than 579.12 m. If the 91.44-m accuracy of the seismic array is taken into account, then up to 89% of seismic events $1.0 M_L$ or greater have occurred under overburden depths of 579.12 m or greater. The seismic network provides an accuracy within 100 m if the event provides a good signal to multiple towers on the surface. If the events that are within 50 m of the 579.12-m overburden contour are considered, then only 19 of the 181 events are outside the 579.12-m contour. Under less than 579.12 m, the seismic events seem to follow a more random pattern and could not be logically correlated to mining or geologic parameters. When all events are considered, the first criterion for creating a seismic forecast map based on global stability is the 579.12-m-and-above overburden contours. The 579.12-m-and-above overburden contour map represents the first stage of the possibility of forecasting a seismic event $1.0 M_L$ or greater, but additional factors are needed to understand where larger events could take place (Fig. 6).

not the Sandstone 2. During the research of the events, it became evident that there was very little correlation between the Sandstone 1 thickness and the recorded events. However, if the Sandstone 1 and Sandstone 2 were viewed as one unit, the thickness within the first 15.24 m provided a strong correlation with the location of seismic events $1.0 M_L$ or greater. A total sandstone thickness of 6.09–12.19 m within the first 15.24 m of roof, in particular, provided the strongest correlation because, if the total sandstone thickness was greater than 12.91 m, it would be too strong to break and would bridge across the longwall panel. In contrast, any sandstones that were less than 6.09 m thick should readily break behind the face support to form gob and provide a cushion to support any massive sandstones higher than 15.24 m in the roof, thus preventing a seismic event. When sandstone thicknesses of 6.09–12.19 m were combined with an overburden of 579.12 m or greater, the mapping resulted in a 72% accuracy (46 of 64 events) of forecasting larger seismic events in the range of $1.5 M_L$ or greater. The forecasting accuracy could be as high as 85% when taking into account the 100-m accuracy of the seismic network. The combination of 6.09–12.19 m of sandstone thickness with 579.12 m or above of overburden represents a moderate potential for seismic activity (see Fig. 6).

When the three criteria were combined, a seismic potential map (Fig. 6) was created to show the greatest probability of a large seismic event. Elevated potential of seismic activity is shown in brown. The areas of elevated seismic hazard include those areas in which all events with magnitudes of $3.0 M_L$ or greater occurred since the installation of the seismic network in 2009 (two total), and the seismic events of magnitude $3.4 M_L$ or greater that occurred at the longwall face in 2005, 2006, and 2007. The elevated potential areas correctly forecasted all five $3.0 M_L$ and greater events that have occurred since 2005.

The subsequent hazard map was created by overlaying the three identified critical geologic criteria on a single map (Fig. 6). This map may then be used to forecast areas of elevated seismic potential. If the area is only blue, then overburden depth is the only identified risk factor present. Yellow indicates that the overburden is 579.12 m or more, and it also has 6.09–12.19 m of total sandstone thickness within the first 15.24 m of mine roof. The areas that are brown meet all three risk criteria—overburden, critical sandstone thickness, and caving height of 4.57 m or less—and represent the areas that have the highest potential for a large seismic event of $3.0 M_L$ or greater (Fig. 6).
