PREVENTING SLIPS, TRIPS AND FALLS FROM FRONT-END LOADERS

Researchers share insights from two decades of findings on equipment injuries. **BY JONISHA POLLARD AND MAHIYAR F. NASARWANJI**

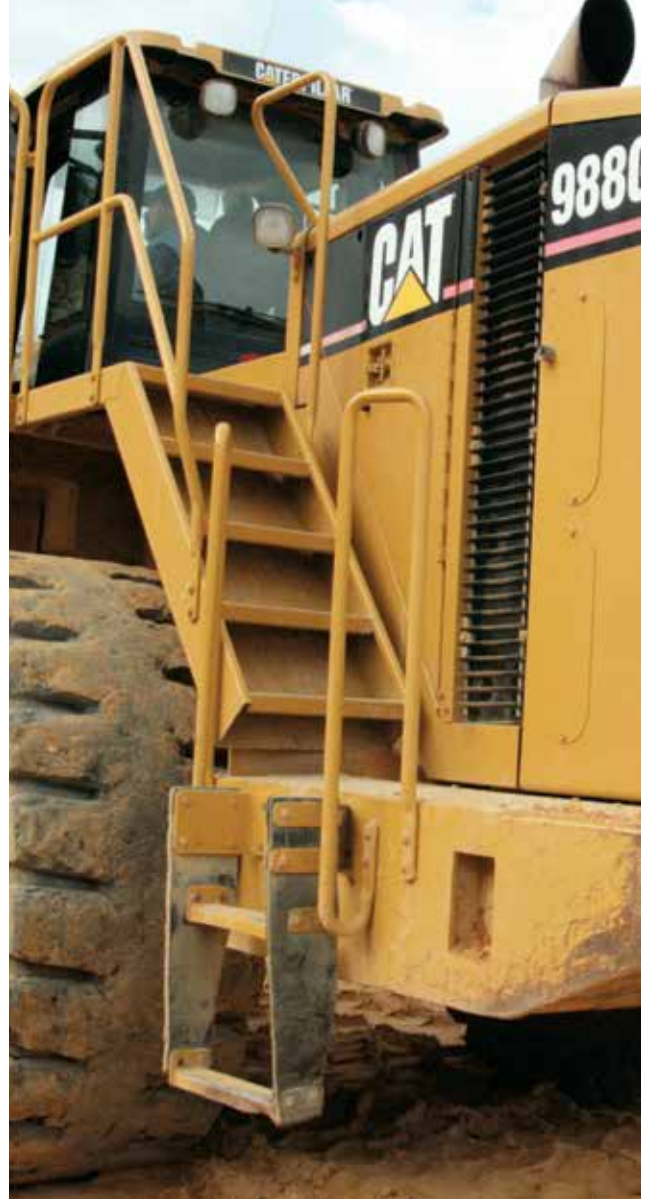
The combination stairway and ladder with two rubber-sided bottom rungs is an example of a ladder rung with flexible rails commonly used as part of the ingress/egress system on front-end loaders.

A unique feature of ladders on mobile mining equipment, including front-end loaders, is the use of bottom rungs with flexible side rails made of wound wire cables, chains or rubber that extend below the frame of the equipment. These ladder rungs are designed to deflect when encountering rough or

uneven terrain while remaining securely attached to the ladder system.

This is an important practical feature because ladder rungs with fixed side rails that extend below the frame of the truck would be at high risk for damage or removal when driving around a mine site.

The photo above shows an example of a ladder rung with flexible side rails commonly used as part of the ingress and egress system on mobile mining equipment. While this is just one example showing a way to reduce the height of the first rung, such a design concept may also create additional risks if it causes excessive or unexpected motion of the rung during ingress or egress.
