# Overview of Current us Longwall Gateroad Support Practices: an Update

**Keywords** Longwall · Coal · Mining · Roof support · Gateroad · Standing support

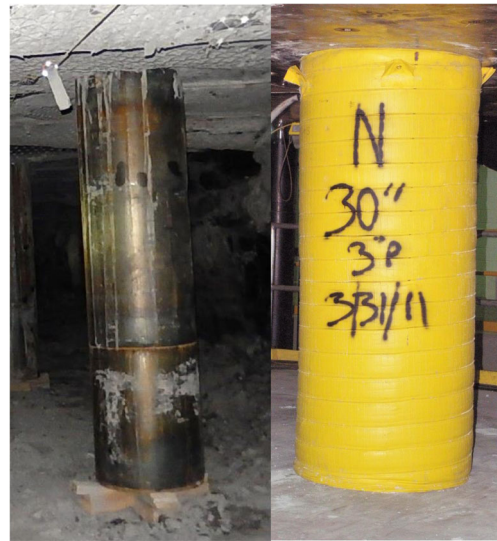
Fig. 5 Example of a can type support (left) and pumpable crib (right)

The types of standing supports observed within the database have been lumped into six major categories regardless of manufacturer: wood cribs, engineered wood cribs, can-type supports, pumpable cribs, and yielding posts (see Figs. 4, 5, 6).

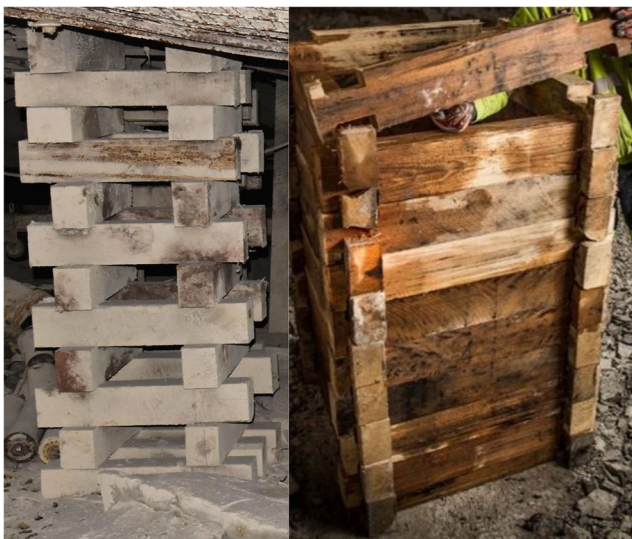
Fig. 4 Example of a four-point crib (left) and an engineered wood crib (right)

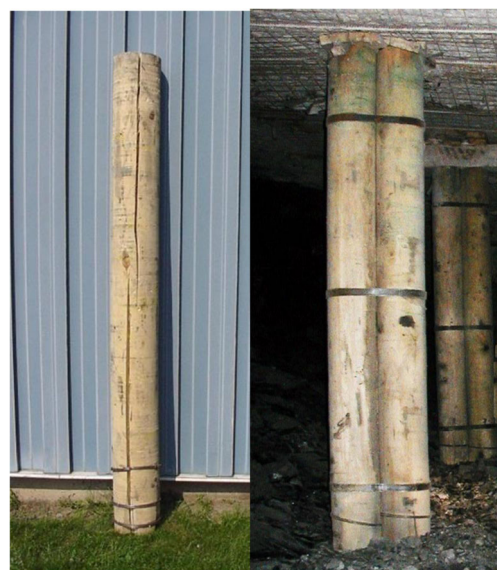
Fig. 6 Example of yielding post (left) and cluster of three yielding posts (right)

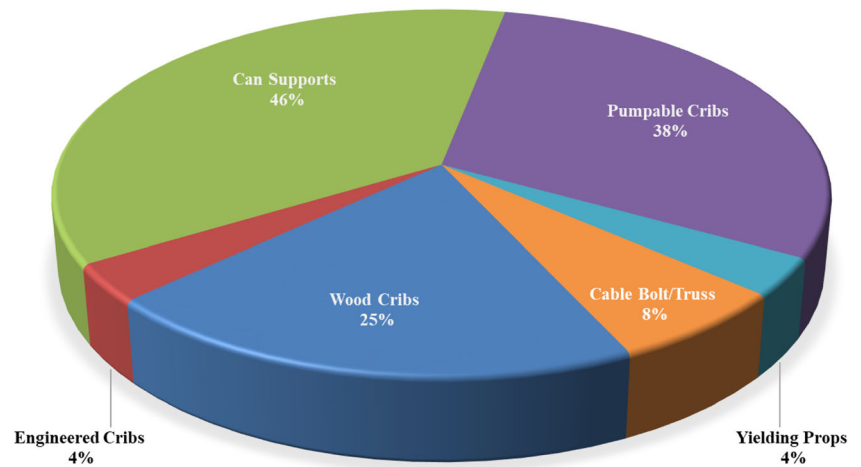
**Fig. 7** Percentage of observed longwall mines utilizing a given support type

cover. Figure 7 shows the distribution of observed mines utilizing a given support system. For example, 46% of observed mines were using can type supports. If one of those mines also used pumpable cribs, that mine is also included in the 38% of mines using that support system. This does not include support systems installed in setup and recovery rooms, which are wider than typical gateroad entries and typically require much higher levels of ground support.

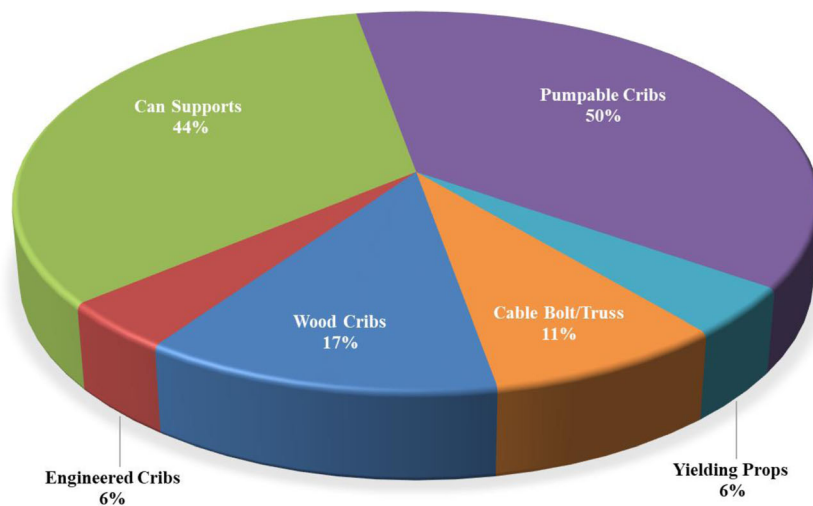
**Fig. 8** Percentage of active longwall mines (2016) utilizing a given support type. Can-type support diameters ranged from 45.7 cm (18 in.) to 91.4 cm (36 in.) with the majority of those being of the 45.7 cm (18 in.) or 61 cm (24 in.) variety. Pumpable support diameters were either 61 cm (24 in.) or 76.2 cm (30 in.). The design and selection of these diameters depends on support capacity needs, the amount of roof coverage desired,

support type does change (Fig. 8). Of the remaining 18 observed mines, can-type supports and traditional wood cribs both saw a decrease in prevalence.
