34th International Conference on Ground Control in Mining

A Survey of the Current Rib Support Practices and Techniques in U.S. Coal Mines

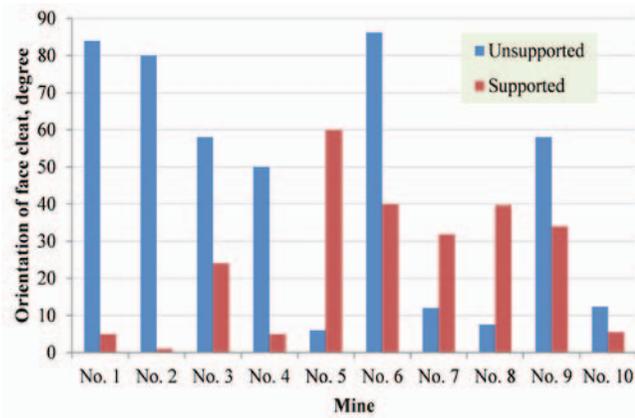
Figure 2. Average face cleat orientation with respect to the driving direction of the mine entry.

It was not possible to evaluate the effect of the face cleat orientation on the measured rib spall volume because of the inherent difficulties in separating the influence of overburden depth and other geological features on the measured rib spall volume.

The studied entries are aligned at a favorable direction with respect to face cleat orientation, where this has been identified as a contributor to rib degradation. The driving directions of the studied roadways could also be defined based on other factors—for example, roof stability, but this factor is not addressed in this research.

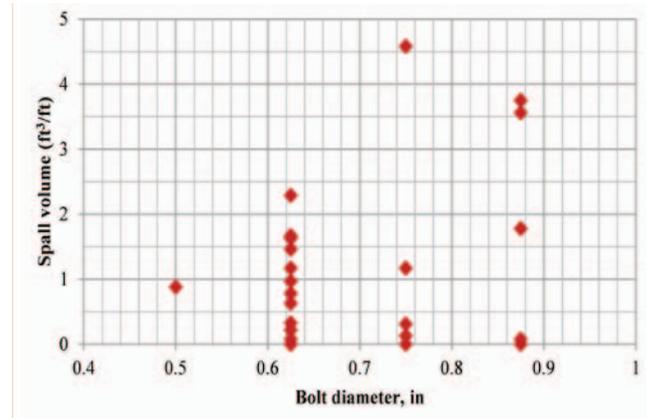
Figure 3. Bolt size vs. rib spall volume at the surveyed sites.

bolts. The diameter of rib bolts is smaller than the diameter of roof bolts at 72% of the studied sites. The length of rib bolts is shorter than the length of roof bolts at 84% of the sites. For about half of the sites, the rib bolts and roof bolts are installed at the same spacing (about 4 ft). The other half of the sites install rib bolts at spacing up to three times the roof bolt spacing.

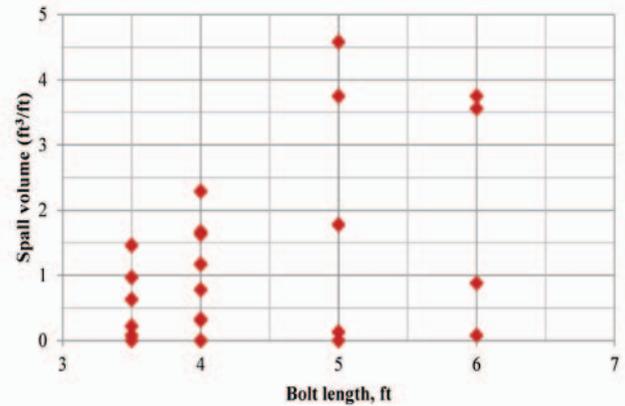
Figure 4. Bolt length vs. rib spall volume at the surveyed sites.

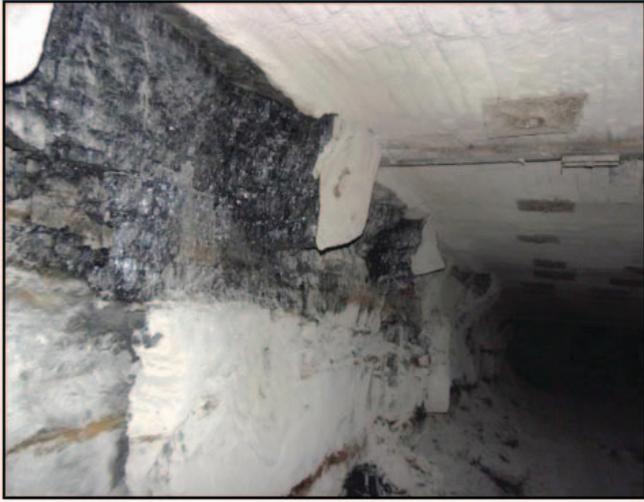
Figure 5a. Inadequate rib bolting in the mains of mine SR 1: (a) isolated rib bolts.

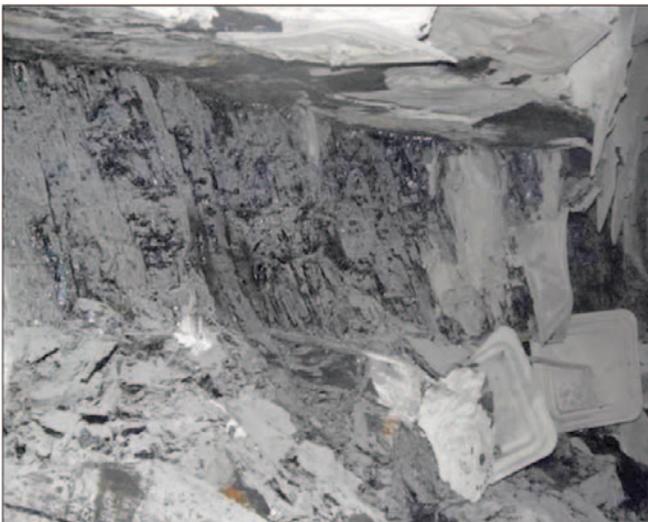
Figure 5b. Inadequate rib bolting in the mains of mine SR 1: (b) failed rib bolts.

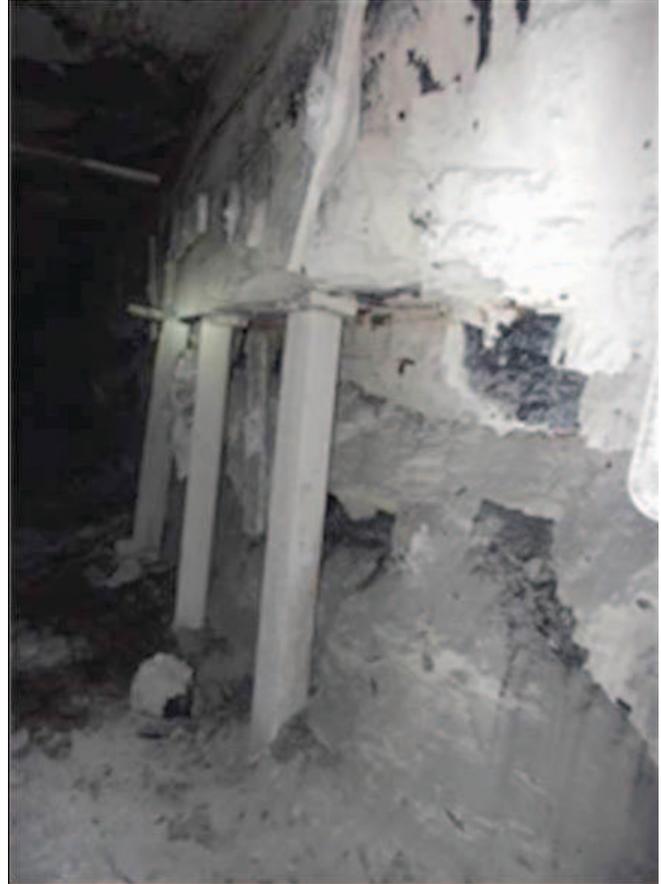
Figure 6a. Timber props (6" x 6") used as secondary supports at the SR 5 mine: (a) rib brow with spalling extended above the bottom row of rib bolts.

- to support formed rib brows when rib sloughing exists below the bottom row of primary rib bolts (Figure 6a),
- to stabilize fractured rib brow at pillars corners (Figure 6b),
- to stabilize pillar corner of mains (Figure 7a),
- to contain excessive chain pillar deformation because of tailgate loading (Figure 7b),
- to restrain detached rib slabs (Figure 8a and Figure 8b), or
- to limit the span of entries that exceed the designed width and/or height (Figure 9).

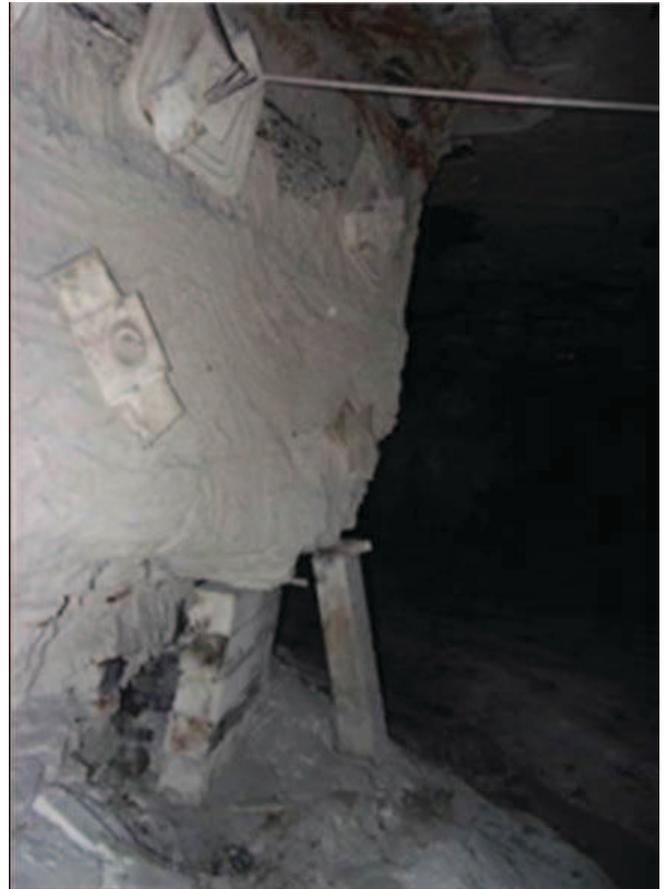
Figure 6b. Timber props (6" x 6") used as secondary supports at the SR 5 mine: (b) fractured brow at intersection.

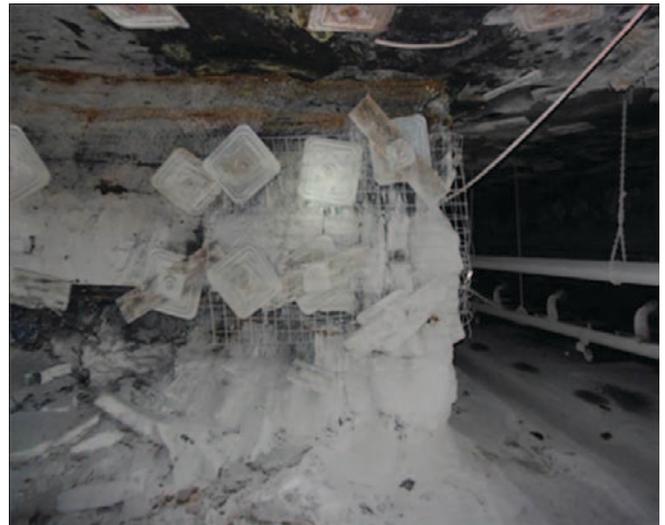
Figure 7a. External liner support: (a) 48" straps of welded steel mesh at the pillar corner of mains, mine SR 5.

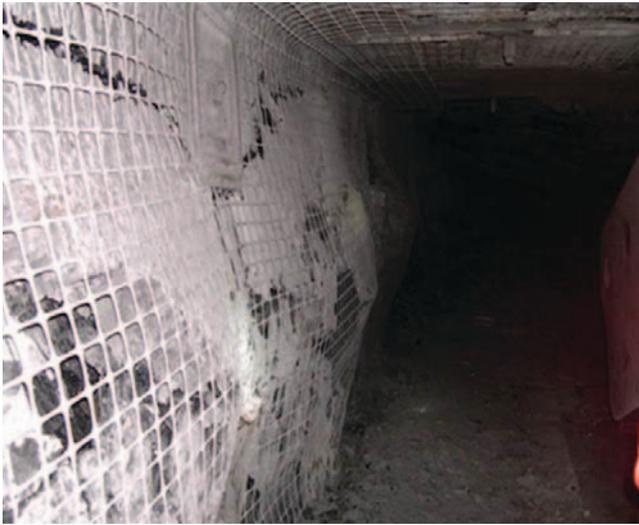
Figure 7b. External liner support: (b) Synthetic grid mesh at the tailgate entry, mine SR 4.

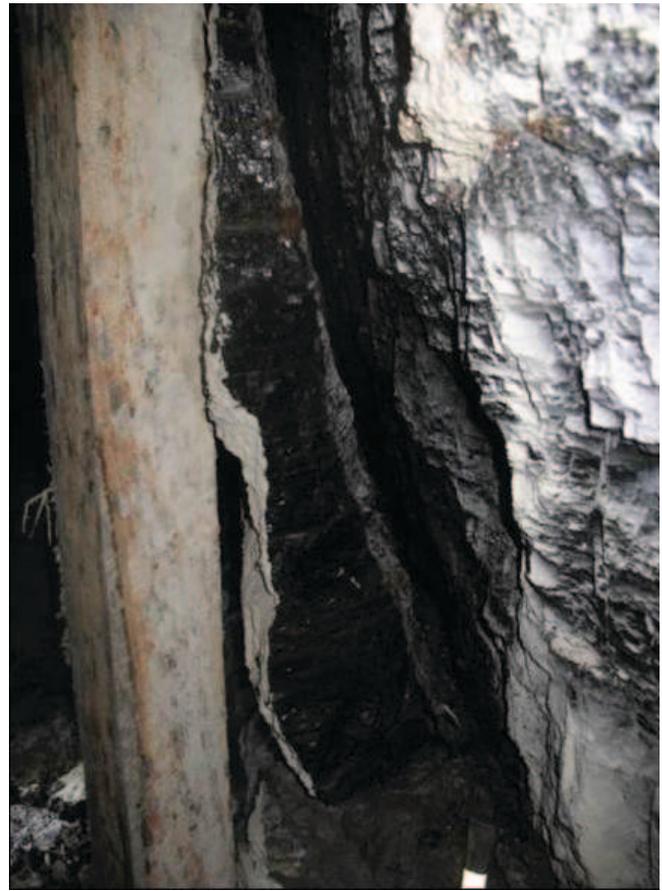
Figure 8b. Timber props (6" x 6") restraining detached rib slabs: (b) mine USR 9.

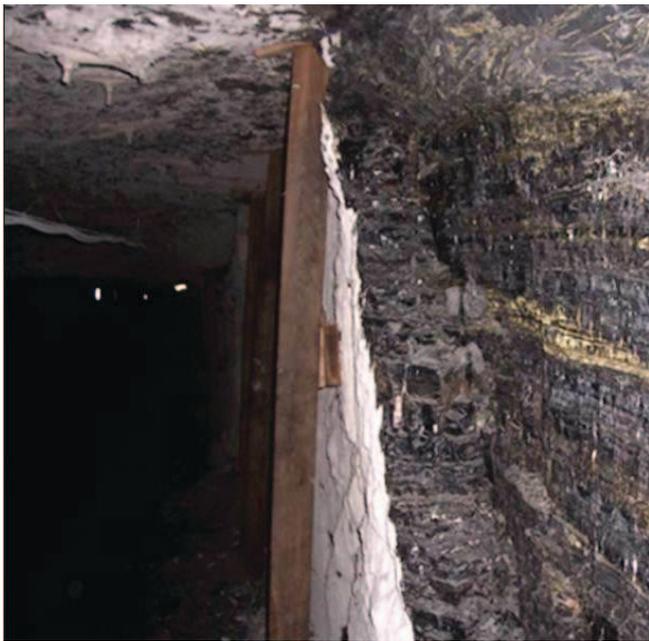
Figure 8a. Timber props (6" x 6") restraining detached rib slabs: (a) mine USR 4.

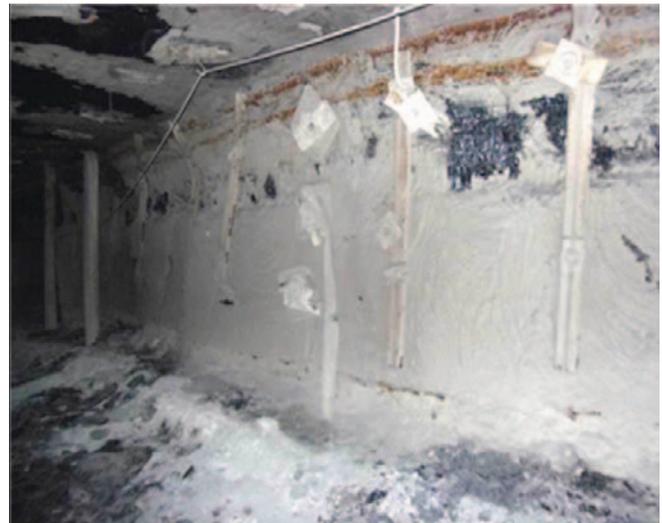
Figure 9. Steel channels and timber props at SR 5 mine installed at an entry that exceeded the design width and height.

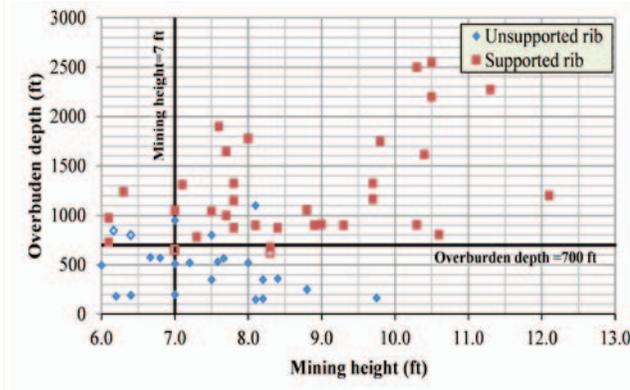
Figure 10. Mining height vs. overburden depth at the surveyed sites.

Figure 10 shows the distribution of mining heights and overburden depths at the investigated sites. The figure shows that most of the unsupported sites (about 78 %) are operating at overburden depths of less than 700 ft. Only two unsupported mines (USR 2 and USR 10, marked by hollow diamonds in Figure 10) are operating at overburden depths greater than 700 ft. The decision not to support the coal ribs at mine USR 2 despite high overburden depth (about 820 ft) could be explained by low mining height (about 6.3 ft) and no pillar extractions. The ribs at mine USR 10 are supported on an as-needed basis during pillar extraction which allows for mining with unsupported ribs at overburden depths greater than 700 ft. Figure 10 shows an inverse correlation between the mining height and overburden depth for the unsupported rib sites. As the overburden depth increases, the unsupported roadways have smaller mining heights.

Figure 10 shows that all the supported sites are operating at overburden depths greater than 700 ft except for mine SR 4 and site SR 6-1 (marked as hollow squares in Figure 10). The decision to support coal ribs at mine SR 4 despite shallow overburden depths (less than 700 ft) could be attributable to the large mining height—7 ft in this case. The collected data at site SR 6-1 was not sufficient to explain the decision about overburden depths made at this site.

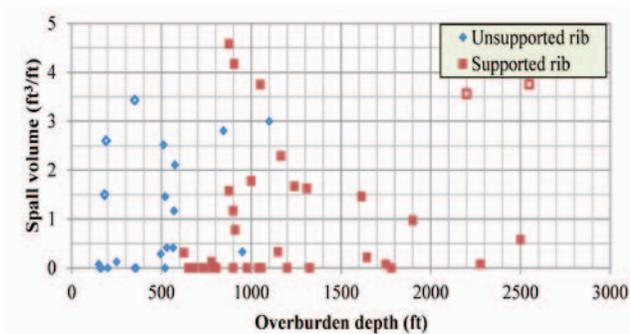
Figure 11. Overburden depth vs. rib spall volume at the surveyed sites.

The impact of overburden depth on rib performance was assessed by measuring the rib spall volume per foot along the entry. Figure 11 shows the distribution of the rib spall volume versus the overburden depth for supported and unsupported sites. The unsupported sites have a wide range of rib spall (0 to 2.52 ft³/ft) at an overburden depth of about 500 ft. With the exception of sites: USR 9-1, USR 9-2, and USR 4-2 (marked by hollow diamonds in Figure 11), the unsupported sites showed no rib spall for overburden depths less than 500 ft. The effects of geology on those particular sites will be addressed in the next section.

Figure 11 shows that the supported rib sites have no rib spall at overburden depths less than 900 ft. The supported sites showed a wide range of rib spall (0 to 4.58 ft³/ft) at 900 ft. Decay in rib spall is observed as the overburden exceeds 1,000 ft, except for sites: SR 9-3 and SR 9-4 (hollow squares in Figure 11). This

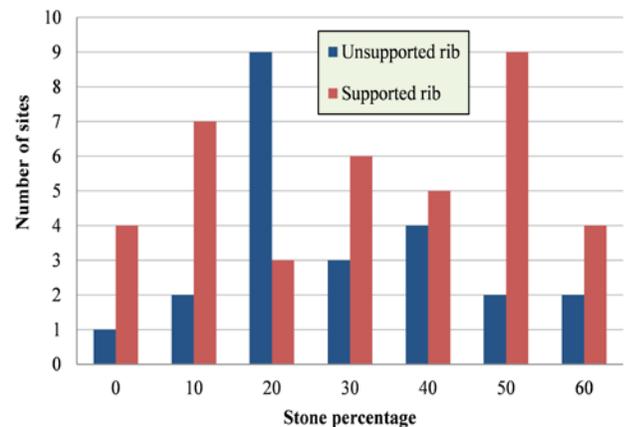
Figure 12. Distribution of stone percentage in the surveyed sites.

To assess whether the presence of stone in the rib profile influences the decision to use rib support, the percentage of stone in a vertical cross section of the rib was plotted against the number of sites in which rib support was or was not employed. Figure 12 shows the histogram of stone percentage for both supported and unsupported sites regardless of the overburden depth. It shows that the numbers of supported and unsupported sites are similar for stone percentage less than 30%, while the number of supported sites are 1.7 times the number of unsupported sites for stone percentage greater than or equal to 30%. It could be concluded that the ribs whose stone percentage is greater than 30% are usually supported. This raises the question of how the overburden depth at these locations influences this observation.

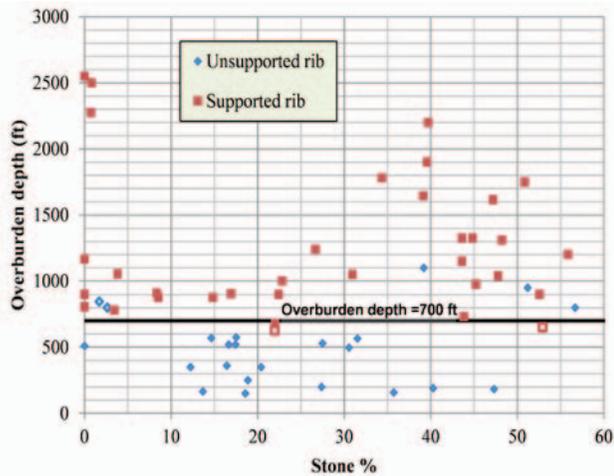
Figure 13. Stone percentage vs. overburden depth at the surveyed sites.

To address this issue, the distribution of stone percentage versus overburden for both unsupported and supported sites was considered (Figure 13). It shows that many ribs with a high stone percentage (greater than 35%) are not supported for shallow mines (less than 200 ft deep). Those sites with a high stone percentage at mine USR 10 are not supported even when overburden depth exceeds 700 ft; they maintain their practice of installing support on an as-needed basis, regardless of the percentage of stone in the rib and overburden depth. The low stone percentage (less than 30%) at mine USR 2 (marked by hollow diamonds in Figure 13) may have played a role into the mine's decision not to support the ribs, even when the overburden depth exceeds 700 ft. Despite the low overburden depth (less than 700 ft) at mine SR 4 and site SR 6-1 (hollow squares in Figure 13), the decision was to support coal ribs for those sites.

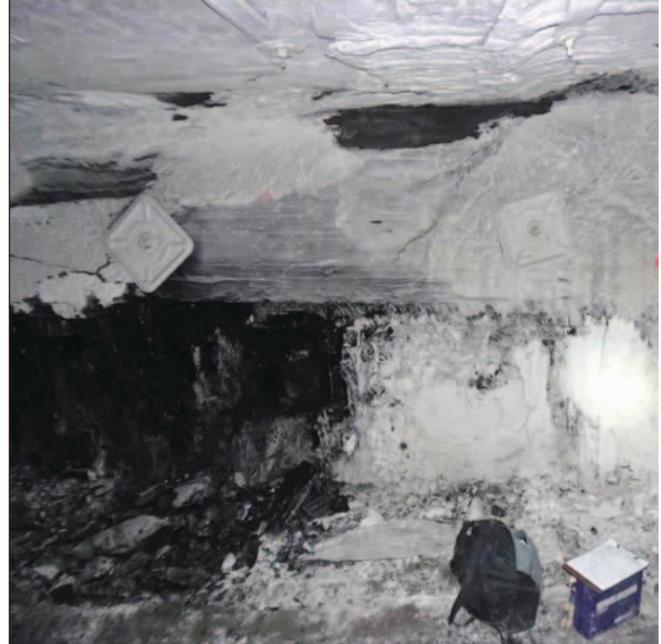
Figure 14a. Effect of geological features on rib performance.
(a) Strong contact between the top section and immediate roof in mine SR 6.

Mine USR 10 has a very similar mine geometry (overburden depth and mining height) to mine SR 6. The rib at mine USR 10 is composed of 3 to 5 ft of coal overlain by 3 to 4 ft of shale. Unlike mine SR 6, a rider seam at the top section of the rib was easily separated from the immediate roof. This facilitated the detachment of the underlying shale unit which easily broke off. This condition was exacerbated by the fact that the shale unit was underlain by a bright coal bench that tended to slough easily (Figure 14b). Mine

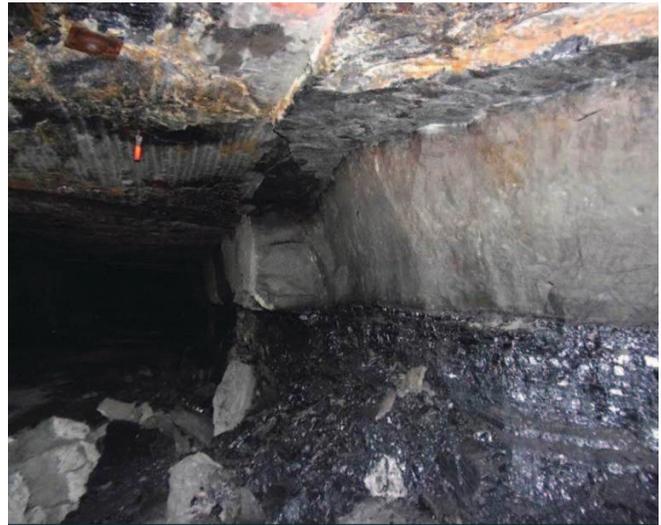
Figure 14b. Effect of geological features on rib performance.
(b) Weak contact between the top section and immediate roof in mine USR 10.

USR 10 tried different bolt designs to support the shale unit, but none were successful. Full mesh would have solved this problem.

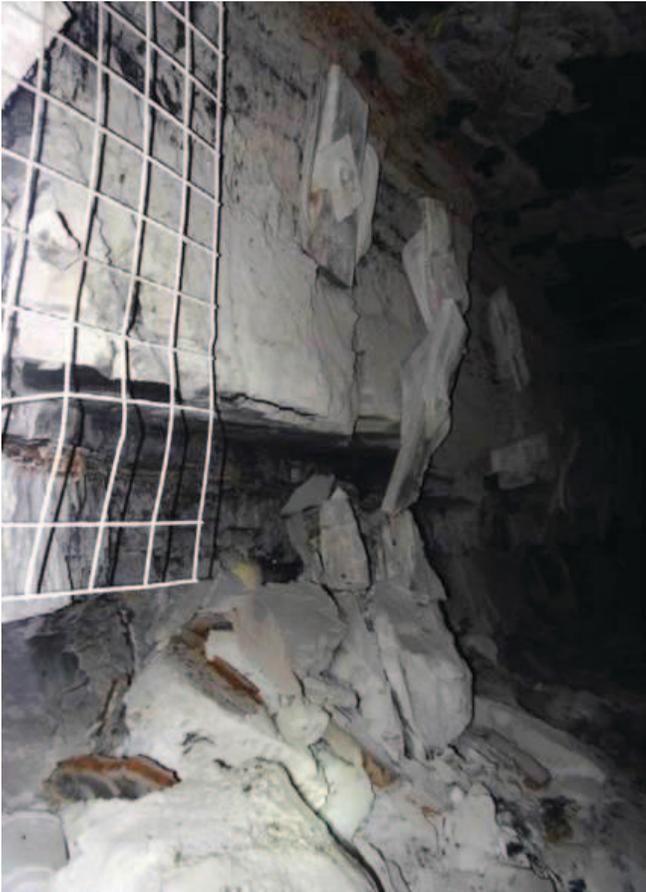
Figure 14c. Effect of geological features on rib performance.
(c) Clay band in the rib at mine SR 5.

The impact of claystone partings on the rib performance can be demonstrated by mine SR 5. The immediate roof is sandstone. The coal seam at mine SR 5 has three benches. The rib shows very little to no deterioration during entry development, with the exception that within a few days rib brows begin to form. Rib bolting is done as part of the development cycle and consists of two rows of 4-ft fully grouted bolts installed at 4-ft spacing. The upper row of rib bolts is angled up at 30 to 45 degrees, and the lower row of rib bolts is installed horizontally. During the mine visit, it was observed that rib brows formed wherever the rock shale is underlain by a claystone parting and soft coal bench (Figure 14c).

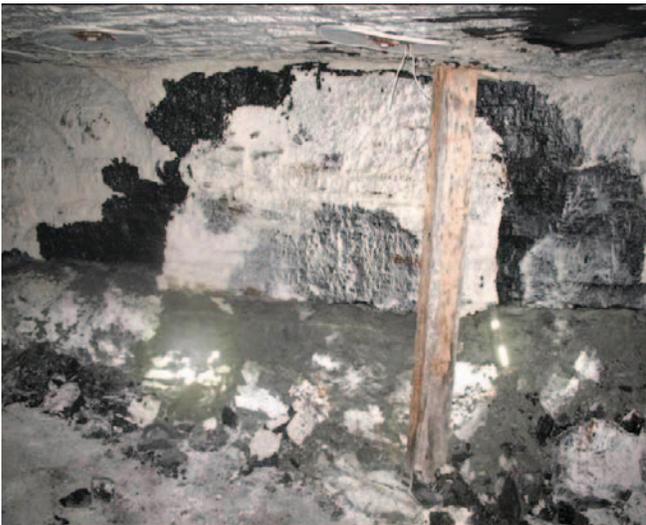
Figure 15. Large slab formed as result of a thick clay band squeeze at mine USR 9.

The coal seam at sites USR 9-1 and USR 9-2 is about 3 to 4 ft thick underlain by thick clay and stone bands of about 2 to 3 ft (Figure 15). Regardless of the low overburden depth (less than 200 ft) at sites USR 9-1 and USR 9-2, large rib slabs were formed due to squeezing of the clay band at the bottom section of the rib

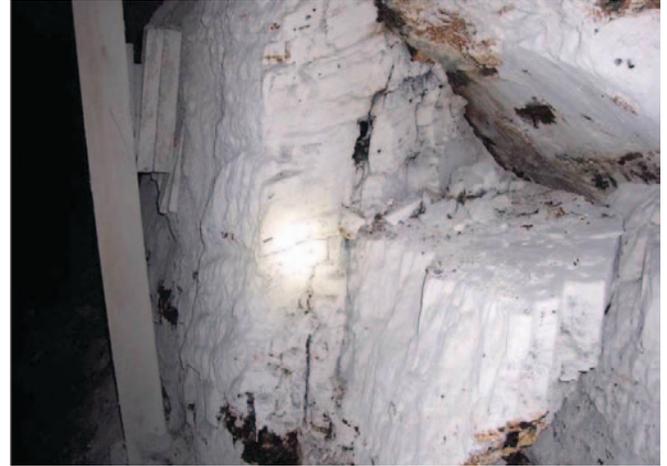
Figure 16. Large slab formed as result of slickenside plan chuting the rib at mine USR 4.

(Figure 15). Significant spall volume at site USR 4-2 was attributed to slickenside planes cutting the rib (Figure 16).

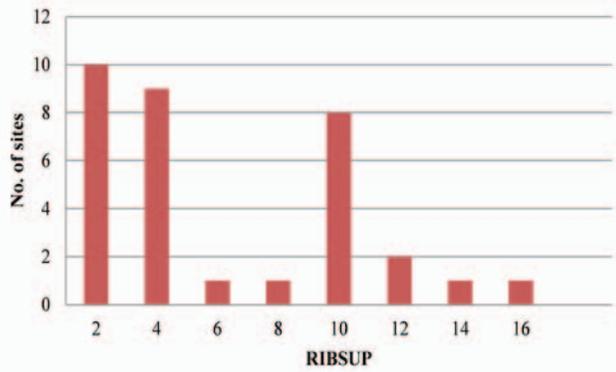
Figure 17. Distribution of Rib Support (RIBSUP) rating at the surveyed sites.

The rib support (RIBSUP) rating was calculated to estimate the density of rib support at the supported sites (Table 3). Figure 17 shows the histogram distribution of rib support density for supported sites. It shows that the supported sites can be divided into two groups: (1) low-density support sites in which RIBSUP is less than 4, and (2) high-density support sites in which RIBSUP is greater than 6. The latter includes sites where bigger bolts with narrow spacing are installed both with and without liners.

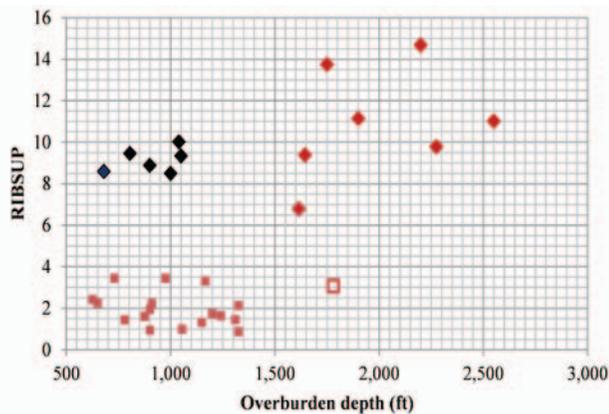
Figure 18. Overburden depth vs. RIBSUP at the surveyed sites. (Squares: low-density support sites; diamonds: high-density support sites.).

To assess the impact of overburden depth of rib support density, the distribution of these values was plotted (Figure 18). The sites of low-density rib support are marked by squares and diamonds marks the high-density support sites. With the exception of site SR 3-4, (marked by hollow square in Figure 18), the overburden depths at the low-support sites are less than 1,325 ft. Sites with low support densities are usually free of excessive loading conditions such as multiple-seam interactions and tailgate side loading. The RIBSUP rating of the sites of low-density support do not correlate with overburden depth.

The high-density support sites could be subdivided into two subgroups: (1) low overburden depth sites of less than 1,050 ft (marked by black diamonds in Figure 18) in which the high-support rating was achieved through bolt design (such as SR1 mine) or using mesh in addition to rib bolts (such as sites SR 4-2 and SR 7-1), and (2) high overburden depth sites of more than

1,645 ft (marked by red diamonds in Figure 18) in which mesh is consistently used in addition to rib bolts.

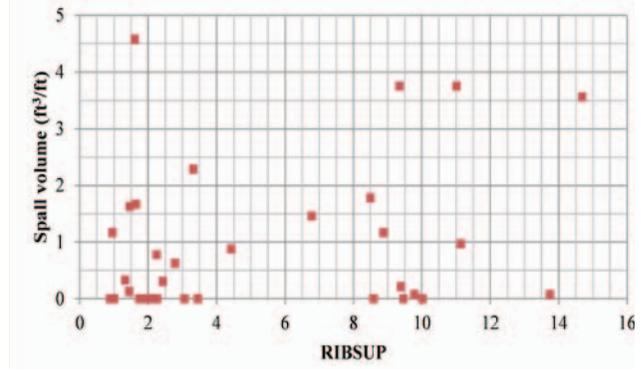
Figure 19. RIBSUP vs. spall volume at the surveyed sites.

Figure 19 shows the distribution of rib support rating versus the spall volume. The figure shows that there is no correlation between the applied rib support density and the measured spall volume. The spall volume ranges from 0 to 4.5 ft³/ft for both low- and high-rib support densities.

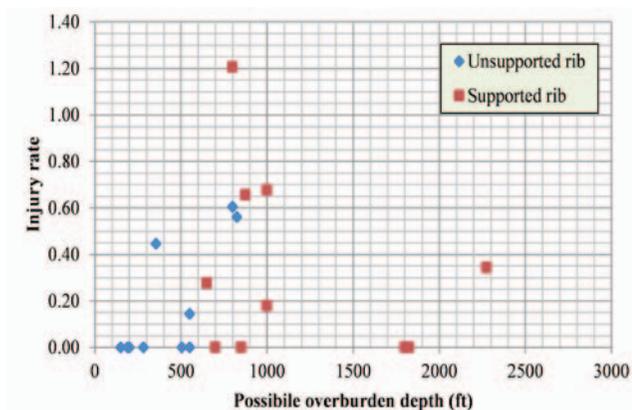
Figure 20. Non-fatal days lost (NFDL) operator rib incidence rate vs. overburden depth at the surveyed sites for 2011-2013.

Figure 20 emphasizes the need for more rib control management for mines operating at overburden depths between 500 ft and 1,000 ft. Similar observations were drawn from the analysis of rib fatalities between 2010 and 2013. The rib fatality rate at mid-depth mines (700-1,250 ft) was found to increase by 225% compared with low-depth mines (less than 700 ft). Meanwhile, the rib fatality rate at deep (greater than 1,250ft) mines was reduced by 61% compared with mid-depth mines (Jones, 2014).
