# Injury Surveillance and Safety Considerations for Large-Format Lead-Acid Batteries Used in Mining Applications

Miguel Angel Reyes and Thomas Novak, *Fellow, IEEE*

**Abstract**—Large lead-acid batteries are predominantly used throughout the mining industry to power haulage, utility, and personnel-carrier vehicles. Without proper operation and maintenance, the use of these batteries can introduce mechanical and electrical hazards, particularly in the confined, and potentially dangerous, environment of an underground coal mine. A review of the Mine Safety and Health Administration accident/illness/injury database reveals that a significant number of injuries occur during the maintenance and repair of lead-acid batteries. These injuries include burns from electrical arcing and acid exposure, as well as strained muscles and crushed hands. The National Institute for Occupational Safety and Health investigated the design and implementation of these batteries to identify safety interventions that can mitigate these inherent hazards. This paper promotes practical design modifications, such as reducing the size and weight of battery assembly lids in conjunction with lift assists, as well

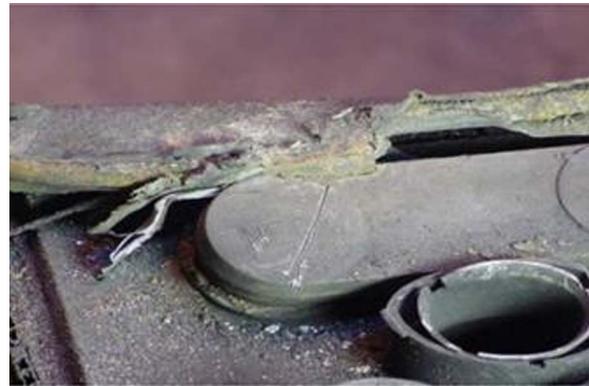
Fig. 1. Scoop tractor battery showing terminal contact with steel battery tray.

**I**N 2001, two sequential explosions inside the Jim Walter Resources Mine No. 5 in Alabama claimed the lives of 13 mine workers. The Mine Safety and Health Administration (MSHA) postdisaster investigation identified the ignition source of the initial explosion as a scoop tractor battery, which was damaged from a roof fall. The battery arced and ignited an explosive mixture of methane and air [1]. Fig. 1 shows how the metal battery assembly came in contact with a battery terminal after the enclosure was damaged. The initial explosion severely injured one person and destroyed numerous ventilation controls, which led to a subsequent and larger explosion. Dubaniewicz [2] subsequently recommended a reevaluation of the Code of Federal Regulations (CFR) Title 30, Part 7

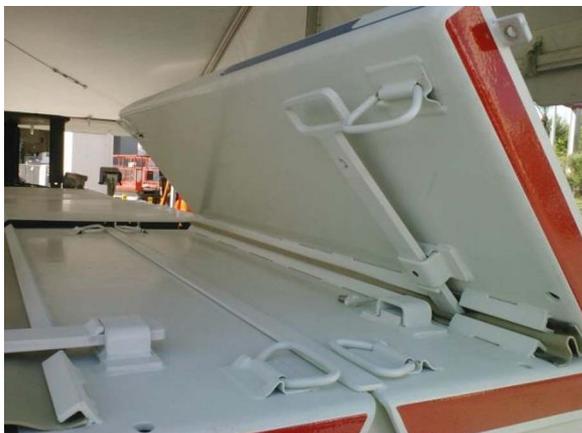
Fig. 3. Rectangular-shaped battery assembly lids.

1) *Size of Lids:* The size and weight of lids may contribute to back and shoulder injuries. Several lid configurations were observed in the field and varied from long rectangular lids to smaller square lids, depending on the manufacturer and equipment type. The two configurations are depicted in Figs. 3 and 4.

vertical space creates more difficulty. The smaller size of the square lids can relieve the strain caused by the frequent need to open and close the lids for maintenance and repair work. The ease of opening the lids also affects the performance of maintenance and repair tasks, because a repairman is more likely to put off preventive maintenance if lids are difficult to open.

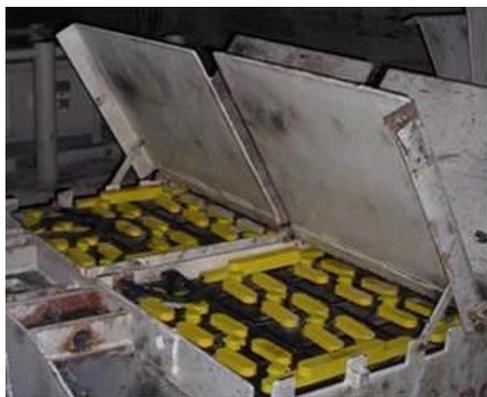
Fig. 4. Square-shaped battery assembly lids.

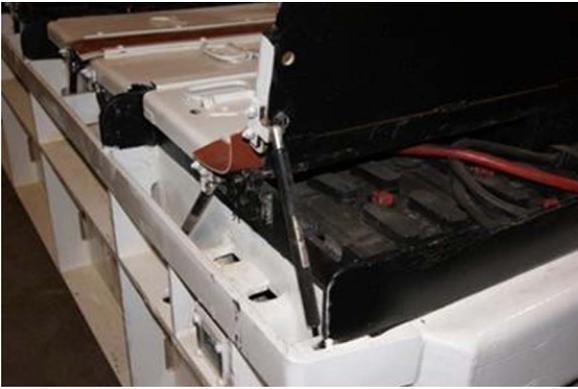
Fig. 5. Battery assembly with a pneumatic lift assist.

3) *Lift Assists:* An alternative solution to the weight issue presented by the heavy steel lids is the implementation of lift assists. Some manufacturers offer pneumatic lift assists to help address this risk (see Fig. 5). A lift assist helps raise the lids safely by reducing the musculoskeletal strain to which a mine worker is subjected. Thus, injuries attributed to the frequent raising and lowering of the battery lids for charging, maintenance, and repairs may be significantly reduced. These lift assists are relatively inexpensive and easy to replace if

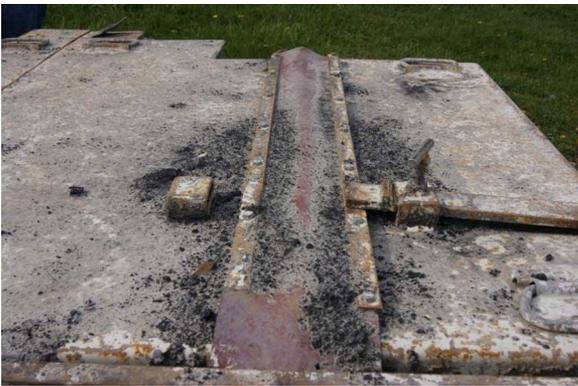
Fig. 6. Battery assembly with hinge cover.

Manufacturers also recommend the use of hinge covers. These covers serve a dual purpose as they effectively keep rock dust and dirt from the hinges while reducing the accumulation of debris inside the battery assembly (see Fig. 6). Debris accumulation can create a potential for a short circuit across battery terminals that may result in a battery fire or explosion. Note in Fig. 6 the amount of debris built up on the battery assembly surface that was effectively kept away from the battery's surface area and terminals by the use of hinge covers.

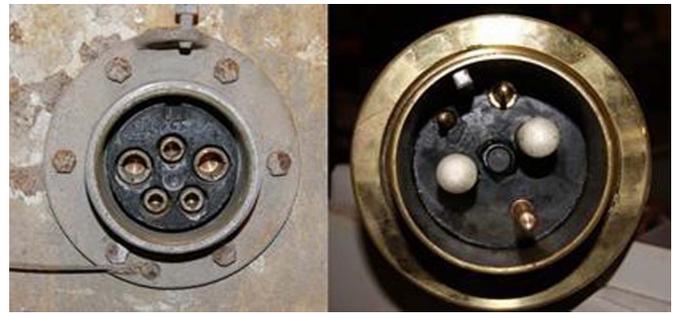
Fig. 7. Five-pole battery cable connectors.

A five-pole look-ahead charging cable connector is a major improvement to the two-pole connector. This configuration, which is depicted in Fig. 7, consists of positive and negative pins, a ground pin, and two pins used to "look ahead." The two look-ahead pins serve the purpose of interlocking with the charging coupler and ensuring that there is a proper connection prior to starting the charging cycle. This feature also eliminates arcing when the charging cables are disconnected from the battery by tripping a circuit breaker before the power contacts are separated.

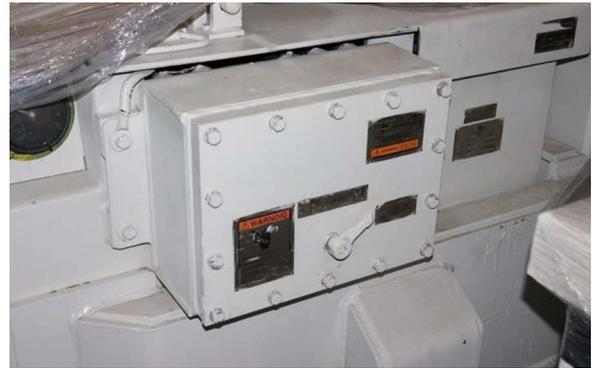
Fig. 8. Side-mounted battery circuit breaker box.

6) *Breaker Boxes*: Accident/illness/injury statistics show a small number of cases involving arcing when cables were pulled from the battery assembly (see Fig. 2). These reported cases, which are included in the arcing/acid burns category, often occurred during the maintenance and the charging of batteries because the batteries were not properly deenergized prior to the cables being disconnected. From an engineering standpoint, the addition of a circuit breaker on a battery assembly, as shown in Fig. 8, reduces that potential by providing a local method for deenergizing a battery.

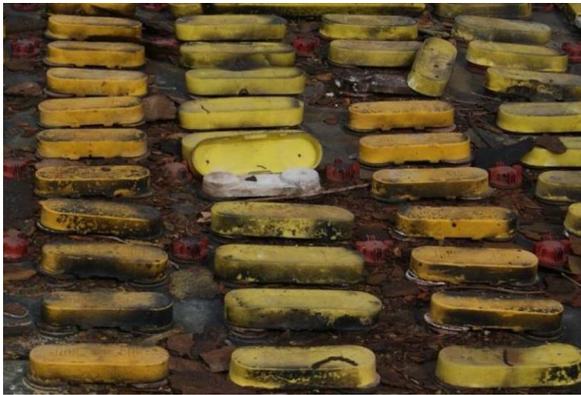
Fig. 9. Debris and leakage buildup on terminals.
