**INCIDENT FACTS**

71-222-2022

# Orchard Worker Driving UTV Struck By Car

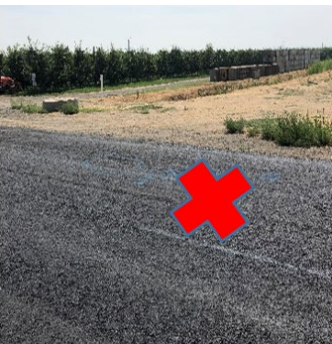
Red X shows where passenger car struck worker's UTV on paved county road.

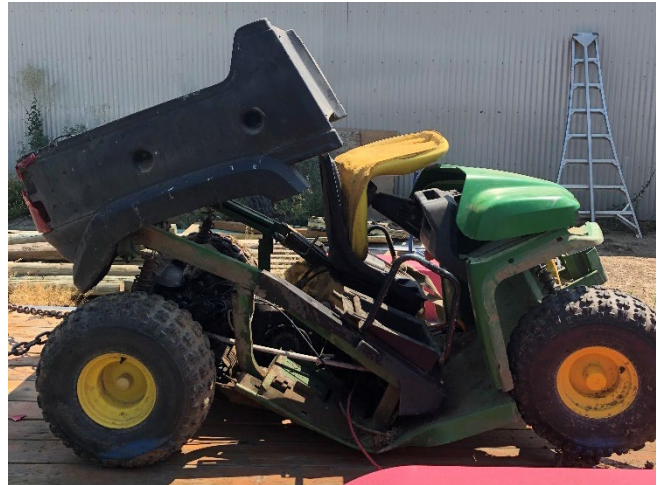
The speed limit was 55 mph, but there were no traffic signs or street lights in the area. It is unknown if the vehicles had their lights on. As the car caught up to the UTV, it struck it from the rear and pushed it 310 feet, nearly the length of a football field, before coming to a stop in an orchard adjacent to the road. First responders pronounced the worker dead at the scene.

**Utility Task Vehicle (UTV) with collision damage caused by passenger car.**

- Use a utility trailer or road safe/legal vehicle to transport UTV, ATV, and other off-road vehicles to worksites to have them avoid using public roads when such use is deemed unsafe by vehicle manufacturers and/or restricted by local ordinances.
- As part of their APP, do a job hazard analysis (JHA) of tasks involving farm vehicles and equipment that may pose risks. Workers should be involved in creating the JHA.
- Make sure APP policies and safety training instruct UTV, ATV, and other off-road vehicle operators to follow manufacturer's safety guidelines and local vehicle and traffic rules.
- Develop APP policies that require UTV, ATV, and other off-road vehicle operators to turn on lights and wear DOT-compliant helmets and reflective, high visibility clothing in poor visibility conditions.
