**INCIDENT FACTS**

71-223-2022

## Orchard Worker Driving Overloaded ATV Struck on Highway

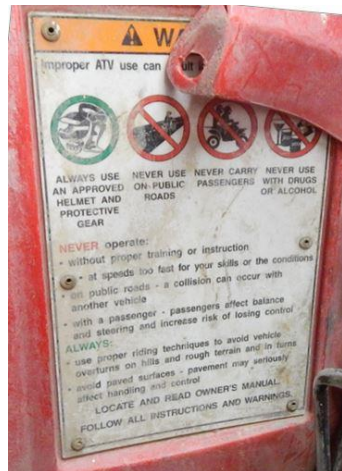
Manufacturer's warning label on ATV showing helmet requirement and public road use restriction.

- The employer did not ensure that workers followed the ATV manufacturer's guidelines to not have any loads that were not secured to the vehicle's front and/or rear cargo racks.
- The employer did not provide helmets nor ensure that workers wore them per manufacturer's guidelines.
- The employer did not prohibit workers from driving ATV on highways and public roads, including shoulders, in accordance with state vehicle and traffic rules and vehicle manufacturer's guidelines.
- The employer did not ensure that workers were provided with proper hands-on ATV safety training.

- Provide DOT-compliant helmets and develop APP requirements and training for ATV, UTV, and other off-road vehicle operators to wear them during vehicle operation. [WAC 296-307-10005](http://WAC 296-307-10005), [WAC 296-800-16055](http://WAC 296-800-16055)
- As part of their APP, do a job hazard analysis (JHA) of tasks involving farm vehicles and equipment that may pose risks. Workers should be involved in creating the JHA. [WAC 296-800-16005](http://WAC 296-800-16005)
- Develop APP policy requirements and safety training for ATV, UTV, and other off-road vehicle operators to follow manufacturer's safety guidelines, including loading procedures, and state, county, and local vehicle and traffic laws and ordinances. [WAC 296-307-030\(1\)](http://WAC 296-307-030(1))

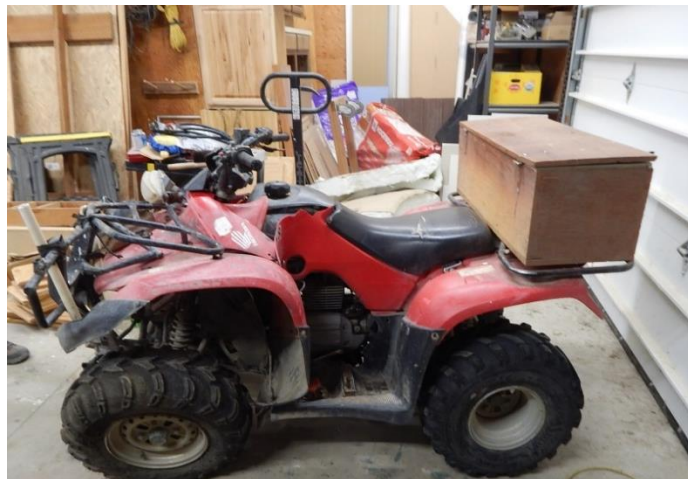
**All-Terrain Vehicle (ATV) with damage from a collision with a horse trailer.**

On the way to the orchard, the two workers drove on a gravel access road to an intersection with a paved state highway. The road had a slight decline where it met the highway. The worker with the pipe was in the lead. He tried turning right from the road onto the highway's southbound shoulder but lost balance and control from the momentum and pipe blocking his steering ability. He rolled across the centerline into the northbound lane where an oncoming passenger truck going the 60 mph speed limit struck the ATV with the left front side of a horse trailer it was towing. The worker was ejected from the ATV and died at the scene.
