**Coal Mine Subsidence and
Land Use in the
Boulder-Weld Coalfield**

**Boulder and Weld Counties,
Colorado**

OFR 77-64

AMUEDO AND IVEY

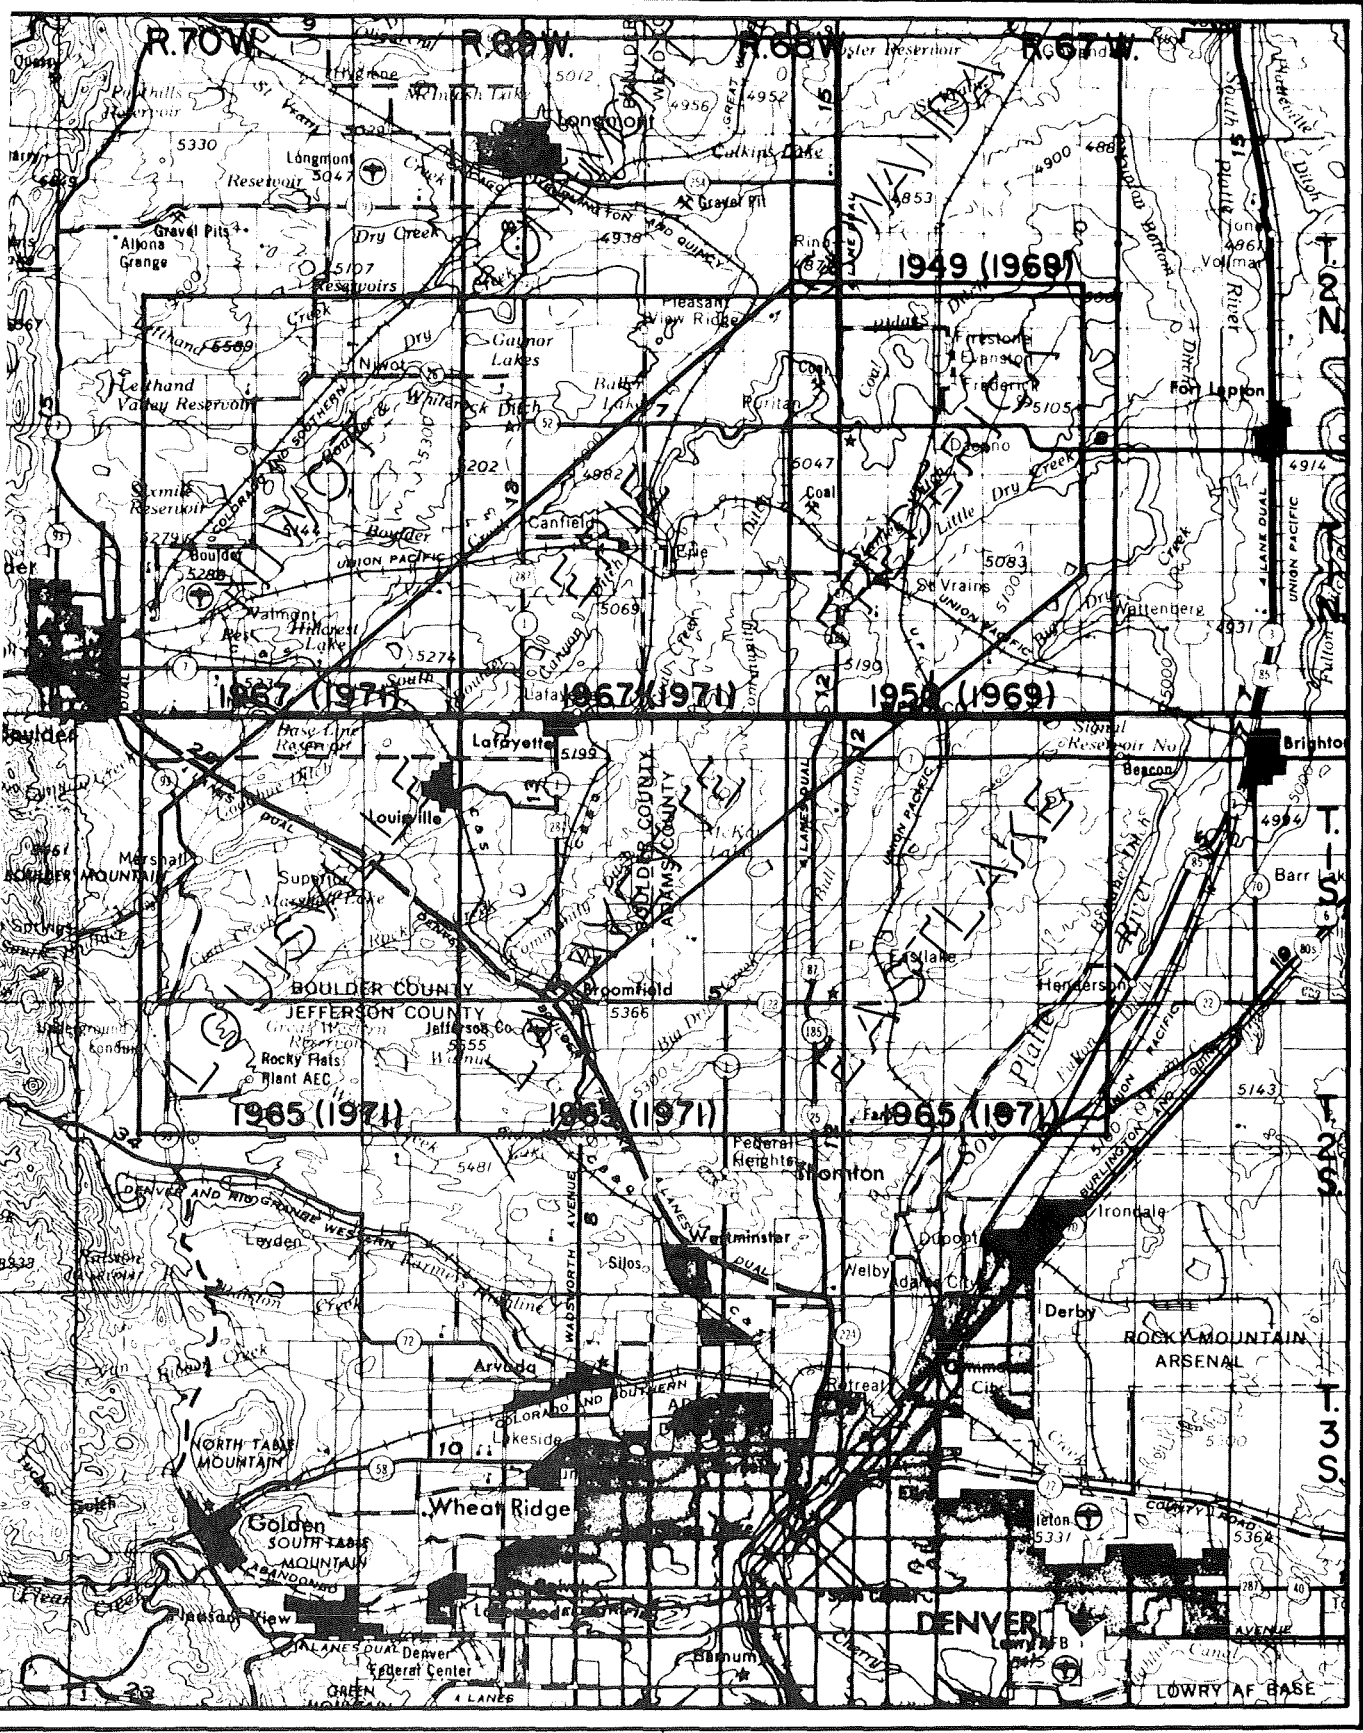
INDEX MAP OF U.S. GEOLOGICAL SURVEY
7 1/2' QUADRANGLE MAPS

The study area is completely covered by U. S. Geological Survey topographic maps (Figure 2) at the scale 1"=2000' (1:24000) and a contour interval of 10 feet. These maps are recent and vary in date of publication from 1949 to 1967. They were subsequently photo-revised in 1969 and 1971, and it is the revised editions which were used to construct the base maps for this report.

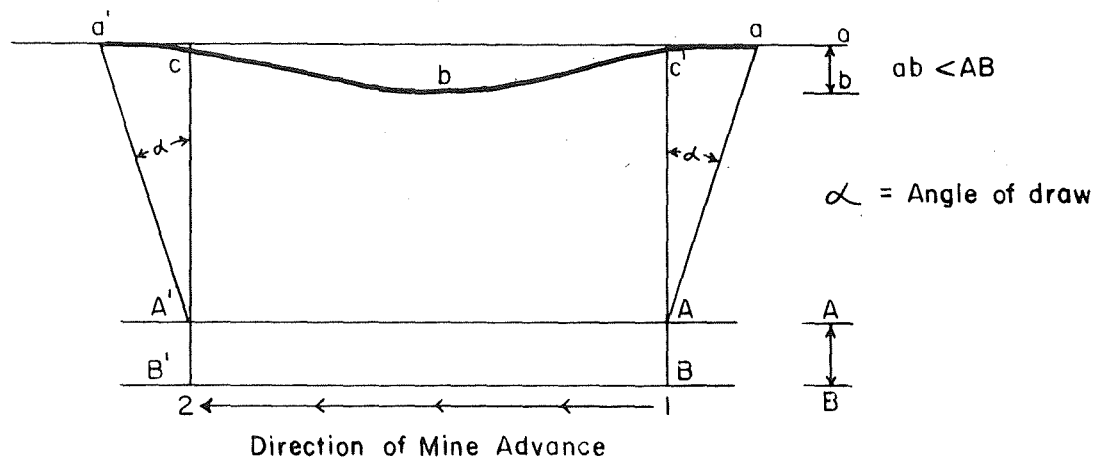
Subsidence Trough before Mining Reaches Critical Width

Figure 4 As a mine face advances from point 1 to point 2 the surface subsidence which occurs will take the form of a shallow trough, shown as curve aba' . The greatest amount of subsidence for a given width of mine opening will be equal to ab and will be located over the center of the opening at b . The amount of surface subsidence will diminish on either side of b until, at points a and a' , it is nil. Since $aa' > AA'$ it can be seen that the area affected by surface subsidence is greater than the mined out opening. Subsidence ab will never be greater than AB and will in fact be less than AB until a certain "critical width" of the mine opening is reached. The line aA connects the point of nil subsidence and the edge of the mine opening and forms one side of the "angle of draw." In British and American literature this angle (α) is measured from a vertical line; in European references it is measured from a horizontal line.

Figures 4 and 5 illustrate diagrammatically the development of a typical subsidence trough. The extraction of coal removes support from the overlying strata causing them to sag into the void space created. The sag is propagated upward to the surface, and, it follows, that the maximum surface subsidence can be no greater than the thickness of the coal bed mined. However, the lateral extent of subsidence at the surface is greater than the extent of underground mining. The surface position of the boundary between areas of subsidence and no subsidence is defined by the "angle of draw." This is the angle between a vertical line and a line drawn from the point of zero surface subsidence to the edge of the underground opening. The angle of draw varies

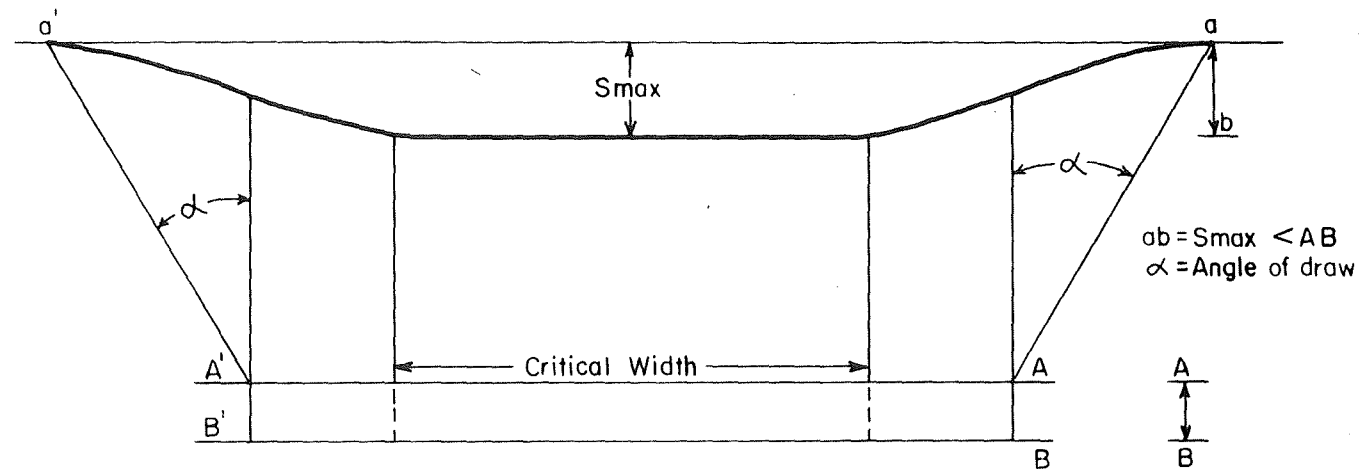
Subsidence Trough after Mining Reaches Critical Width

Figure 5 As the mine face advances, ab and angle α will increase until a "critical width" of the mine opening is reached. At this point the amount of vertical subsidence, ab , reaches a maximum value, S_{max} . Further enlargement of the mine opening will subject a larger and larger area at the surface to maximum subsidence though S_{max} itself will not increase. In three dimensions the deepest part of the subsidence trough will change from an axial line, as would be the case in Figure 4, to a flat bottom as shown above.

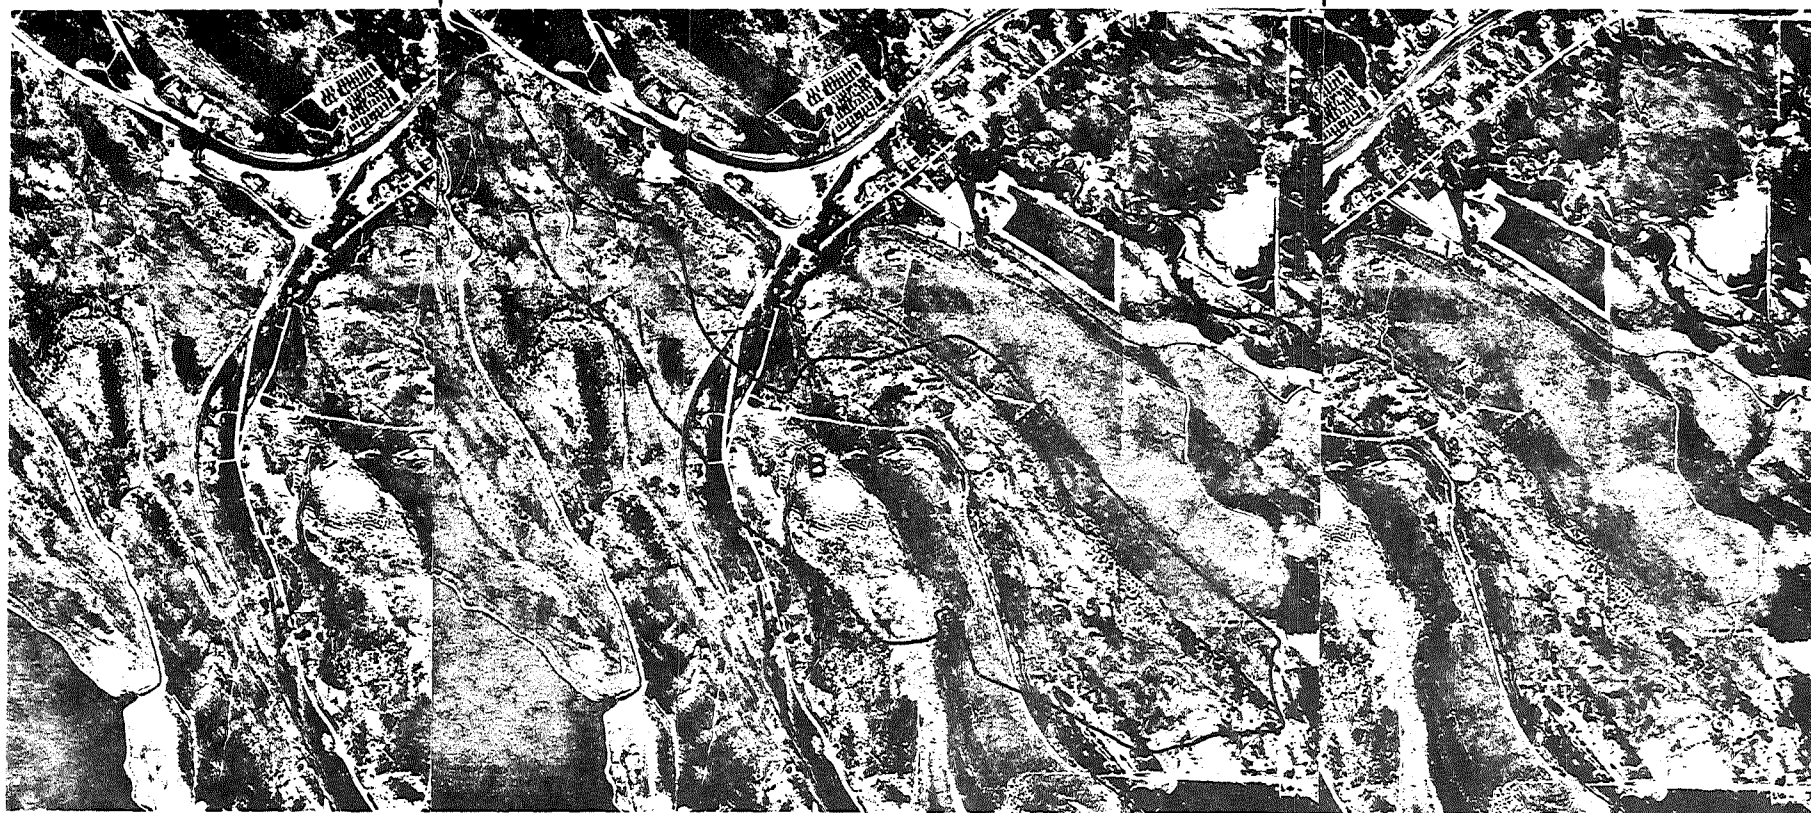
Figure 6. Stereo triplet of Marshall area. Much of the mining in the Marshall area was done before adequate maps and records were kept. Fortunately, mining in this area was very shallow, so that the outlines of the mines are delineated by surface subsidence features. In the absence of good mine maps, these features, as observed in the field and on the aerial photos, were used to determine the extent of mining. The northwest portion of the mining area, as defined by this study (dashed line), differs considerably from the previously reported boundary (solid line). Areas A and B are the same as Figures 29-30 and 31-32 respectively. Photo scale 1"=1667' (1:20000). Localities 1-11, subsidence-inventory map.

This map was compiled by visually reducing the outlines of individual large scale 1"=200' (1:2400) mine maps to a scale of 1"=2000' (1:24000). Most of these maps are on file with the Colorado Division of Mines, some are in the microfilm collection of the U. S. Bureau of Mines, and a few are in the collection of Roger B. Colton, U. S. Geological Survey. In some areas, air photos and field observations of subsidence were valuable in re-defining the extent of underground workings and in determining the existence of several mines which had not been plotted by previous workers. Such areas included the Marshall #1, Marshall #3, Fox, Black Diamond, Old Black Diamond, and Allen Bond mines, mined areas around the Blue Ribbon adit, and an unknown mine in SE 1/4, NE 1/4, sec. 18, T.1N., R.68W. (Figures 6, 13 and 14).

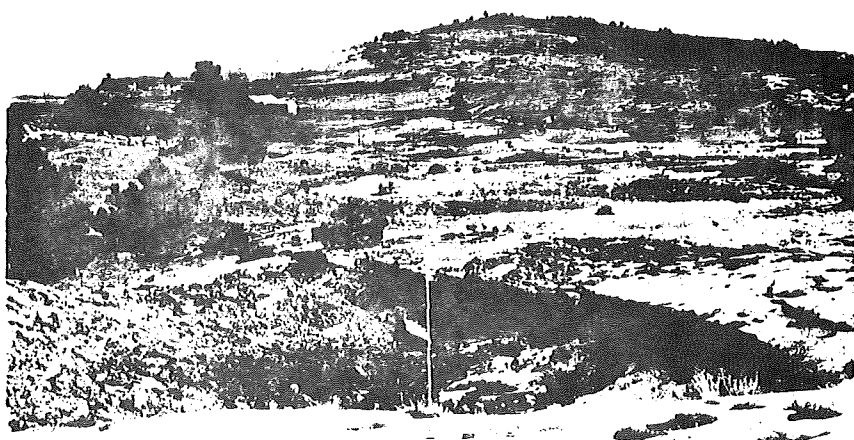
Figure 7. Collapse over room of Marshall No. 1 mine. The collapse area is approximately 15 feet by 30 feet and is about three feet deep. From five to ten feet of coal were extracted from this area at a depth of about 50 feet. Lower slopes of hill in background are also shown in Figures 6 (area A), 8, 31, and 32. Locality 4, subsidence-inventory

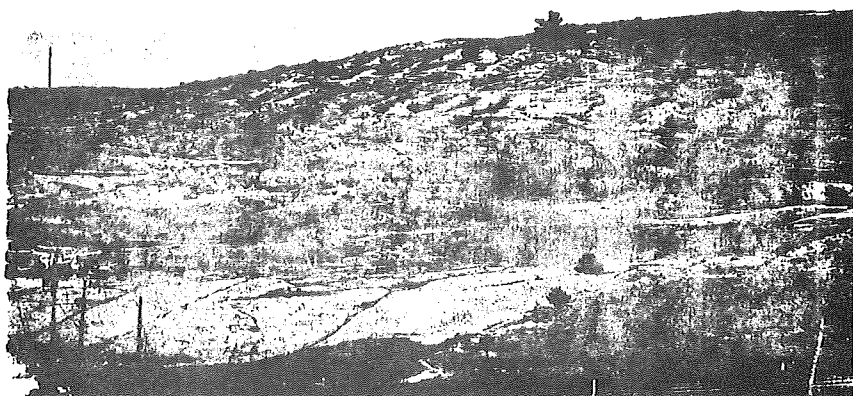
Figure 8. Collapse area over Lewis No. 1 and No. 2 mines. Outcrops of these mines are expressed by depressions and pillars and ridges. Mining was at a depth of less than 100 feet, and about ten feet of coal was extracted. Compare joints in exposed sandstone in foreground with same area shown on Figures 31 and 32. Locality 7, subsidence-inventory map.

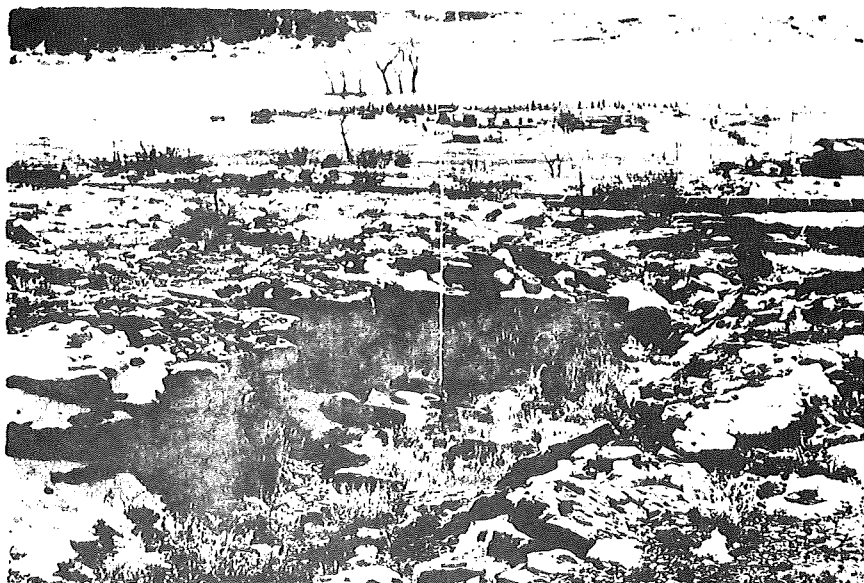
Figure 9. Collapse over room of Lewis No. 1 mine. Pit is about ten feet by 15 feet and is three feet deep. From five to ten feet of coal was extracted at a depth of approximately 50 feet. Flume carrying irrigation water in middle ground must be periodically re-set because underground fires in this area are causing continued subsidence. Locality 7, subsidence-inventory map.

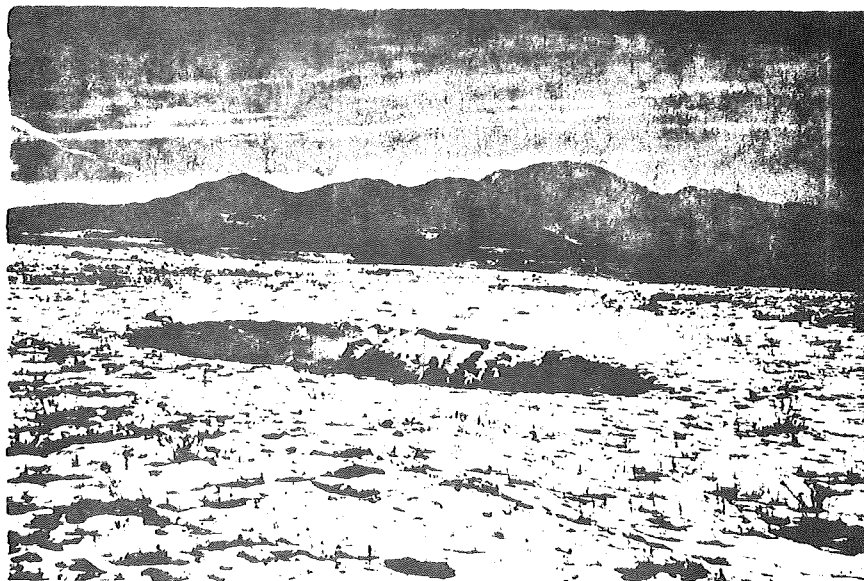
Figure 11. Large subsidence pit over the Premier mine. The pit is approximately 30 feet in diameter and eight feet deep. About ten feet of coal was mined at a depth of about 100 feet. Near locality 1, subsidence-inventory map.

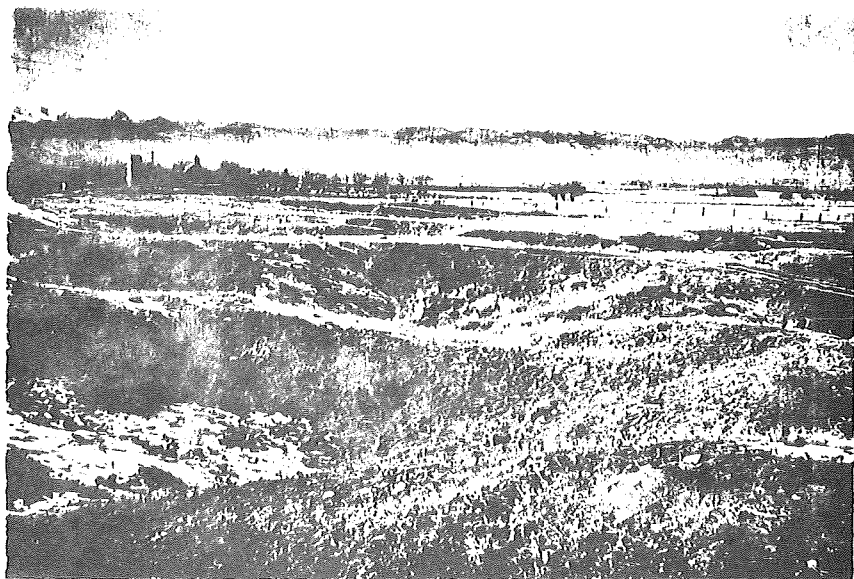
Figure 12. Large, well-developed subsidence pits over rooms at the Shanahan mine. Pits are eight to ten feet deep and 15 to 25 feet across. The coal seam at this mine was unusually thick (10 to 15 feet), which accounts for the large amount of vertical subsidence. The mining depth was less than 100 feet. Locality 21, subsidence-inventory map.

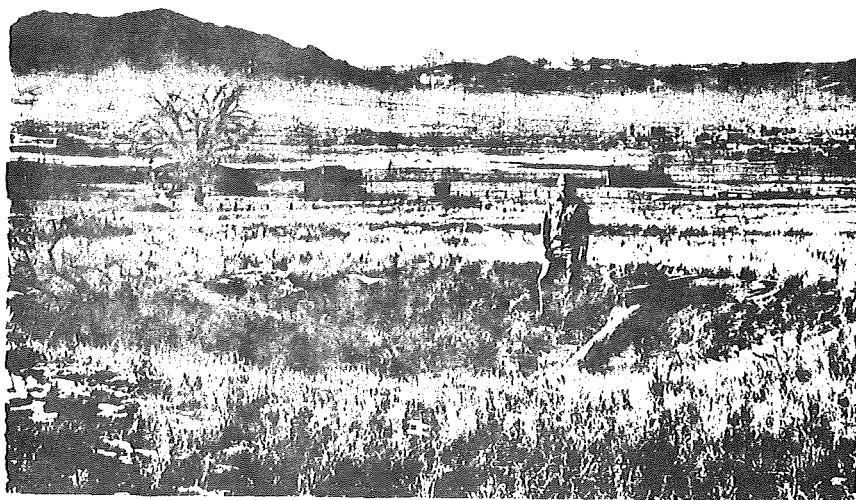
Figure 13. Collapse pit over the Allen Bond mine. Features such as this aided in locating the true position of the Allen Bond mine. The previously reported position of the mine showed no evidence of surface subsidence. A thick (10 to 15 feet) coal seam was mined here at a depth of approximately 100 feet. Locality 19, subsidence-inventory map.

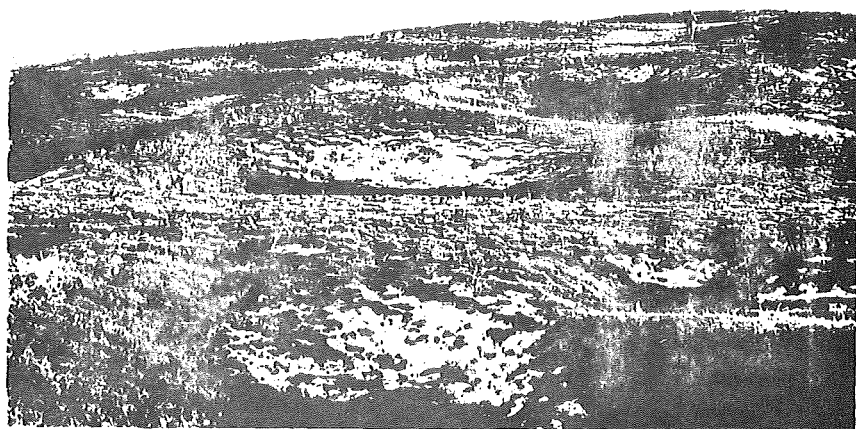
Figure 14. Numerous subsidence pits above an unreported mine located east of Erie. No maps were found of this mine in the files of either the Colorado Division of Mines or the U.S. Bureau of Mines. Examples such as this illustrate the necessity for field reconnaissance of all prospective development areas. Based on conditions in nearby mines, it is estimated that five to ten feet of coal was extracted at depths of 50 to 100 feet. Locality 67, subsidence-inventory map.

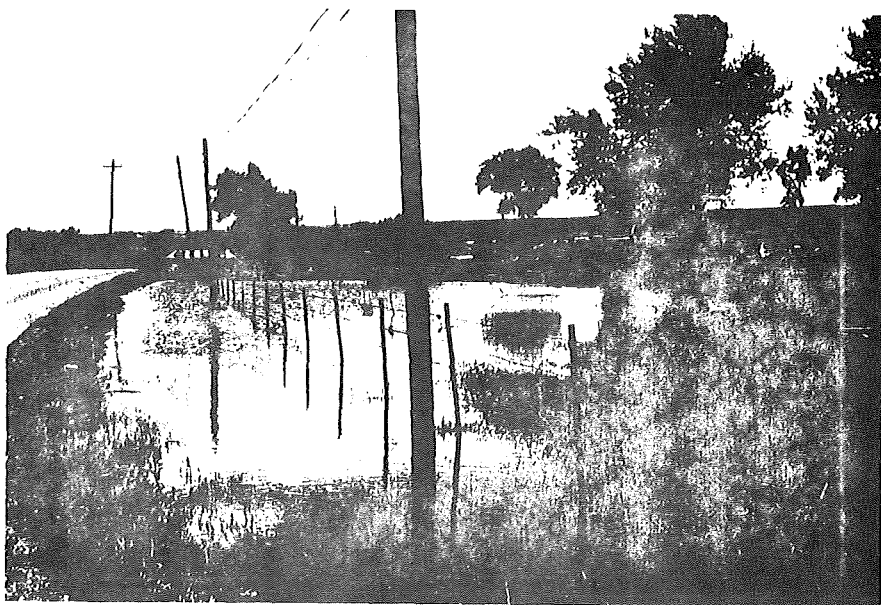
Figure 15. Water-filled depression over Nonpareil mine. Depression is partially closed by base of section line road. This is a typical example of a questionable subsidence feature. Locality 40, subsidence-inventory map.

depressions (Figure 15), features of less positive subsidence evidence (swales and broad ground "sags," Figures 16-17) and areas of reported but unverified subsidence were also noted. Recent (1969) aerial photographs were of some use in delineating areas of subsidence over areas of shallow mining such as the Fox, Allen Bond, Pluto, Northwestern, and an unknown mine in NE 1/4, sec. 18, T.1N., R.68W. In Weld County, older (1949) aerial photographs were used to determine an area of subsidence over the Shamrock mine (depth of cover about 100 feet). This area was leveled and reclaimed for farming in 1956 and all surface evidence of subsidence was obliterated at that time.

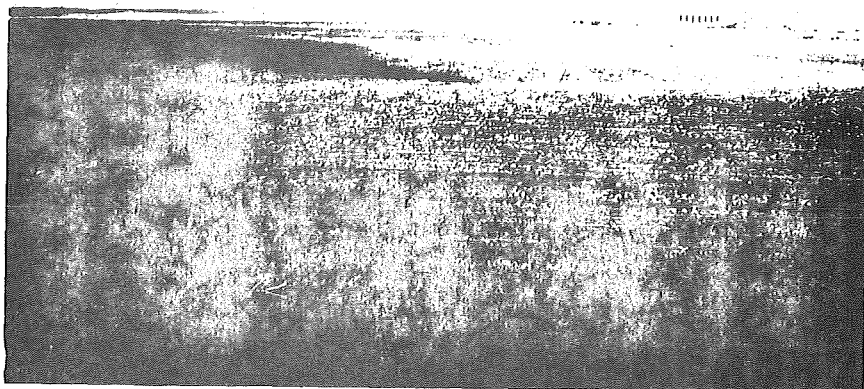
Figure 16. Broad swale over Lincoln mine. The swale in mid-foreground is fortuitously outlined by shadows cast by trees. Normally, this feature would be hard to discern with the unaided eye since it is quite broad (100 feet) and is only two or three feet deep. The mining depth at this locality is 50 to 200 feet and five to ten feet of coal has been extracted. Tipple of the Lincoln mine is in background. Locality 77, subsidence-inventory map.

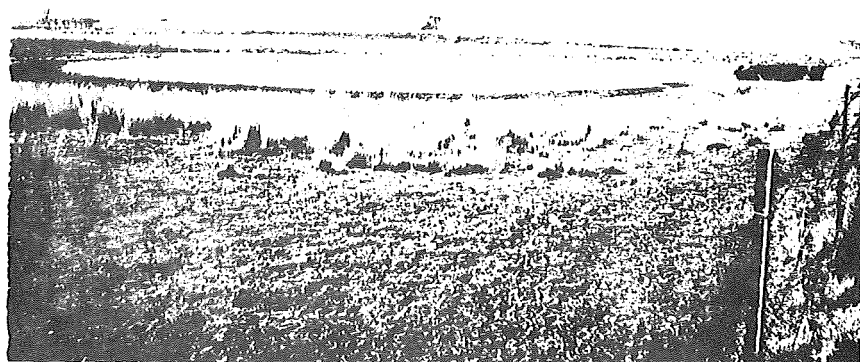
Figure 18. Water-filled depression just east of Russell mine. The depression lies a few hundred feet beyond the reported northern limit of the Russell mine. This may be a case of subsidence over an area which was poached and the mining was not reported. The shallow (one to two feet) depression may also be the result of wind erosion. Locality 94, subsidence-inventory map.

Another complicating factor in subsidence identification is that surface effects above deeper mines (greater than 200 feet) are likely to be faint. Unless observed immediately after mining, they may soon be totally obscured. Subsidence over deeper mines is not represented by well-defined pits and swales, but is typified by broad depressions several hundred yards in diameter. Even broad depressions over known mined areas may be suspect because "blowouts" (wind-eroded depressions) occur in the area, especially around Frederick and Firestone (Figures 18-19).

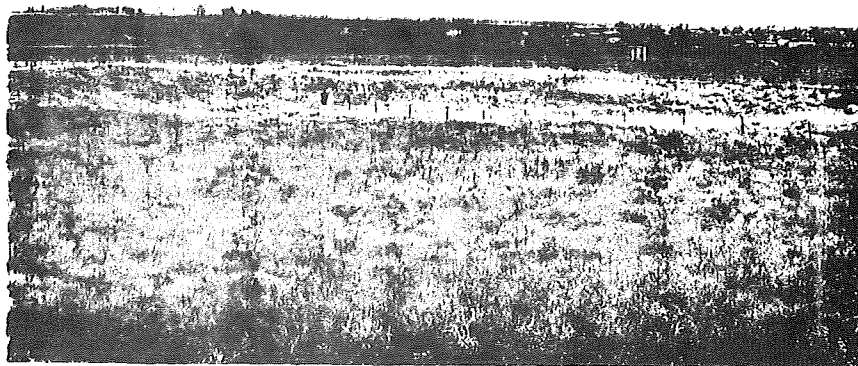
Figure 19. Sand dune area one-half mile west of Firestone. Irregularities of fence line indicate the irregular nature of the topography. This area overlies the Frederick mine where a two to ten foot coal seam was mined at a depth of 100 to 150 feet. The poor, sandy soil of the area and the close proximity to an undoubted dune field indicate that the irregular topography is due to wind deposition rather than subsidence.

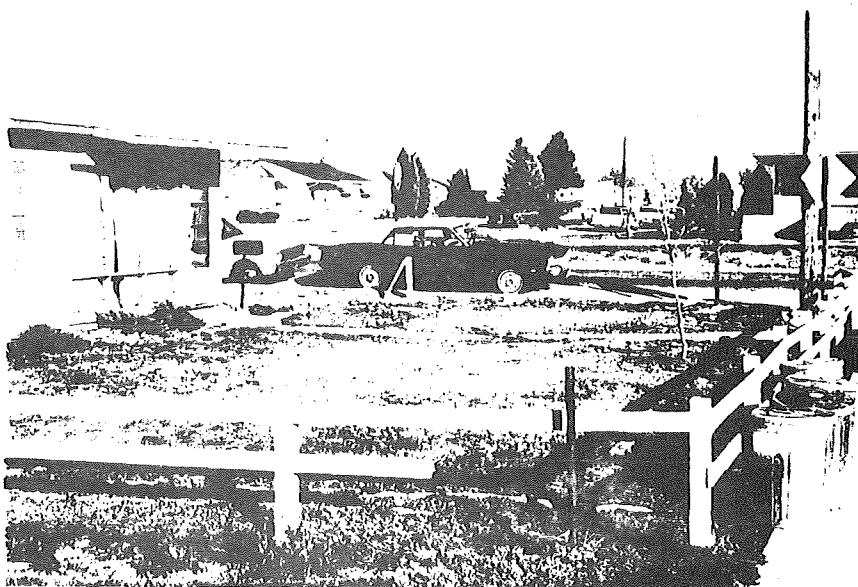
Figure 20. Subsidence over Strathmore mine, South Longmont, Colorado, Lafayette. The low sag in the front lawn and the irregular sidewalk are subsidence related. This "subsidence" is actually the result of compaction of trash and rubble used to fill a true subsidence pit which formed in 1956 (Denver Post, March 27, 1956). There was rapid collapse and overnight development of a hole 40 feet deep and 15 to 20 feet square. Locality shown on subsidence-inventory map.

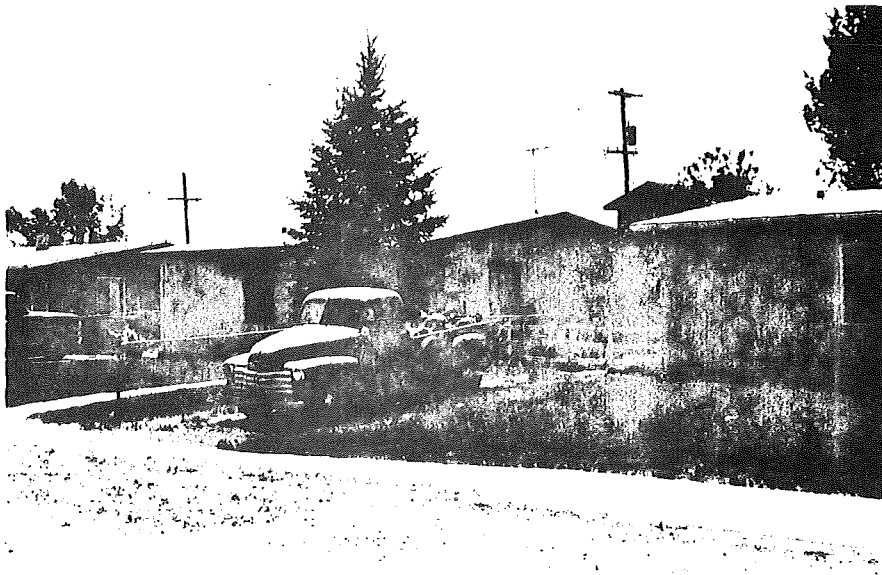
Figure 21. Subsidence over Strathmore mine, South Longmont Street, Yvette. The most recent damage to the street has not yet been repaired. Note unpaved section of street and sagging sidewalk. The coal seam in this area of the Strathmore mine was quite thick, and the probable thickness of coal extracted was 20 to 25 feet. Depth of mining was 100 to 125 feet. Locality 55, subsidence-inventory map.

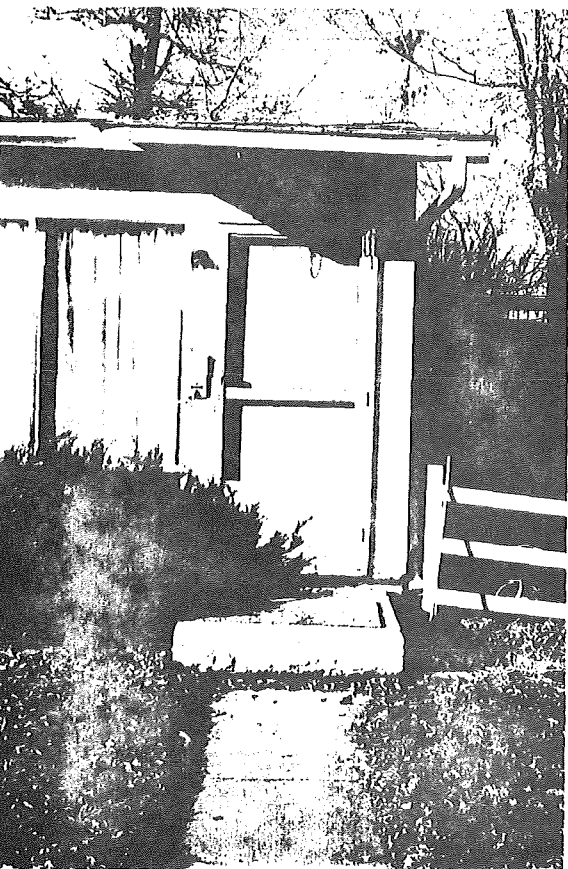
Figure 22. Front stoop of house to the right in Figure 21. This house is immediately south of home shown in Figure 20. The walk has pulled away from the stoop and it in turn has pulled away from the house. Bricks have been jammed beneath the house and beneath the stoop for temporary support. Locality 55, subsidence-inventory map.

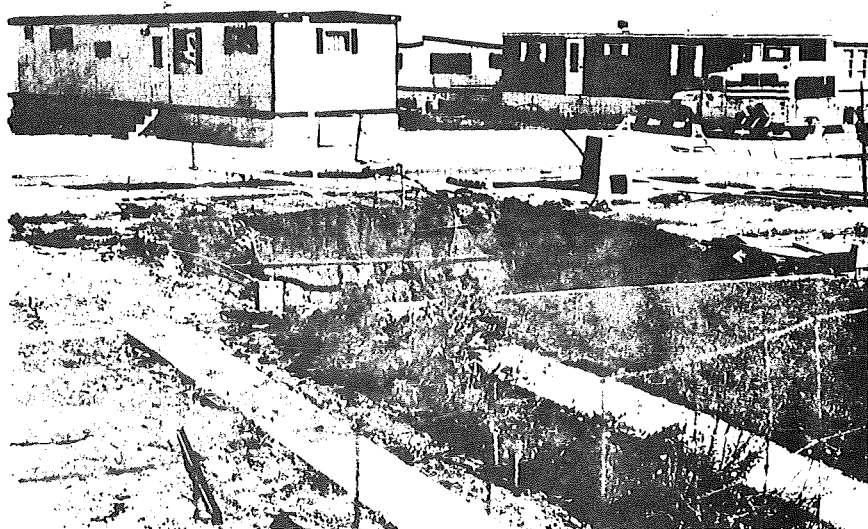
Figure 23. Subsidence pit at a trailer court in Lafayette. Ground began caving in the early morning of August 29, 1974, and continued to enlarge until noon. Final dimensions of the subsidence pit were 24 X 18 X 15 feet. The subsidence occurred in a vacant area and only minor damage to utility lines was sustained. Had one of the large "mobile" homes shown in the background of this figure been parked on top of the subsidence area it is doubtful that it could have been moved quickly enough to save it. This recent event is a dramatic example of continuing subsidence problems in an area where mining ceased over half a century ago.

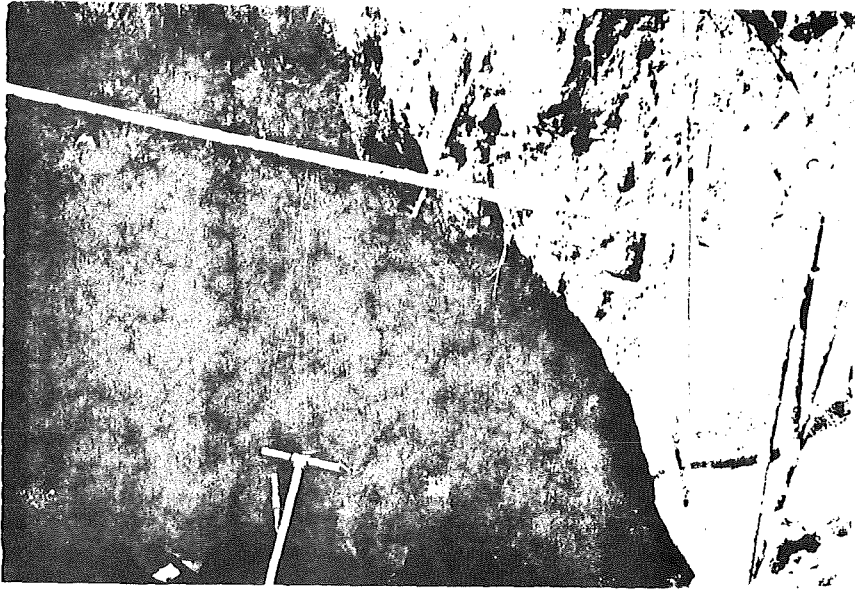
Figure 24. Detail of subsidence pit at trailer court in Lafayette. The upper 12 feet of the subsidence pit walls are composed of sand and silt size material; the lower three feet of the pit consists of bedded, angular gravel. The subsidence occurred over the Strathmore mine which lies at a depth of 100 to 150 feet and was last worked in 1919. Normally only one level was worked in this mine but in the area of the trailer court two levels were mined and it is estimated that a total void space of 20 to 25 feet was created.

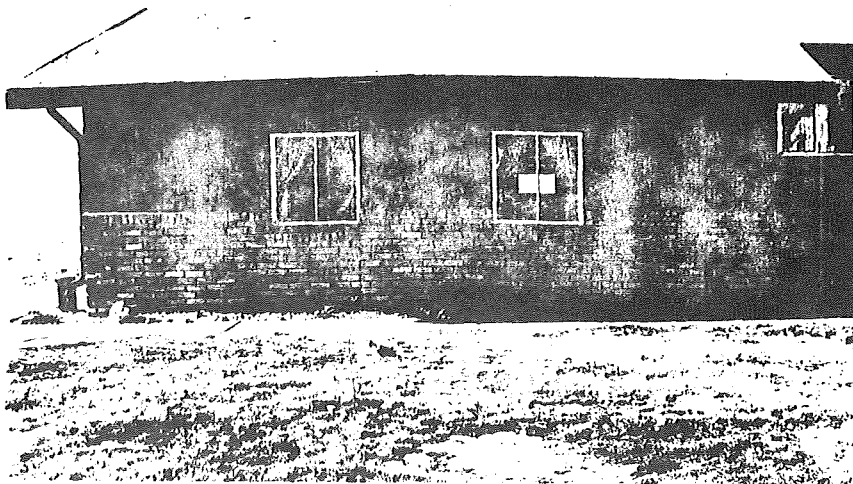
Figure 25. Garage over Black Diamond mine. At this locality, ten to ten feet of coal were extracted at a depth of 150 to 150 feet. The garage and house are fairly isolated, so that surrounding terrain is relatively undisturbed by man. No ditches, swales, or other indications of subsidence were found in fields around the house. For this reason, the damage to the garage is thought to be due to swelling soils. Note bow of roof line along gutter. Locality 15, subsidence-inventory map.

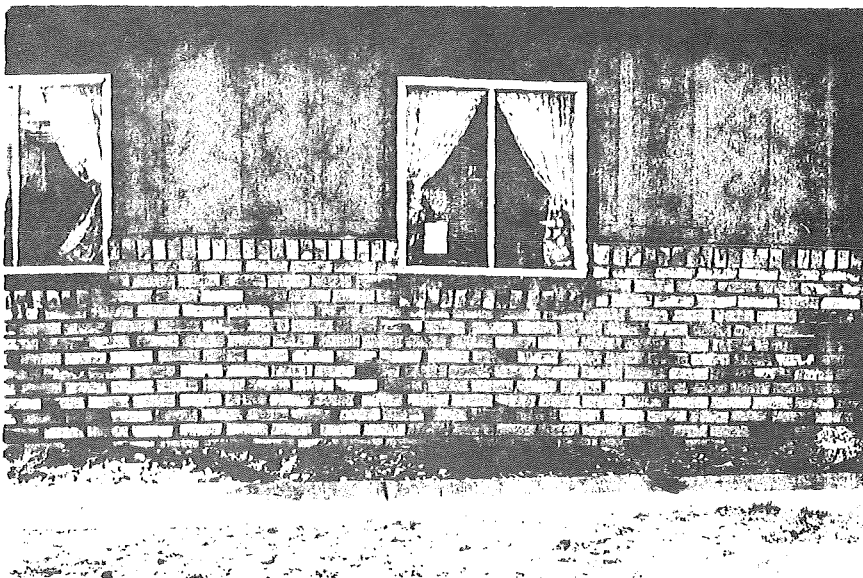
Figure 26. Detail of garage shown in Figure 24. Stairstep cracks and pickwork are one-half inch wide. Window has rhomboid shape, glass is cracked. This damage is similar to what one might expect if ground beneath foundation had subsided. Locality 15, subsidence-inventory map.

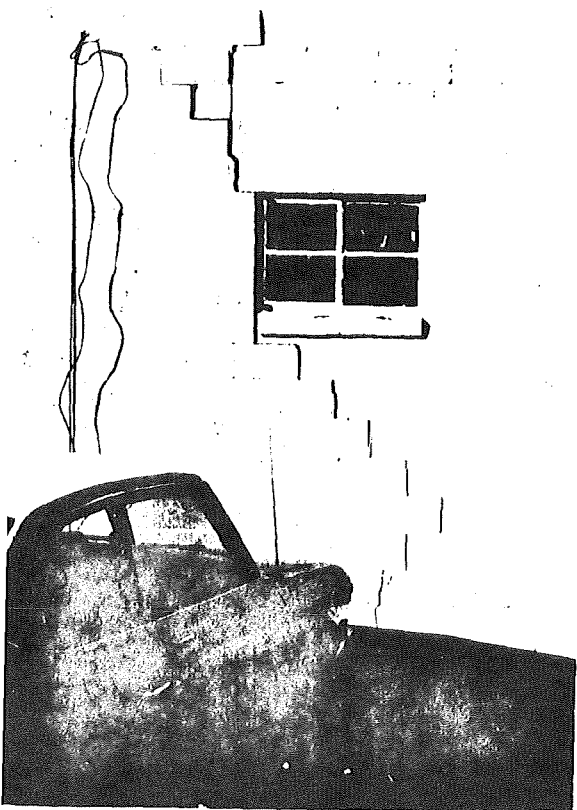
Figure 27. Damage to VFW hall, Main Street, Louisville. This part of Louisville was undermined many years ago. A seam 10 to 15 feet was extracted at a depth of about 100 feet. Because the mining occurred so long ago, it is thought that the damage to this relatively recent building is related to faulty design or construction, rather than to subsidence. Locality 43, subsidence-inventory map.

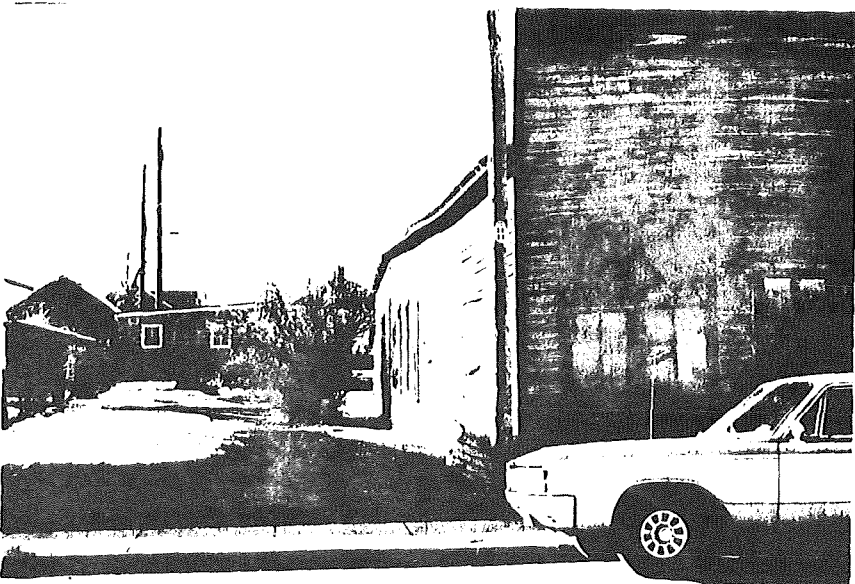
Figure 28. Abandoned building, Main Street, Louisville. The uniformity line of the siding and the rhomboid shape of the windows suggest torsional effects which might be associated with subsidence. However, the obvious age of the building suggests that the structural warping is simply due to general deterioration over a span of time. Locality 43, subsidence-inventory map.

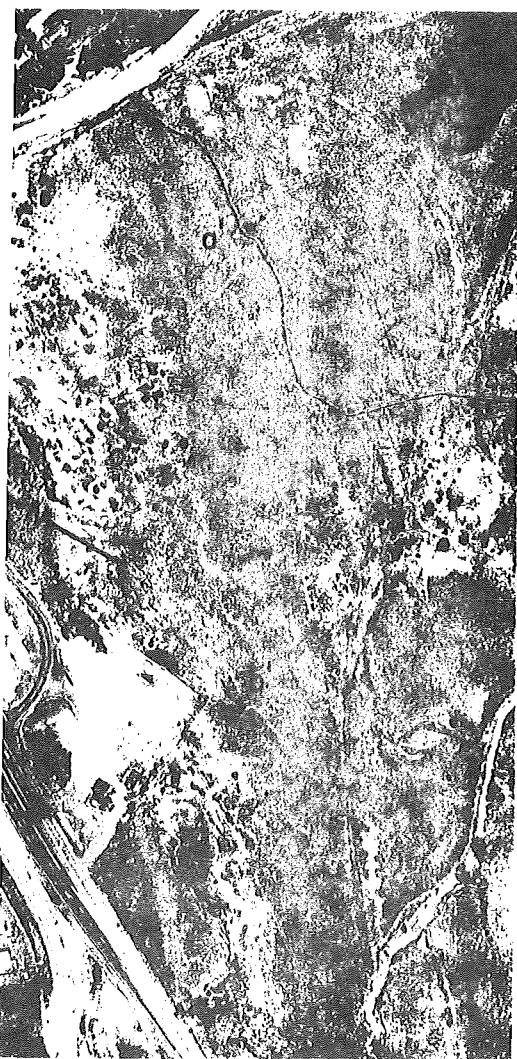
Figure 29. A.S.C.S. photo of
area A, south of Marshall
High-sun-angle Photo

shadows on the low-sun-angle photo enhance the outline of col-
ed rooms at a and b. The same features (a', b') are nearly
scernible on the high-sun-angle photo. The subsidence pits at
' are also more strongly enhanced on the low-sun-angle photo.
two figures are both enlargements and have an approximate
e of 1"=450' (1:5450). The enhancement of detail brought
t by enlargement is seen by comparing Figures 6 and 29, both
hich were made from the same negative.

figures 29 and 31. The latter are merely enlargements of the former, but the subsidence features which they show have been greatly enhanced by an increase in perceived depth and detail. It should be noted that there is a trade-off involved when one is choosing between large and small scale photos. Large scale photos show subsidence features very well, but require a large number of photos to cover a given area. Fewer small scale photos are needed to cover the same area, but there is a greater likelihood of overlooking subsidence features.

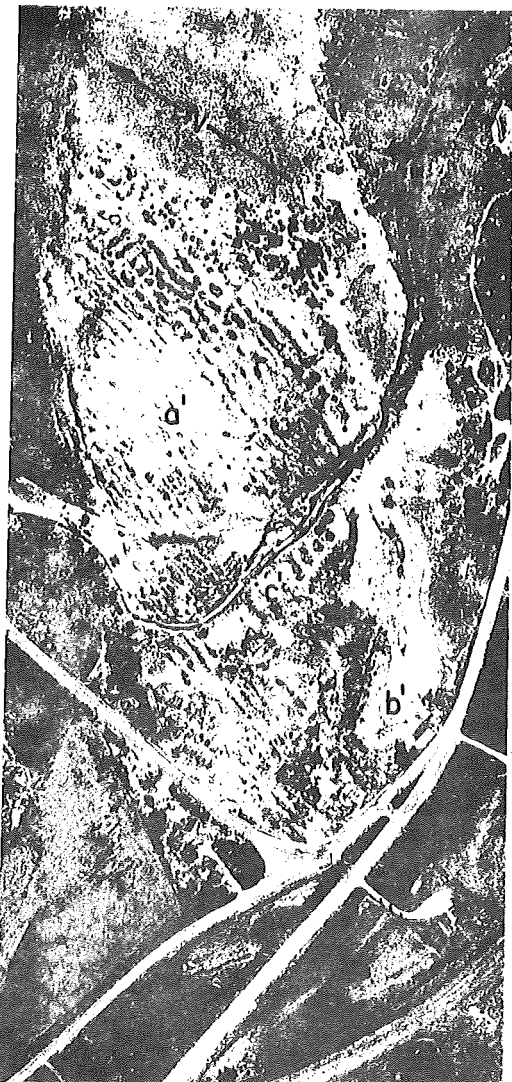
Figure 31. A.S.C.S. photo of
area B, north of Marshall
High-sun-angle Photo

apse features a (a') outlining the rooms and pillars of the
s No. 1 and 2 mines are enhanced by the shadows of the low-sun-
e photo. The same features become blurred on the high-sun-
e photo because of the large amount of light reflected from the
rock near mid-day. For the same reason, subsidence induced
ts at b (b') are also better displayed on the low-sun-angle
o. Joints at b (b') are also shown in foreground of Figure 8
flume c (c') of irrigation ditch is in middle ground of Figure
The figures above are enlargements and have an approximate
e of 1"=450' (1:5450). Figures 6 and 31 were made from the
negative. A comparison of the two shows the enhancement of
il brought about by enlargement.
