**RI 9550**

**REPORT OF INVESTIGATIONS/1995**

## **Field Demonstration of Two Pneumatic Backfilling Technologies**

**By Robert C. Dyni, Mackenzie Burnett, and David Philbin**

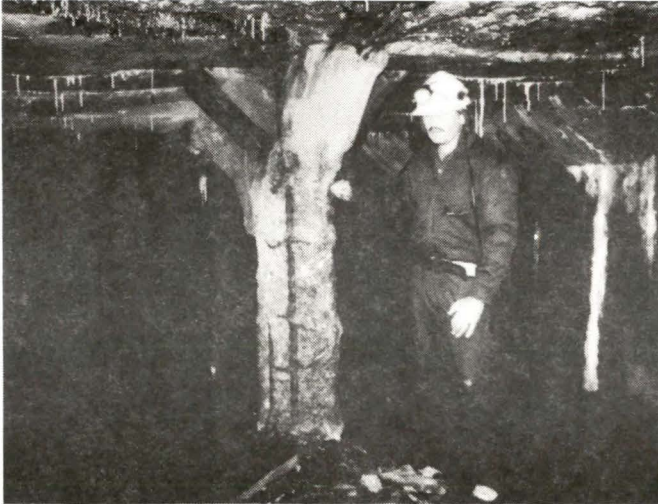
*Figure 1*

*One of three concrete columns in tunnel.*

The tunnel was constructed presumably by the cut-and-cover method; a trench was likely cut into the ground, the tunnel was fabricated, and fill was then placed over the top of the tunnel to the original grade level. The roof, walls, and floor of the tunnel were fabricated of poured concrete with four layers of 2.5-cm (1-in) steel reinforcing bars embedded in the concrete for structural reinforcement. The only interior support in the tunnel is located at the point where the tunnel passes underneath State Highway 171. Here there are three concrete columns spaced 4.6 m (15 ft) apart and centered on the tunnel's longitudinal centerline (figure 1). These columns support a two-span concrete roof-support beam, designed to support the tunnel roof. At the time of construction a railroad line passed over the tunnel at this location, and it was feared that the weight of overlying trains could collapse the tunnel if no interior supports were provided. Figure 2 shows the deteriorated condition of the concrete support beam.

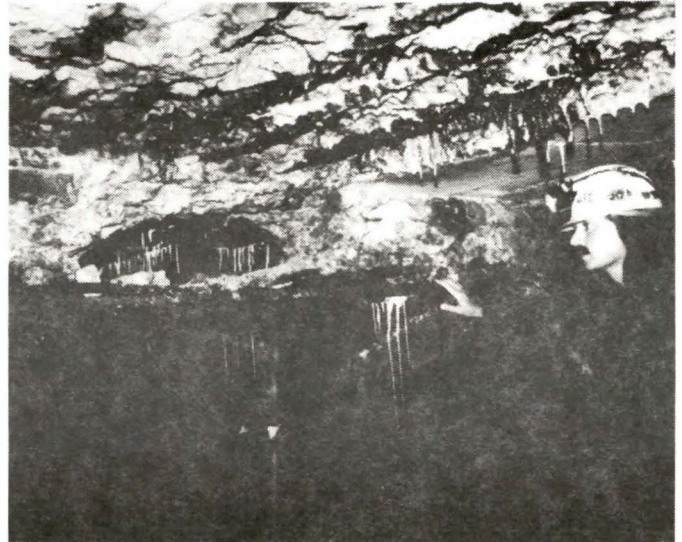
*Figure 2*

*Deteriorated condition of tunnel support beam.*

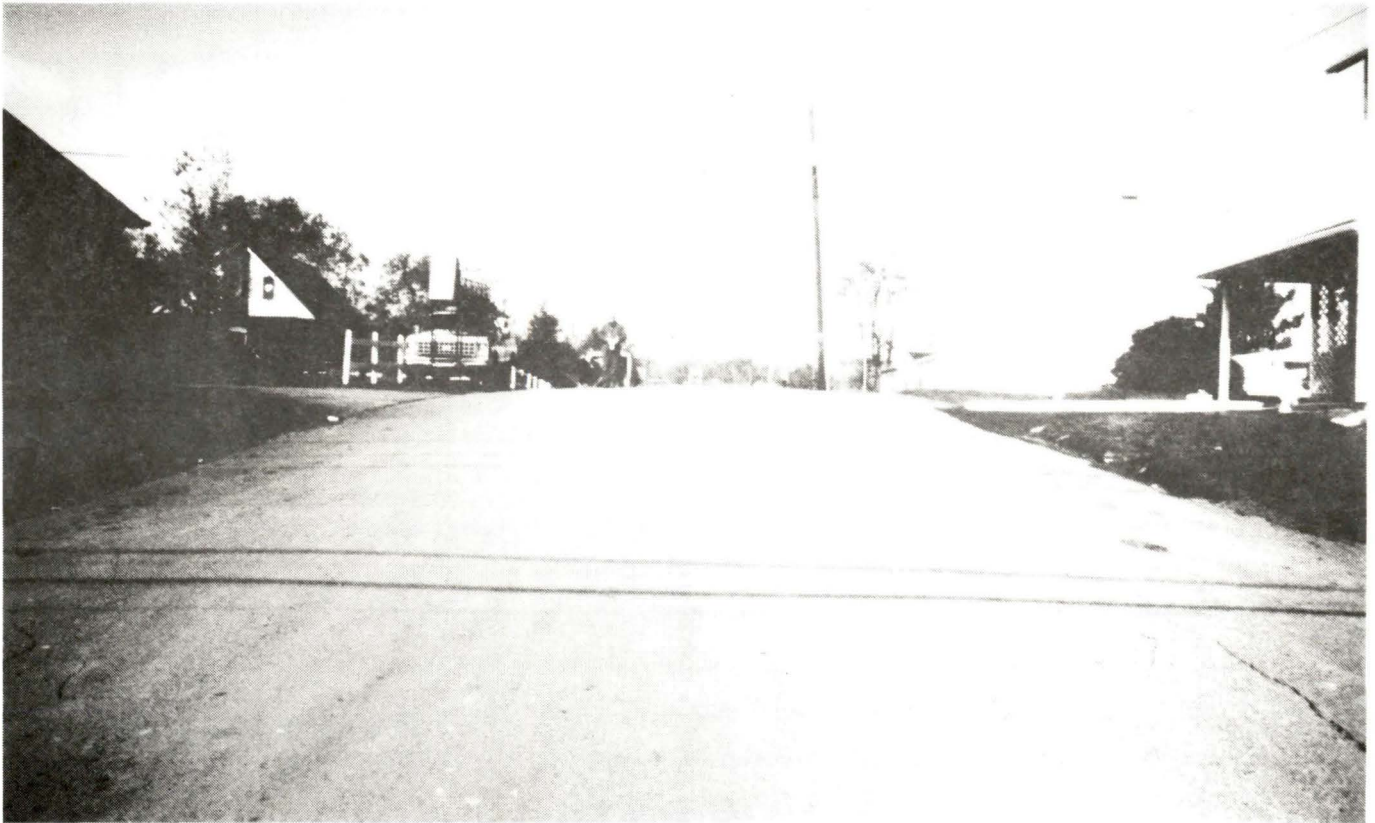
*Figure 3*

*View of ground surface above tunnel, looking toward upper tunnel end. Upper tunnel end is at end of street near utility pole.*

The tunnel was straight, through its entire length, and was sloped so that the upper portal was approximately 15 m (50 ft) higher than the lower portal. Figures 3 and 4 show the ground surface directly over the tunnel. The overall length of the tunnel was approximately 183 m (600 ft), the width was 4 m (14 ft), and the maximum floor-to-roof height was approximately 2.5 m (8 ft). Irregular deposits of silt on the floor of the tunnel throughout its length reduced the roof height in many places. The top of the tunnel at the upper elevation was

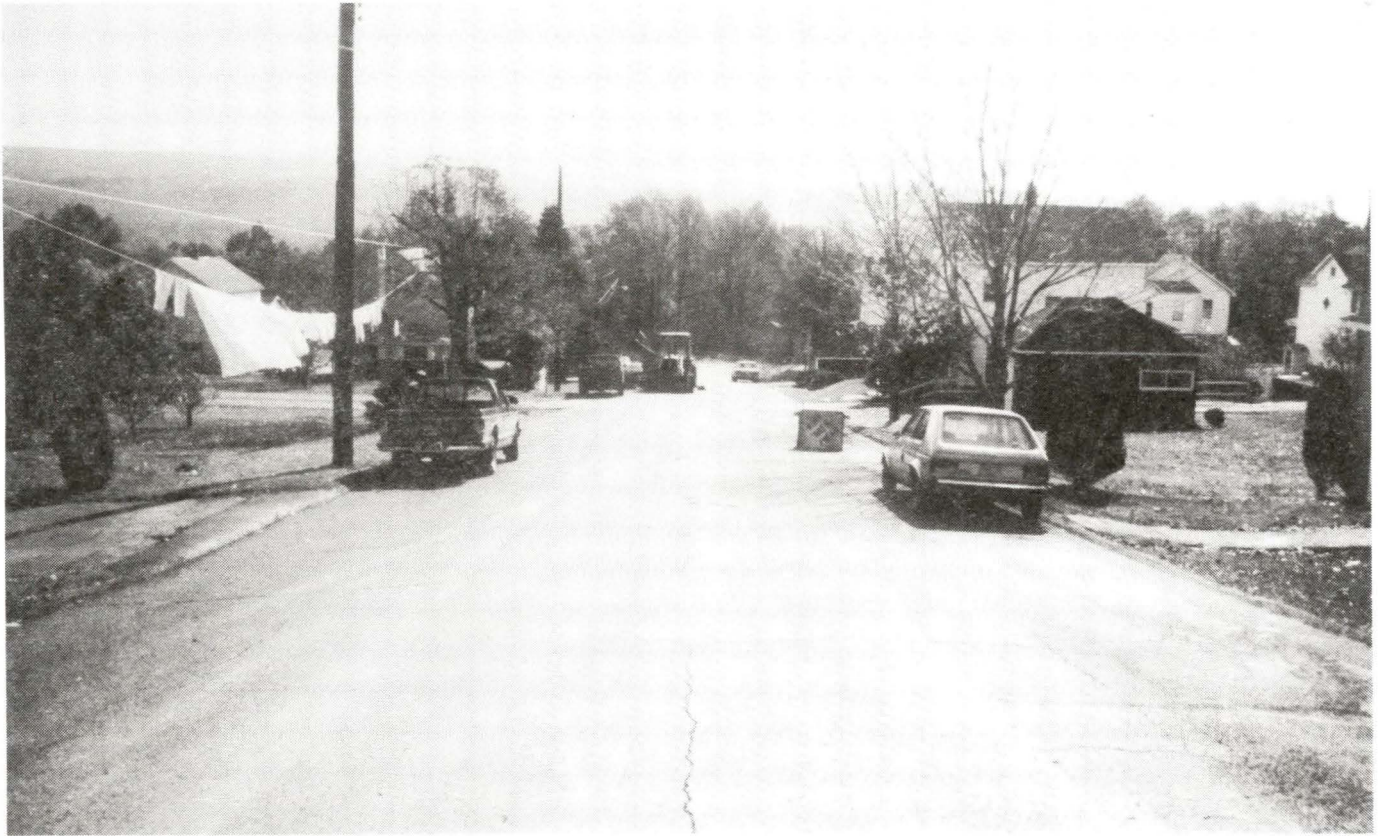
**Figure 4**

*View of ground surface above tunnel, looking toward lower tunnel end. Lower tunnel end is at end of street near tree line.*

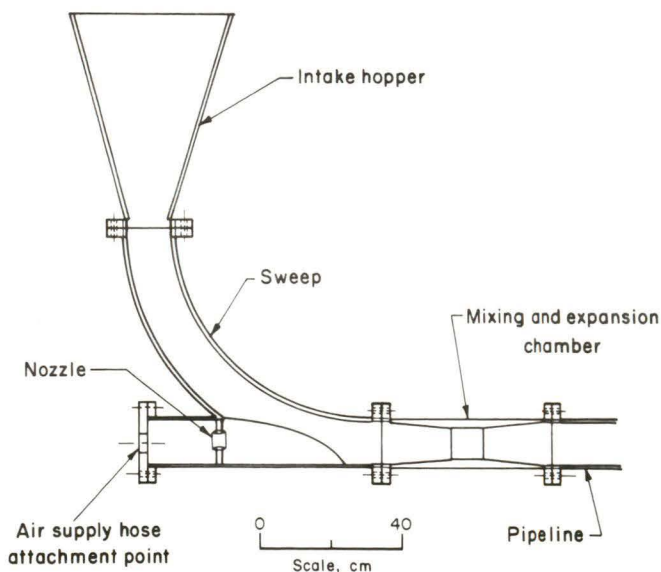
**Figure 5**

**Pneumatic Pipefeeder.**

The Pneumatic Pipefeeder was designed to transport backfill material through the 15-cm (6-in) diameter pipeline for lengths of up to 300 m (1,000 ft). Figure 5 shows the major components of the Pneumatic Pipefeeder assembly. This device was tested at the SAIL in 1989, where it successfully transported backfill material through a 26-m (85-ft) long, 15-cm (6-in) diameter pipeline. The maximum pipeline length through which the Pneumatic Pipefeeder could successfully transport backfill material was not determined during this testing.

Basically, the Pneumatic Pipefeeder utilizes a supersonic-velocity airstream to accelerate the backfill material to a high transport velocity. The intake hopper is used to feed the backfill material into the pipefeeder. The intake hopper was constructed of 0.6-cm (¼-in) steel plate and was bolted to the sweep. The intake hopper was

The sweep delivers the backfill material from the intake hopper to a position directly in front of the supersonic nozzle. This sweep was constructed of 15-cm (6-in) diameter, Schedule 40 steel pipe. As the backfill material passes through the sweep, it is reoriented from a vertical transport direction to a horizontal direction. The sweep was designed with a 0.6-m (2-ft) radius elbow to ensure that the backfill material traversed the sweep without plugging. A short-radius elbow could potentially cause plugging of the sweep, which would prohibit the flow of backfill material from the intake hopper. When the slow-moving backfill material traverses the sweep and passes in front of the supersonic airstream, it is accelerated by the high-velocity air from the supersonic nozzle, which is oriented directly down the pipeline.

The nozzle itself is a specially designed convergent-divergent nozzle that accelerates incoming 690-kPa (100-psig) air to over 488 m/s (1,600 ft/s). The supersonic-velocity air impinges directly on the backfill material, and by the principles of momentum exchange, the material is accelerated to over 30 m/s (100 ft/s). The air supplied to the nozzle for the tests at the SAIL was provided by two air compressors delivering 60 m<sup>3</sup>/min (2,120 ft<sup>3</sup>/min) at 690 kPa (100 psig).

The mixing and expansion chamber assists in thoroughly entraining the backfill material in the airstream and further accelerating the air-backfill mixture. This chamber is bolted onto the horizontal end of the sweep. The pipeline tested at the SAIL was made up of sections of

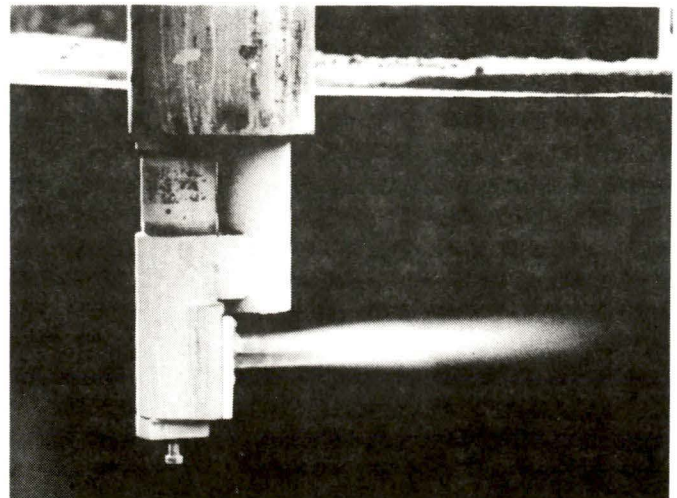
**Figure 6**

**High-Efficiency Ejector.**

Unlike the Pneumatic Pipefeeder, which requires direct access to an underground mine opening so that the pipeline can be assembled, the High-Efficiency Ejector was designed to remotely backfill an underground mine opening through a 20-cm (8-in) diameter borehole. The High-Efficiency Ejector was designed to solve the high wear problems associated with earlier pneumatic borehole backfilling designs, which incorporated 90° elbows that redirected the flow of backfill material from a vertical direction to a horizontal direction. Figure 6 shows the major components of the High-Efficiency Ejector. Like the Pneumatic Pipefeeder, the High-Efficiency Ejector utilizes a supersonic airstream to accelerate the backfill material and redirect it horizontally. The High-Efficiency Ejector tested at the SAIL contained five supersonic nozzles.

The overall design of the High-Efficiency Ejector is straightforward. Basically, two 8.9-cm (3.5-in) diameter steel pipes supply air and the backfill material from the ground surface through the borehole and to the High-Efficiency Ejector. The five nozzles are situated directly below and behind the bottom of the backfill supply pipe, so that as the material passes in front of the nozzles, it is redirected and accelerated horizontally. At the top of the material supply pipe is an intake hopper identical in design to the intake hopper used for the Pneumatic Pipefeeder. The air supply pipe delivers 57 m<sup>3</sup>/min (2,000 ft<sup>3</sup>/min) air at 690 kPa (100 psig) to the five nozzles, and after passing

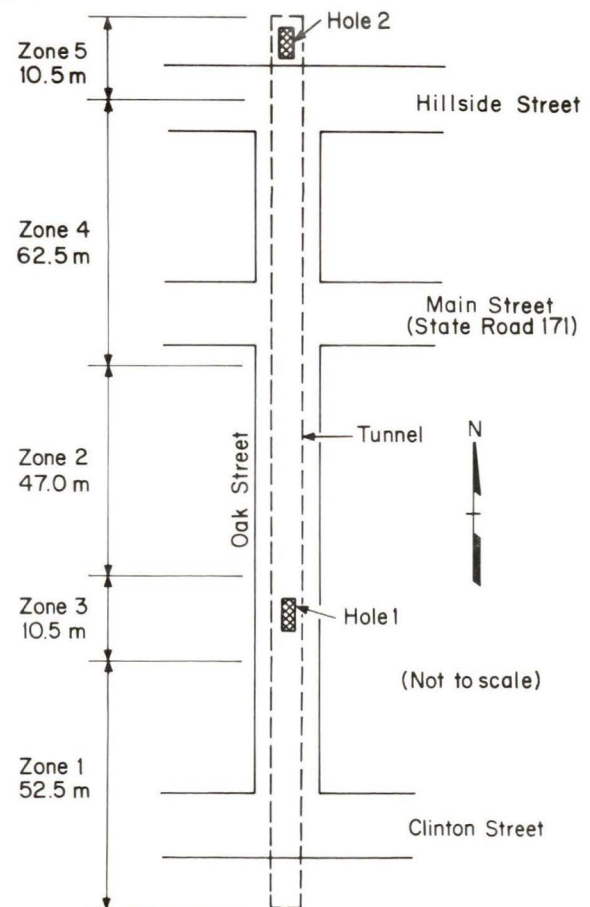
**Figure 7**

**Tunnel plan view.**

The goal of the project at the Vandling site was to fill 100% of the abandoned coal mine haulage tunnel with backfill stone using both the Pneumatic Pipefeeder and the High-Efficiency Ejector. The tunnel was divided into five zones (figure 7); zones 1 through 3 were backfilled from the hole 1 location, and zones 4 and 5 were backfilled from hole 2. Zones 1, 2, and 4 were backfilled using the Pneumatic Pipefeeder, and zones 3 and 5 were filled using the High-Efficiency Ejector. The zones were sequentially backfilled in order from 1 to 5.

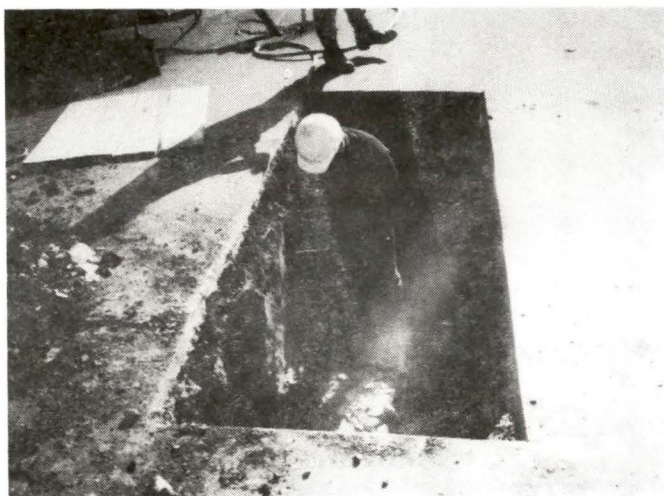
*Figure 8*

*Preparation of hole 1.*

Hole 1 was constructed by removing approximately 1.2 m (4 ft) of overburden overlying the roof of the tunnel with a backhoe, then removing a 1-m (3-ft) by 3-m (10-ft) portion of the concrete tunnel roof with a pneumatic hammer (figure 8). The hole was oriented so that it was centered over the roof centerline. The four mats of steel rebar were cut using an electric grinder. Hole 1 was located approximately 60 m (200 ft) up from the bottom end of the tunnel.

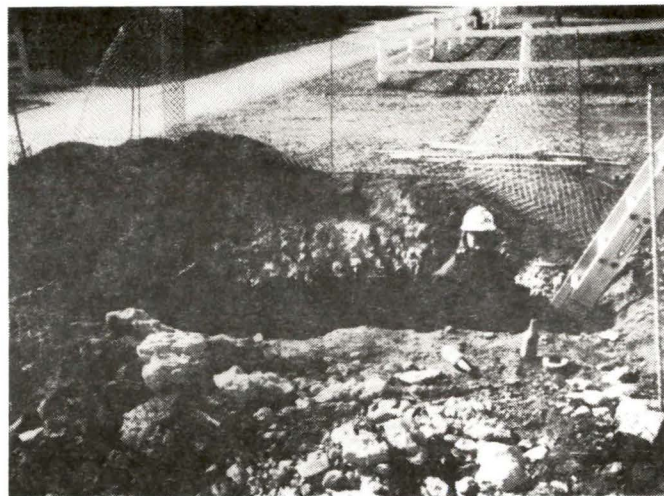
*Figure 9*

*Hole 2.*

Hole 2 was opened in the same manner; the overburden depth above the tunnel roof at the hole 2 location was approximately 0.3 m (1 ft). The approximate dimensions of hole 2 were 1.2 m (4 ft) wide by 3 m (10 ft) long. Hole 2 was located in the center of the roof at the upper limit of the tunnel (figure 9).

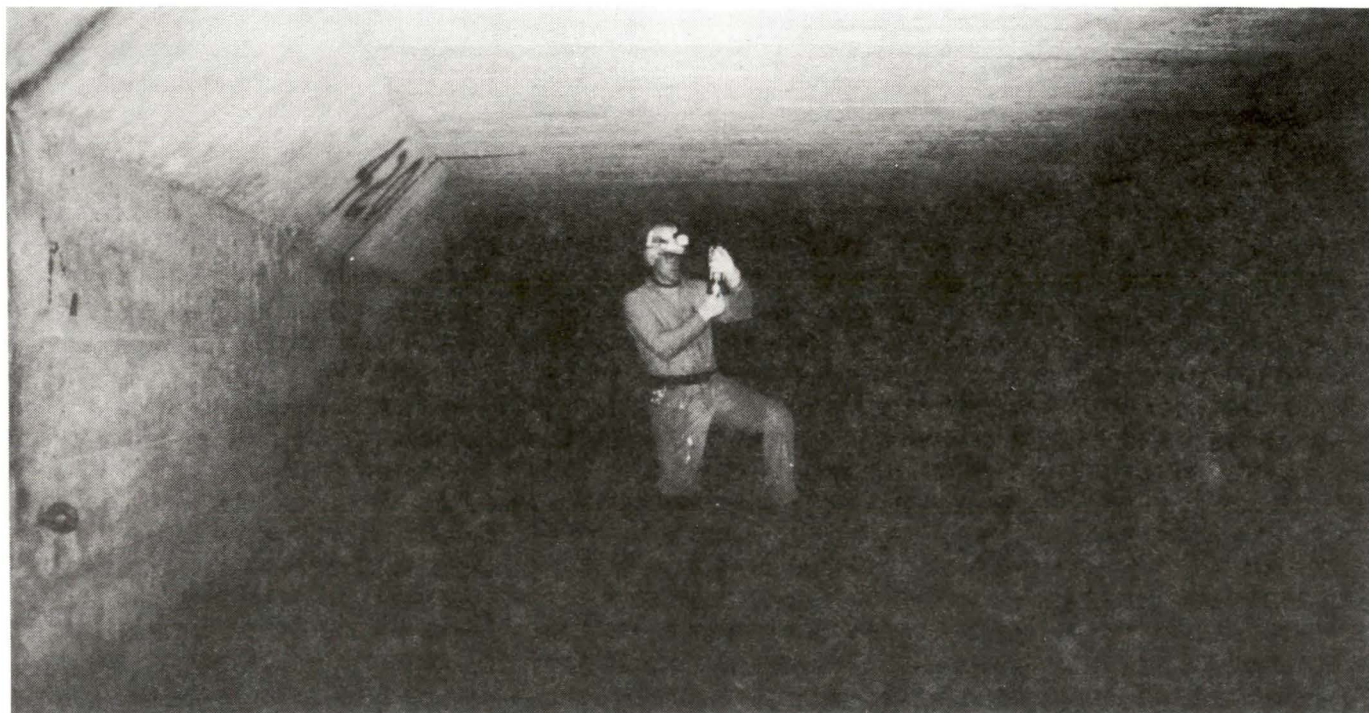
*Figure 10*

*Air-quality testing in tunnel interior.*

2 was able to clear most of the visible dust from the tunnel opening, and an air-quality survey was conducted by OSM (figure 10).

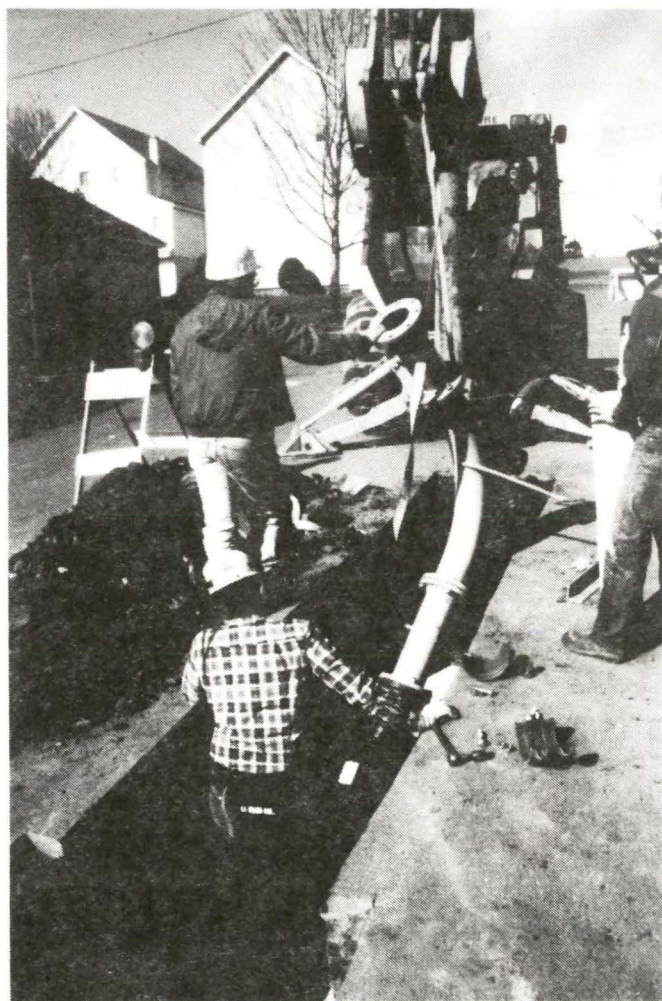
Figure 11

Installation of Pneumatic Pipefeeder in hole 1.

Backfilling operations began at hole 1 with the Pneumatic Pipefeeder. The Pneumatic Pipefeeder was placed on top of the tunnel roof at the edge of hole 1, and 46 m (150 ft) of 3-m (10-ft) long, 15-cm (6-in) diameter high-density polyethylene pipe was placed from the Pneumatic Pipefeeder down toward the lower end of the tunnel (figure 11). This resulted in approximately 15 m (50 ft) of separation between the discharge end of the pipeline and the end of the tunnel. The pipe sections were connected with two-piece Victaulic couplings.

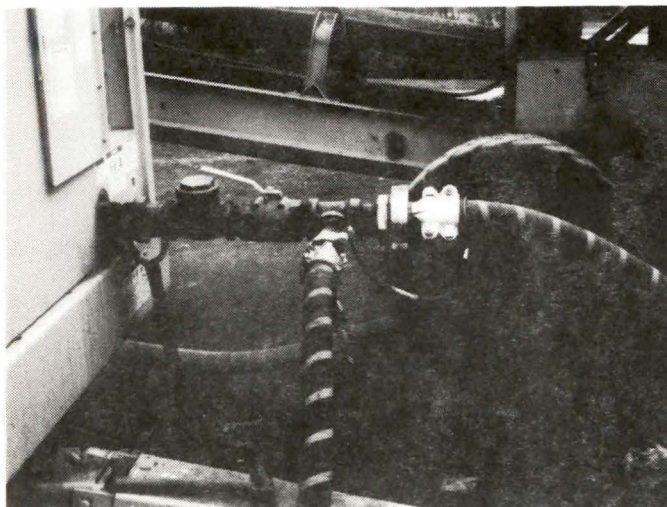
Figure 12

Connection of two air compressors.

On the surface, the support equipment required for operating the Pneumatic Pipefeeder was assembled and readied for operation. Two diesel-powered air compressors were used to supply the air to the Pneumatic Pipefeeder; one compressor was rated at 35 m<sup>3</sup>/min (1,250 ft<sup>3</sup>/min) at 690 kPa (100 psig), and the other was rated at 21 m<sup>3</sup>/min (750 ft<sup>3</sup>/min) at 690 kPa (100 psig). The output hoses of the two compressors were joined with an adapter (figure 12), and a single hose was connected from the adapter to the Pneumatic Pipefeeder.

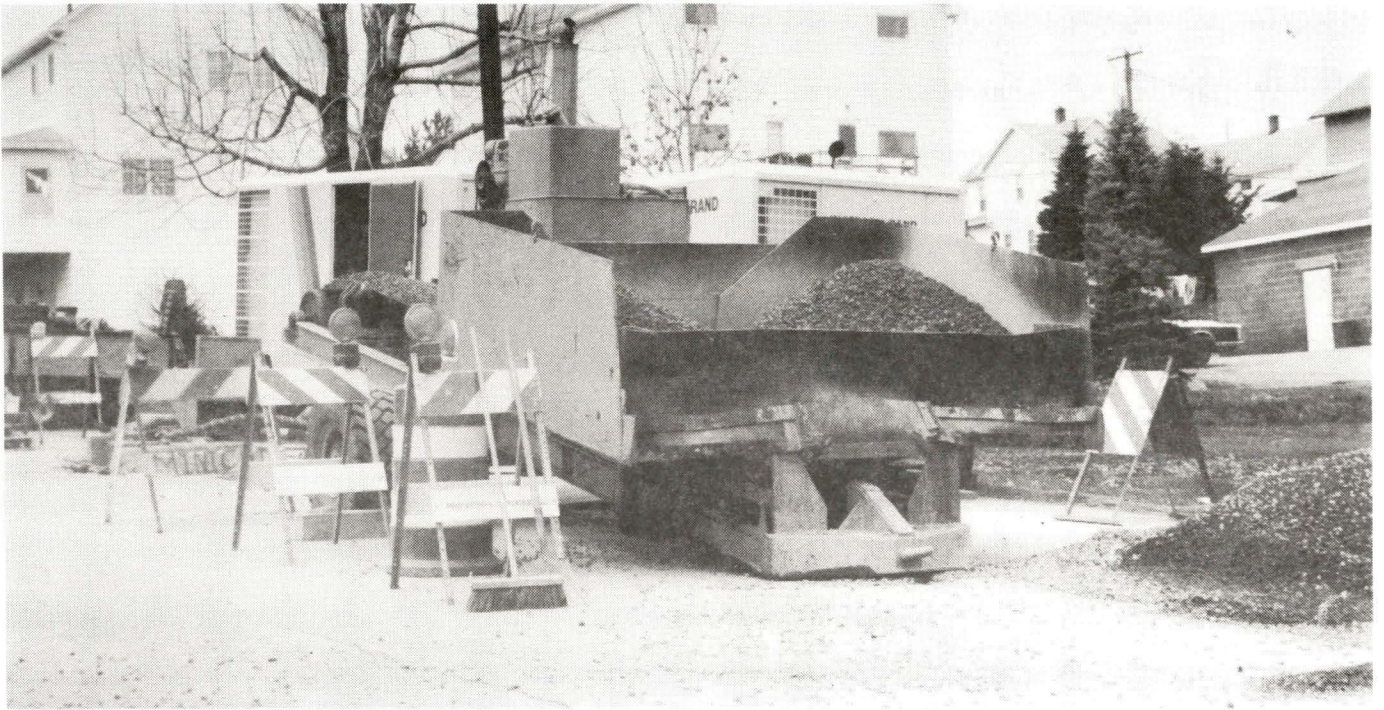
*Figure 13*

*Portable hopper-conveyor.**Figure 14*

A gasoline-powered portable conveyor with an integral 4-m<sup>3</sup> (5-yd<sup>3</sup>) hopper was placed over the Pneumatic Pipefeeder's conical hopper (figure 13) to feed backfill into the Pneumatic Pipefeeder. The conveyor's belt velocity was adjustable, so that the amount of backfill stone entering the Pneumatic Pipefeeder was controllable. The hopper for the conveyor was loaded and maintained with backfill stone with a front-end loader. The stockpile of backfill stone was maintained near the conveyor unit.

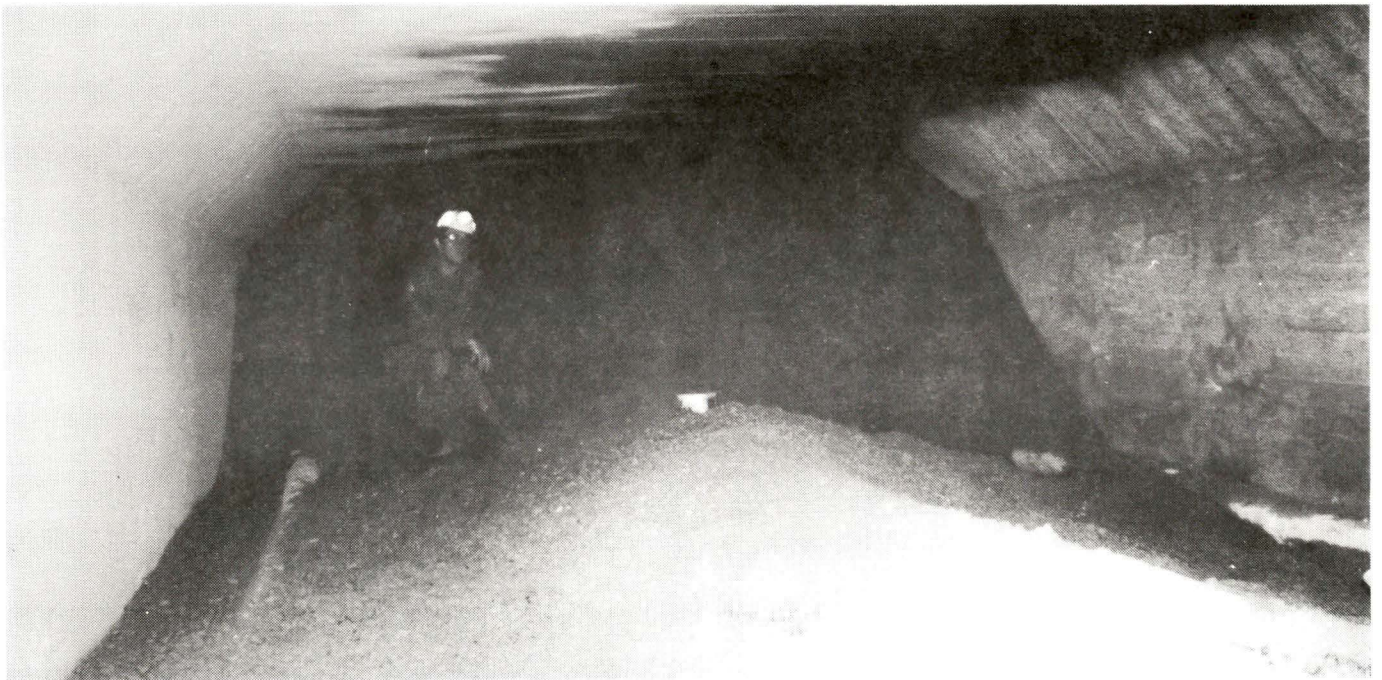
*Deposition of backfill in tunnel interior.*

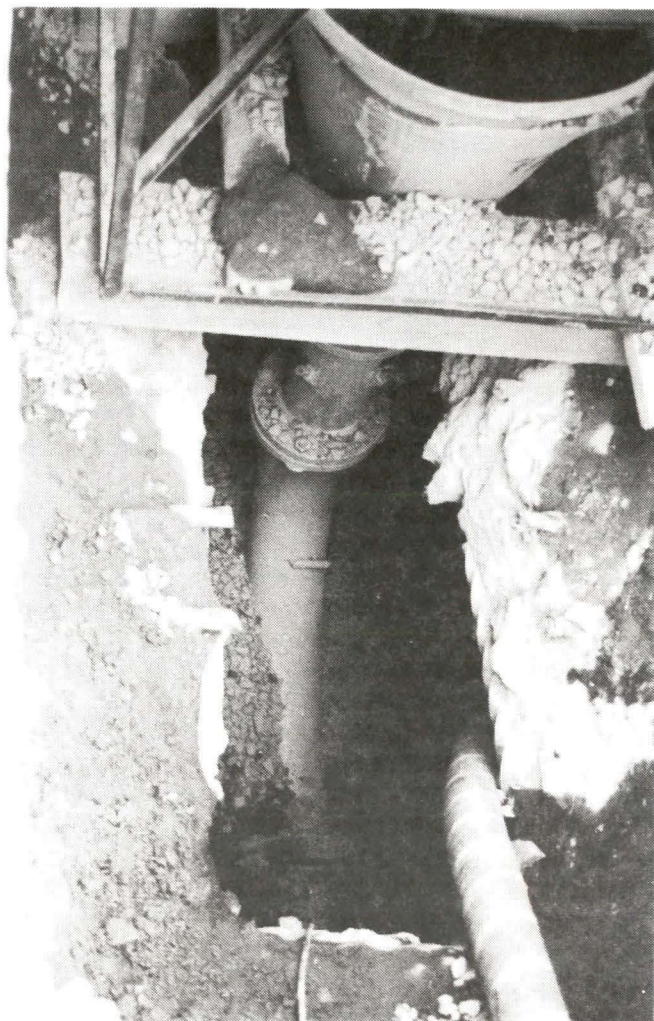
Figure 15

Installation of Pneumatic Pipefeeder on tunnel floor.

Pipefeeder directly on the tunnel floor (figure 15) to minimize the bends in the pipeline that were necessary to pass through hole 1. After four more working days, it was evident that even though the bends were minimized, the high-density polyethylene material could not withstand the abrasion exerted by the backfill. The researchers then decided to replace the high-density polyethylene pipe with Schedule 10 steel pipe. Although 15-cm (6-in) nominal diameter Schedule 10 steel pipe is approximately 200% heavier per unit length than the high-density polyethylene, its resistance to abrasion is greater. To minimize the difficulties in handling the steel pipe, 2-m (7-ft) sections were obtained. Backfilling the remainder of zone 1 was completed with the Schedule 10 steel pipeline and with the Pneumatic Pipefeeder resting on the floor of the tunnel directly below hole 1.

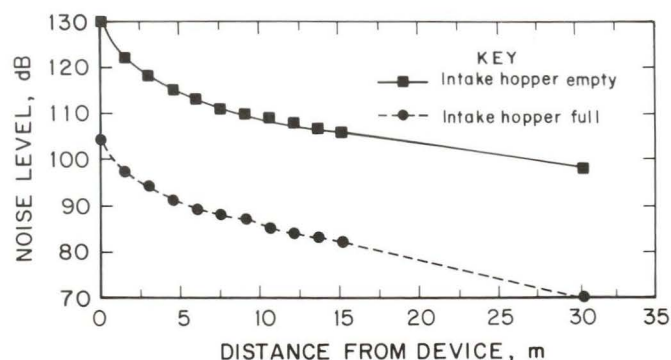
Figure 17

Typical noise levels at site during operation of Pneumatic Pipefeeder and High-Efficiency Ejector.
