# DEM Analysis of the Effect of Lamination Properties on the Stability of an Underground Coal Mine Entry with Laminated Shale Roof

Received: 11 August 2021 / Accepted: 4 January 2022 / Published online: 11 January 2022  
© Society for Mining, Metallurgy & Exploration Inc. 2022

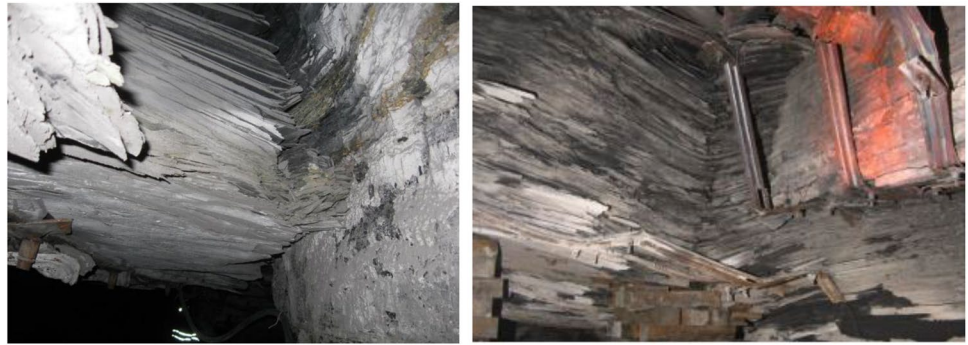
**Fig. 1** Cutter roof failure of shale roof [2, 7]
