**REPORT #:**  
71-275-2026

**SCENE:**  
Temporary and mobile liquified  
natural gas transfer station

## SERVICES / TRUCKING FATALITY NARRATIVE

### Technician Killed and Driver Injured in Natural Gas Vapor Cloud Explosion

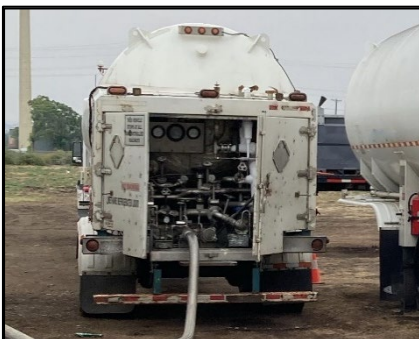
Control cabinet with transfer hose  
at back of transport trailer.

The technician connected an 18-foot transfer hose from the trailer control cabinet to a queen storage trailer and began the LNG transfer. The driver unexpectedly turned his truck on and drove forward 17 feet while the transfer was still in progress, which yanked and disconnected the hose coupling from the queen. LNG vapor leaked from the trailer and formed a large thick cloud in the work area.

- The driver believed he could move his truck when a technician gave him paperwork before the transfer was complete. He did not exit his cab or complete a pre-trip inspection before moving the truck forward.
- The transport trailer's wheels were not chocked before the transfer hose was coupled to the queen trailer.
- Possible sources of ignition included a spark from ungrounding when the truck moved, nearby generators, or static electricity.

- **Equip trucks with electronic interlock brake systems.** Interlock systems lock the truck's wheels when the trailer's control cabinet doors are open to prevent vehicle movement while LNG transfer is in progress.
- **Check parking brakes, ignition, and wheel chocks.** Make sure technicians and drivers visually check that the truck's parking brake is set, the ignition is off and keys are removed, and the trailer's rear wheels are chocked before coupling the transfer hose. Transfer should not begin until these tasks are verified.
- **Develop standard communication procedures.** Develop a step-by-step verbal communication procedure for technicians and drivers to follow before, during, and after an LNG transfer. Check with third-party transport companies to ensure they meet or exceed requirements.
