# State FACE™ Fatality Narrative

## Driver Killed and Co-Worker Injured When Truck Brakes Fail

**REPORT #:** 71-273-2026s REPORT

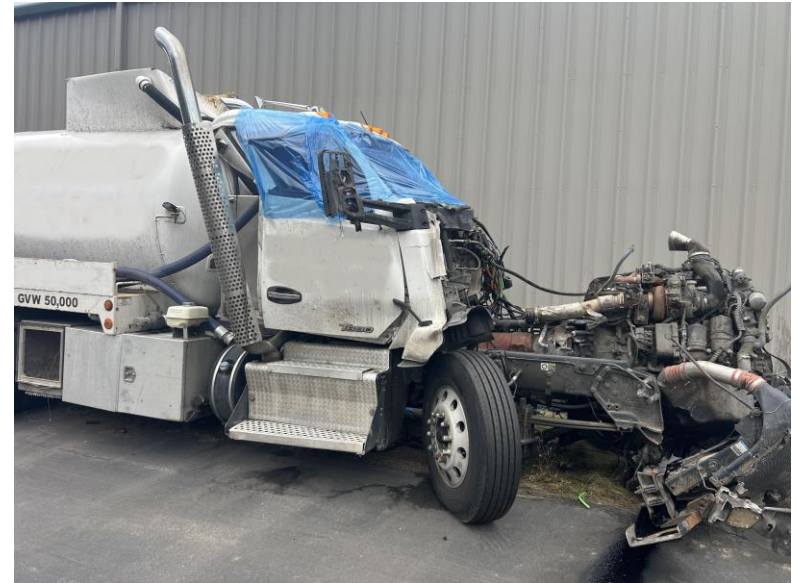
**Image 1.** Truck with crash damage.

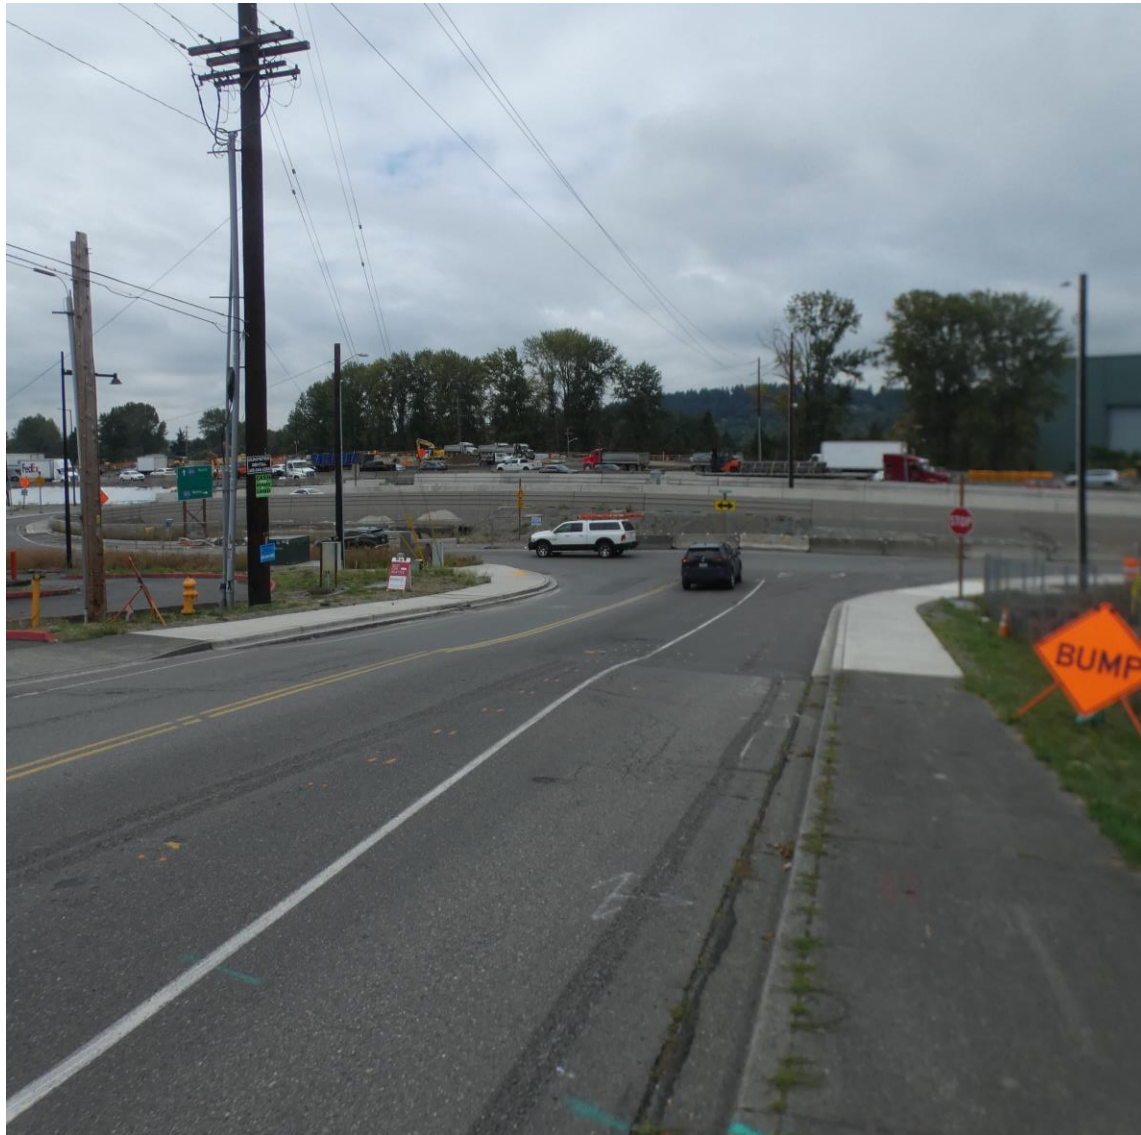
**Image 2.** Hill where brakes failed with T-shaped intersection at bottom where truck crashed.

They took an unfamiliar route to the station instead of the usual one the employer wanted them to take. They ended up on a steep quarter-mile hill with a T-shaped intersection at the bottom. The truck began moving dangerously fast down the hill.

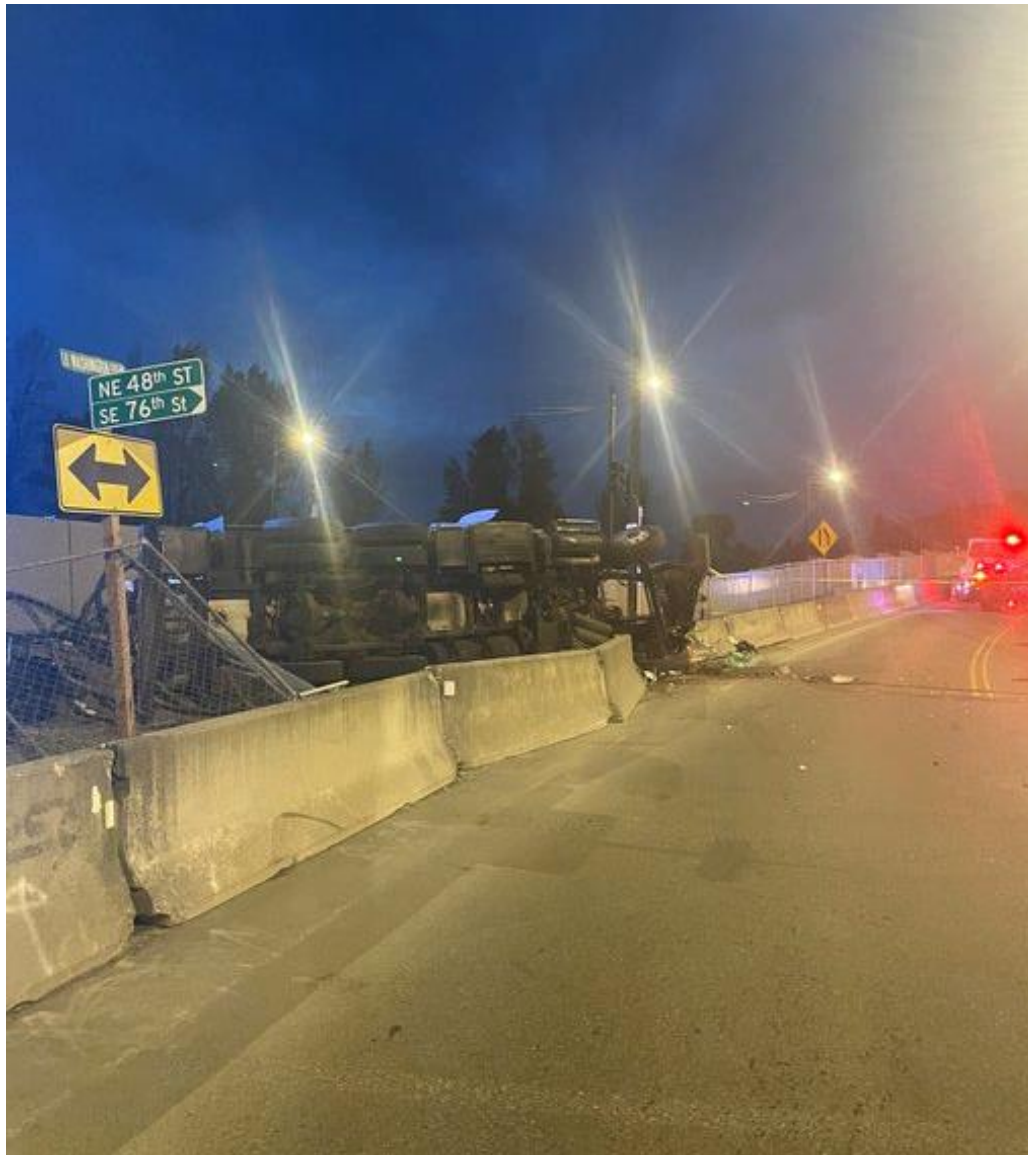
**Image 3.** Truck resting on side after crashing through Jersey barriers.

Finally, he released the clutch which shut off the engine but could not stop the truck. He tried to turn right at the last moment as the truck sped through the intersection at the bottom of the hill. The truck's momentum made it tip over on its left side and crash through a concrete Jersey barrier. It came to rest in a gravel lot near a busy highway.

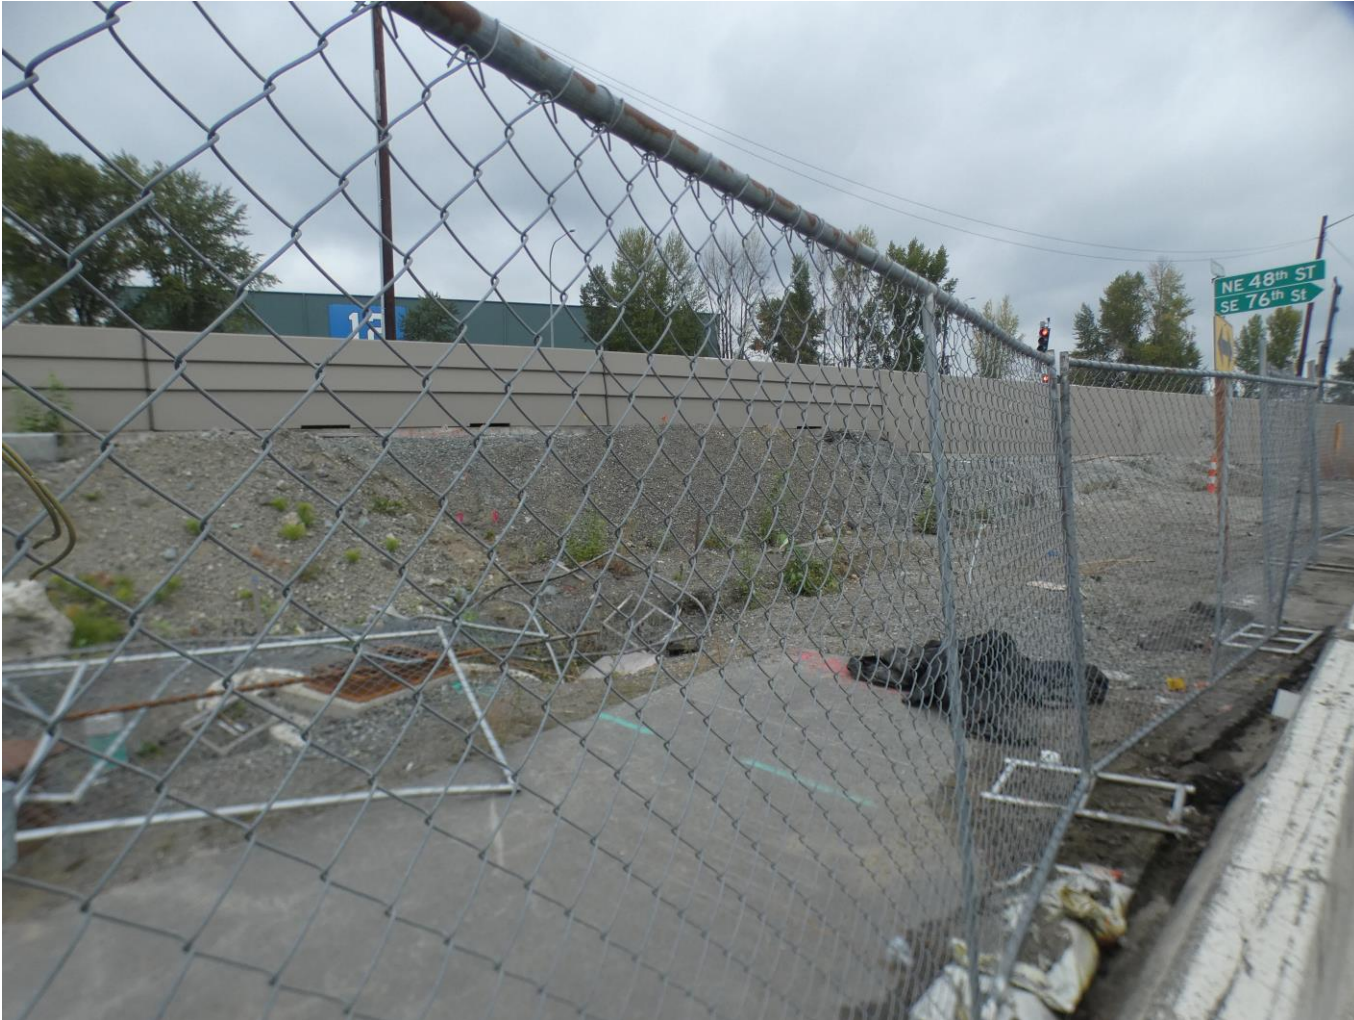
**Image 5.** Gravel area where truck came to rest.

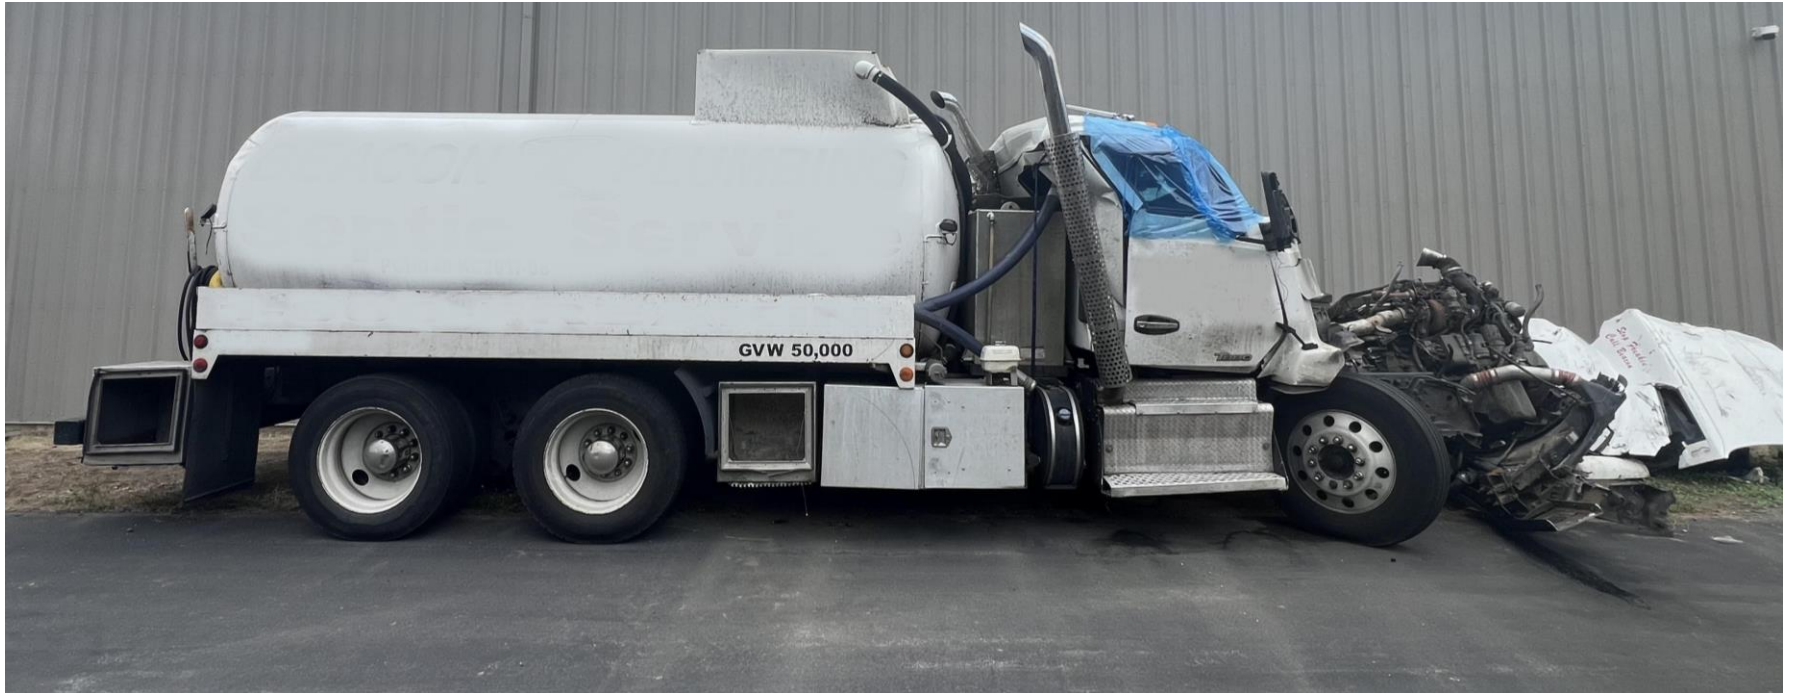
**Image 6.** Tanker truck with collision damage.

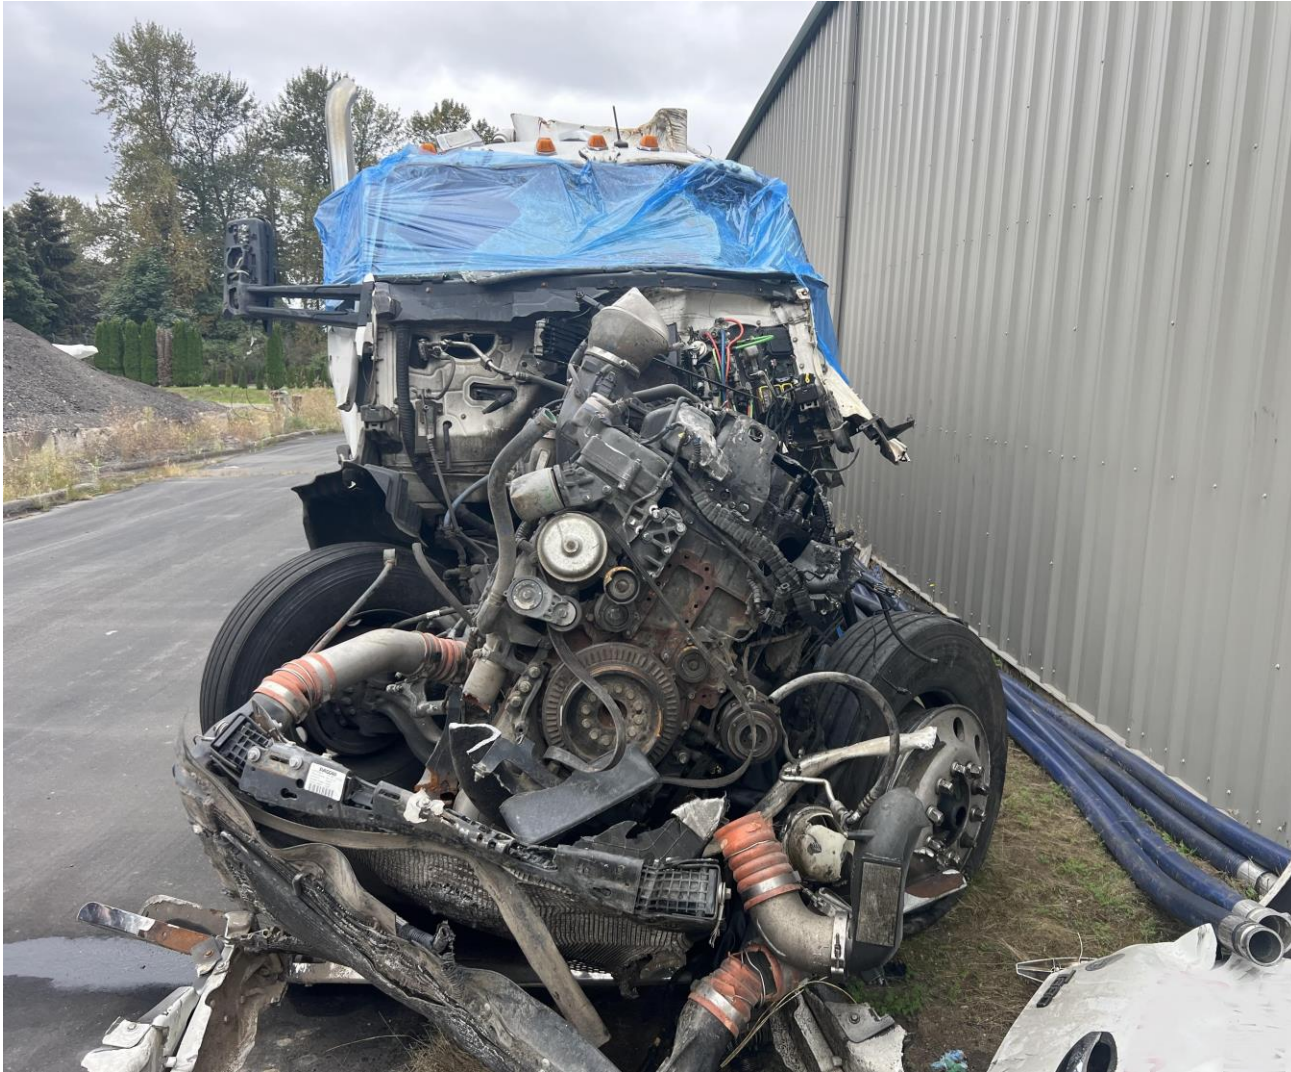
**Image 7.** Front view of damaged truck.
