Disinfection of Hot Tubs Contaminated with *Legionella*

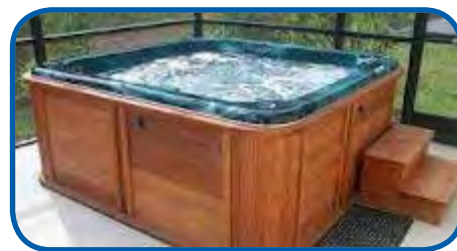
This image is of a typical pool/spa water chemistry test kit for measuring chlorine, bromine, and pH.

13. Ensure that halogen (chlorine or bromine) and pH levels meet local and state standards before re-opening the hot tub to bathers. **Maintain water quality** according to local and state standards. Continued *Legionella* testing may be considered on a case-by-case basis to ensure complete elimination of *Legionella*.
