WORKPLACE SOLUTIONS

Preventing Death and Injuries of Fire Fighters Operating Modified Excess/Surplus Vehicles

DHHS (NIOSH) Publication No. 2011-125

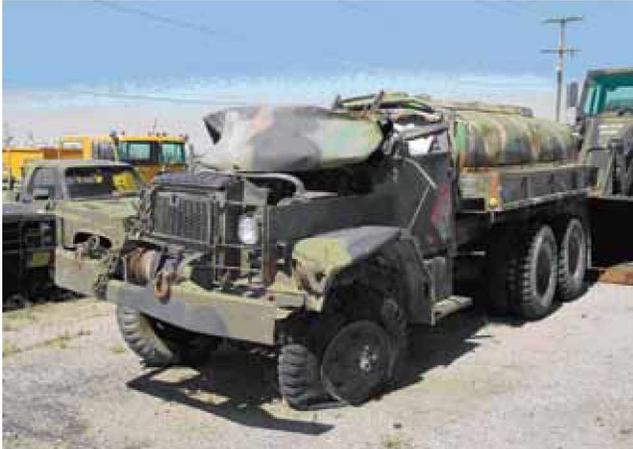
On June 21, 2005, a 52-year-old male volunteer chief died from injuries sustained during a tanker rollover. While driving on a gravel road at approximately

40 miles per hour, the left front tire ruptured, causing him to lose control, leave the road, and roll over several times. The chief was ejected and died on the scene from his injuries. Seat belts were not used during the incident [NIOSH 2006].

The apparatus was a 1981, 2½-ton, 6 × 6 military tanker originally designed to carry gasoline (Figure 1). The truck, primarily used off road, weighed 13,530 pounds empty and had a GVWR of 16,530 pounds cross-country.† The tank was divided into three sections and had a capacity of 1,200 gallons. The estimated fully loaded water weight was 9,960 pounds, which exceeded the cross-country weight rating by approximately 7,000 pounds. Both rear axles had dual wheels. The tanker was equipped with lap-type seat belts and still had the original split rim wheels. Eight out of ten tires were bias-ply‡ tires manufactured in 1981. The apparatus was acquired by the department in 1998 through a loan

program. The fire department did not inspect or make any modifications to the apparatus.

Figure 1. Military surplus vehicle involved in Case Study 1.

- Ensure that the weight of a fully loaded vehicle does not exceed the GVWR. This is especially important when using military fuel trucks as water tankers, since water weighs 8.33 pounds per gallon, approximately 20% more than certain fuel types. The weight of additional fire fighting equipment should also be monitored, as this added weight may increase total vehicle weight in excess of the GVWR. Since wildland fire fighting apparatus may see severe off-road use, the cross-country GVWR should be considered the maximum if specified [REC 2009b].

- Ensure that the vehicle maintains ample suspension, steering, and braking ability through periodic vehicle inspections and maintenance.
- Inspect tires often for uneven wear, proper inflation, and deterioration. Adequate tread depth does not necessarily mean that tires are safe. Maintain tire pressures and replace tires according to the manufacturer's recommendations (e.g., replacing tires of a certain age). Tires that show signs of dry rot or cracking should also be replaced. Consider if military grade tires are adequate for the road surfaces the vehicle may be operated on. Some military tire tread patterns may not be suitable for use on wet, hard surfaces.

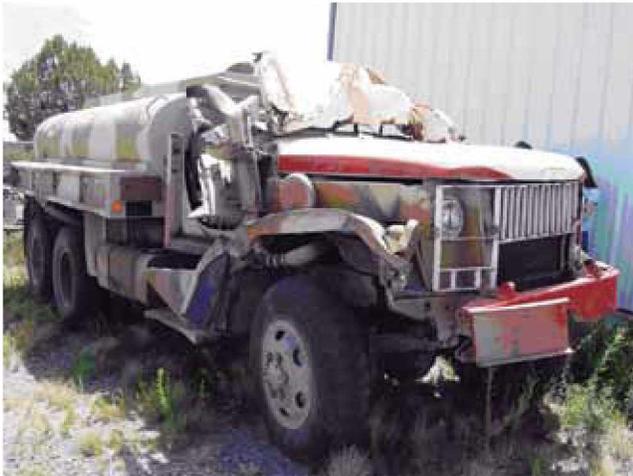
On June 26, 2003, a 46-year-old male volunteer assistant chief was fatally injured after being ejected from a water tanker as a result of a rollover crash. The victim was driving to a wildland fire on an unpaved road within a national forest. The tanker failed to negotiate a curve and rolled down into a canyon. The victim was ejected from the cab during the rollover and was found lying unresponsive on the ground. He was pronounced dead at the scene [NIOSH 2003].

Figure 2. Military surplus vehicle involved in Case Study 2.

The apparatus was reported to be a 1954, 2½-ton military fuel servicing truck acquired through a loan program with a recommended payload weight[§] (without personnel) of 7,500 pounds (Figure 2). The truck had a 1,200-gallon tank that was originally

used to transport diesel fuel. The estimated, fully loaded water weight was 9,960 pounds, which exceeded the recommended payload weight by more than 2,000 pounds. State police reported that the tanker probably had brake failure before the incident; the master cylinder was leaking brake fluid, and the emergency brake was inoperable. Both front shock absorbers and three tires were defective. The vehicle did not have seat belts.

- Ensure that all fire fighters are seated in appropriate riding positions and are secured by seat belts whenever the vehicle is in motion (NFPA 1500). Vehicles without a restraint system should have one installed that meets current standards of the Society of Automotive Engineers [SAE 1994, 1995a; 1995b].
- Develop a standard operating procedure or guideline for operating modified excess/surplus tankers, including when the vehicle should and shouldn't be used and required training for operators. Consider operating these vehicles only in nonemergency mode (i.e., no lights or siren).
- Develop procedures to declare a vehicle mechanically deficient or unsafe, and immediately remove it from service until it is repaired or replaced.

- Ensure that tanks are baffled for safe handling of water (NFPA 1901). Fuel tanks generally lack appropriate baffles to allow for the safe transport of water.
