**Preventing Falls of Workers through
Skylights and Roof and Floor Openings**

DHHS (NIOSH) Publication No. 2004-156
August 2004

This Alert describes five deaths resulting from falls through skylights and roof and floor openings. Recommendations are provided to help prevent similar deaths in the future.

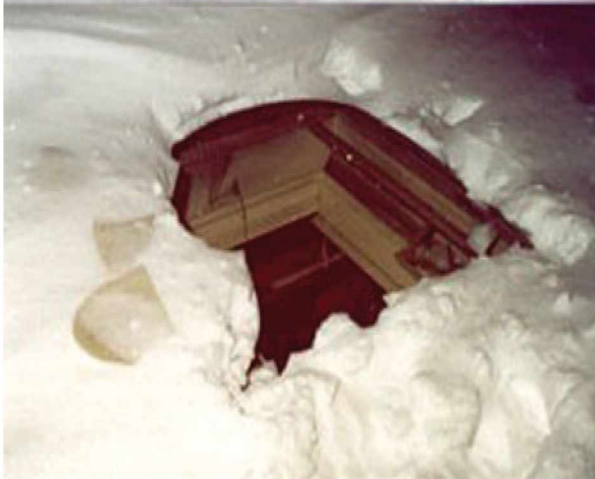
A 43-year-old male laborer at a coatings manufacturing company died after falling through an unguarded, 3-foot-square skylight lens to a concrete floor 14 feet below (Figure 1). The victim and a coworker were clearing snow from the flat roof of the building. The victim walked on the roof through deep snow that completely covered the skylights in that area of the roof. He apparently failed to see the snow-covered skylight and stepped onto its lens, which broke under his weight. The victim's coworker, who was walking toward the opposite side of the roof, looked back toward the location of the victim after hearing a noise coming from that area. He saw the broken skylight lens and called for help.

Figure 1. Snow-covered 3-foot-square skylight.

The skylight did not have a protective screen, cover, or guarding around it [Wisconsin Department of Health and Family Services 1999].

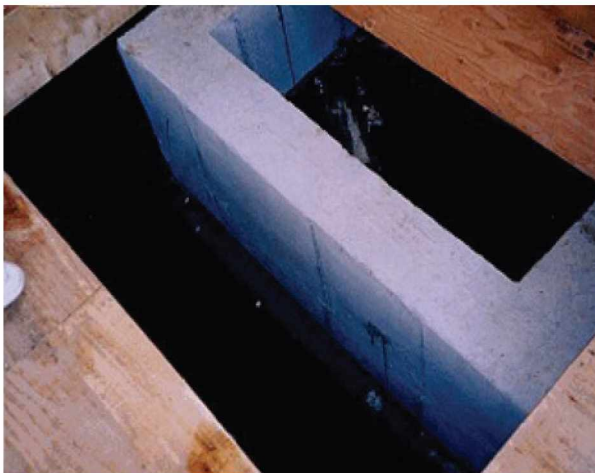
A 39-year-old, self-employed residential construction contractor died after falling through an unguarded floor opening and onto the concrete footing 10 feet below (Figure 2). He was framing the second floor with two other workers and was in the process of holding a level to the gable end of the second-floor master bedroom when

Figure 2. Unguarded floor opening.

he apparently stepped back into one of two floor openings built to accommodate a chimney. Both the first and second floors had been decked with plywood except for the chimney floor opening. Each floor opening measured approximately 4 feet x 5 feet [Massachusetts Department of Public Health 1999].

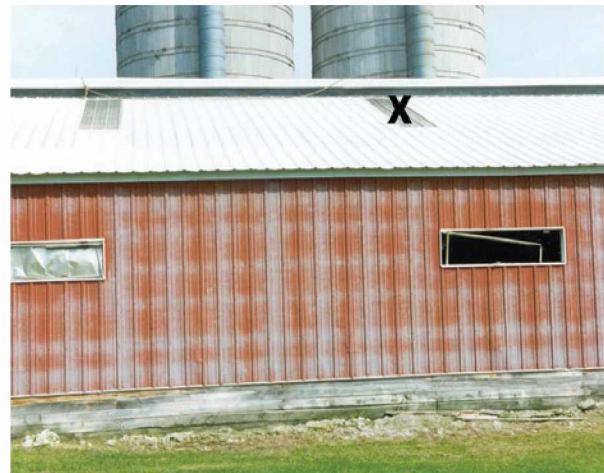
A 62-year-old farmer died from injuries sustained when he fell through a corrugated fiberglass panel used on the roof of a pole barn to let light into the building (Figure 3). On the day of the incident, the farmer drove a tractor equipped with a front-end loader next to the barn. He used the loader bucket to climb onto the roof. He walked up the slope of the roof until he reached a rope tied into the roof vent. Evidence suggests that he held the rope in one hand as he pushed snow off the roof. He stepped onto a snow-covered 3- x 10-foot corrugated fiberglass panel that broke, causing him to fall approximately 16 feet to the concrete floor below. The fiberglass panel had not been guarded or marked with a warning to indicate that it covered a hole [Minnesota Department of Health 1994].

Figure 3. Fiberglass panel on metal roof (marked with an X).

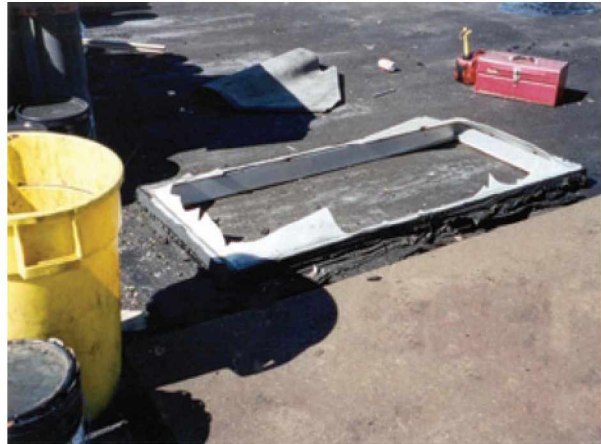
A 14-year-old male laborer died from injuries he sustained when he fell through the lens of a 56- x 24-inch, curb-mounted skylight to a concrete floor approximately 12 feet below (Figure 4). Along with several other day laborers, the victim and his 16-year-old brother had been hired by a roofing contractor on the day of the incident to pull up and remove built-up roofing materials from the flat roof of a one-story wholesale florist shop. The victim had been working for approximately 15 minutes pulling up roofing materials by hand when he fell back onto a skylight lens that broke under his weight. The skylight did not have a protective screen, cover, or

Figure 4. Rectangular skylight after it had been removed from the roof and placed on the ground.

guarding around it, and the lens was not marked with a warning against sitting or stepping on it. The employer had assigned the victim and his brother to roofing work in violation of HO16 [NIOSH 2002].

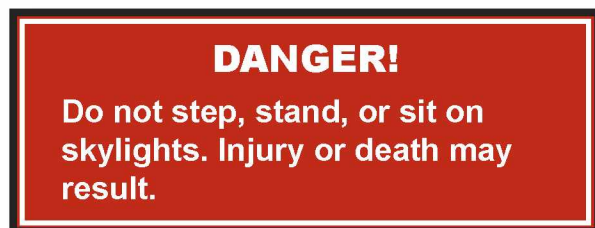
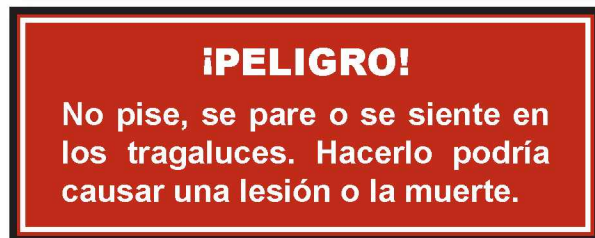
- Post warning signs on skylights and at entries (doors, stairs, ladders, or roof hatches) to areas containing skylights.
 - Post these signs in English and in the predominant language of workers who do not read English. The following example is a warning sign printed in both English and Spanish:
