Three Phase Sanitation Program in the Klamath Flood Disaster

JOE CREISLER, M.P.H., R.S.

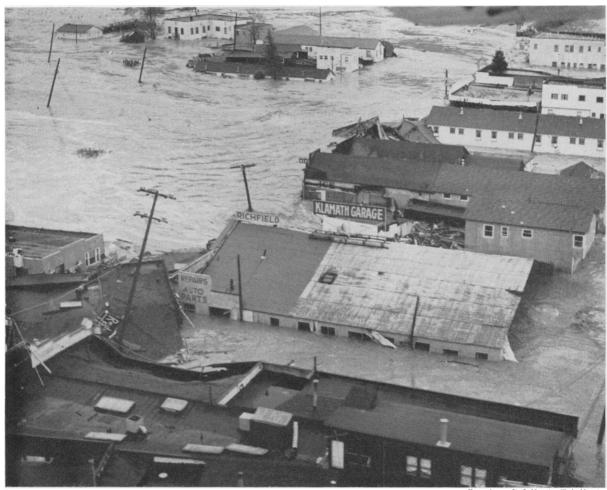
Flood peak in Klamath on December 22, 1955.

The lower Klamath River was subject to the greatest flooding in the history of its recorded stream flow during the week preceding Christmas of 1955. The previous record peak flow at Klamath was 297,000 second-feet with a gauge height reading of 43.7 feet in January 1953. On December 22, 1955, the peak flow at Klamath was 400,000 second-feet with a gauge height of 49.7 feet (1). From December 19 to 25, the total volume of flow past the town of Klamath was 2,500,000 acre-feet.

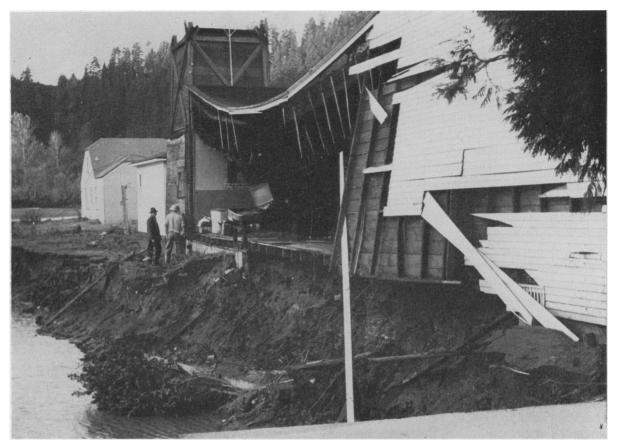
Flood-made hole and projecting sidewalk where house once stood in Klamath.

The postflood survey drew attention to the special problem presented by the gaping holes which pitted the ground in Klamath, Terwer Valley, and Klamath Glen. Some of these holes predated the flood, but many had been made by it. They ranged from 2 to 20 feet in depth and from 10 to 200 feet in length. Because of their depth, location, or contents, we recommended that they be filled.

More than 41 parcels of land in the urban sections of the disaster area were filled. In the town of Klamath, 5 major holes covering 19 parcels of property occupied before the flood were filled under the contract. Three other holes in Klamath, 8 parcels of land in Terwer Valley, and 12 parcels of land in the Klamath Glen area were filled using the force-account arrangement.

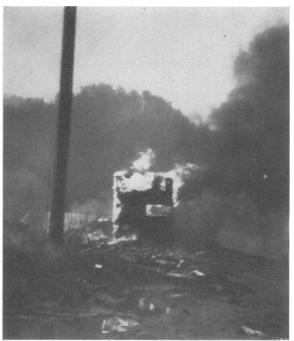
A flood-damaged building is burned in the cleanup program.

The cleanup program included the destruction of flood-damaged buildings in and near the town of Klamath. Of the 68 parcels of occupied land in Klamath, structures on 18 had been wiped out by the flood. Under the cleanup program, damaged structures on 9 parcels were removed with the owner's written consent, and 1 or 2 damaged housing units were removed from 3 parcels of land on which other housing units remained intact.

In the second stage of the program the working crews were employed in a wooded area adjacent to and down river from the town of Klamath where flood debris of all kinds had drifted and lodged. To forestall a serious infestation of rodents and insects and to prevent use of damaged building material for possible substandard housing, the area was cleared and burned.
