Analysis of Highwall Mining Stability - The Effect of Multiple Seams and Prior Auger Mining on Design

David Newman, President
Appalachian Mining and Engineering, Inc.
Lexington, KY

R. Karl Zipf, Mining Engineer
NIOSH-Pittsburgh Research Laboratory
Pittsburgh, PA

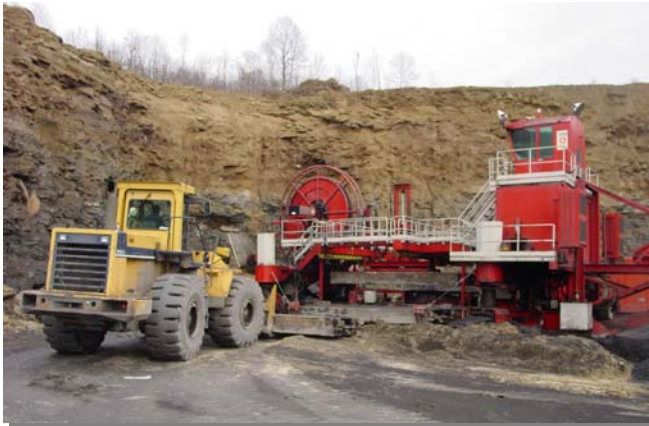
Photograph 1. "Push beam" being loaded into a SHM.

The two systems are similar in that a cutter head, consisting of a continuous miner head and gathering arms is attached to a series of coal transport modules that are added as the cutter head is advanced into the coal seam. The machines are operated from an enclosed, climate controlled cab, located at the rear of the unit. The SHM, shown in photograph 1 uses 20-foot long rectangular "push beams" that are dropped in place as the cutter head is advanced. Twin spiral augers are fully enclosed within the "push beams" and are used to move the coal away from the face.

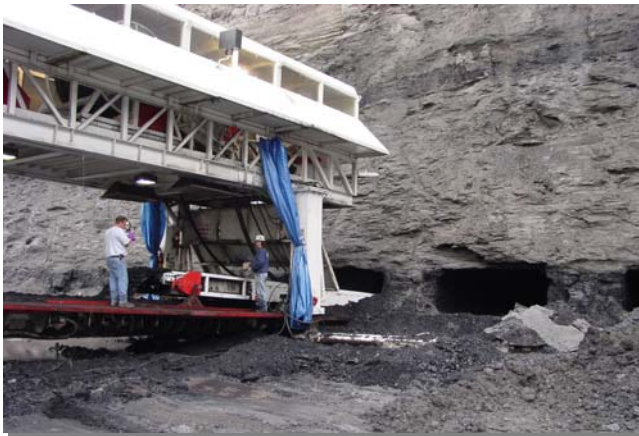
Photograph 2. Conveyor car on the launch vehicle of an ADDCAR Systems Highwall Miner.

The ADDCAR system relies upon a series of conveyor cars that utilize conveyor belts to transport coal from the face, as shown in photograph 2. Another significant difference between the two HWM systems is the guidance and monitoring systems utilized to

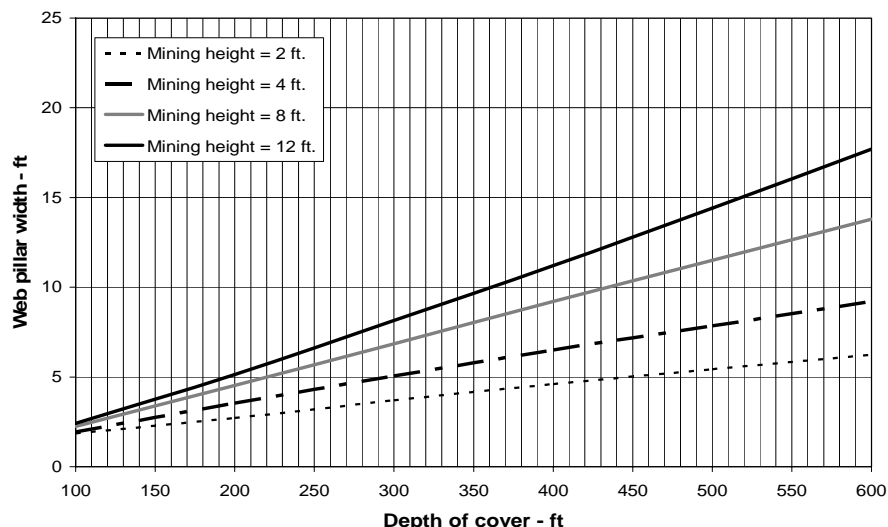
Figure 1A – Suggested web pillar width with stability factor of 1.3, coal strength of 900 lb/in²

Based on equation 1, web pillar design charts are developed and presented in figures 1 and 2. Figure 1 applies to a 9-ft-wide highwall miner cut, while figure 2 applies to a 12-ft-wide cut. In figures 1 and 2, options a and b apply to stability factors of 1.3 and 1.6, respectively. Similarly, based on equation 4, design charts for barrier pillars are presented in figure 3. Options a, b and c apply to panel widths of 100, 200 and 400 ft, respectively. Note that this design chart assumes a barrier pillar stability factor of 1.0 and it neglects any load carrying capacity of the web pillars within a panel. To use figures 1, 2 or 3, the user begins with the design depth on the x-axis, moves up vertically to the applicable mining height and then moves left horizontally to the y-axis where the suggested web (or barrier) pillar width is read.

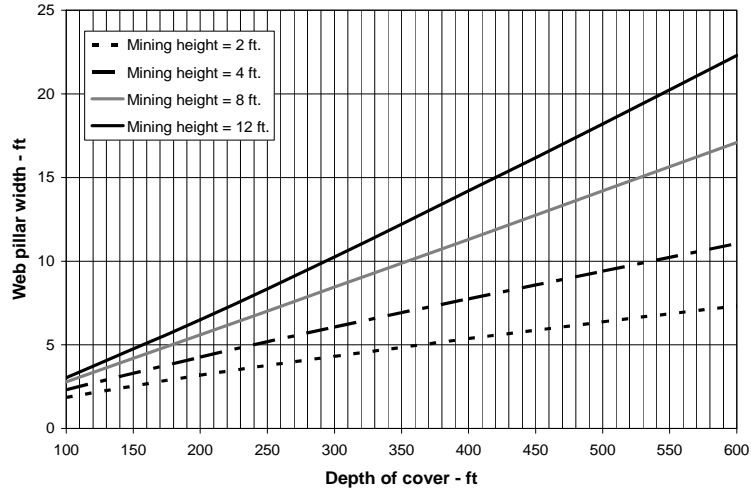
Figure 1B – Suggested web pillar width with stability factor of 1.6, coal strength of 900 lb/in² and 9-ft wide cut.

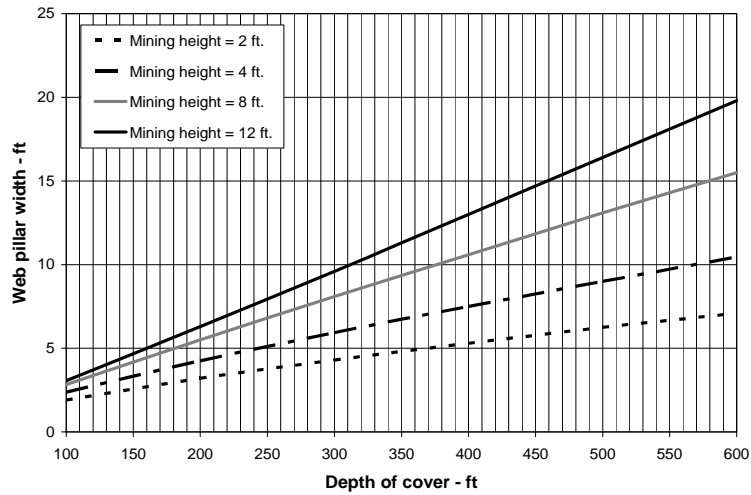
Figure 2A – Suggested web pillar width with stability factor of 1.3, coal strength of 900 lb/in² and 12-ft wide cut.

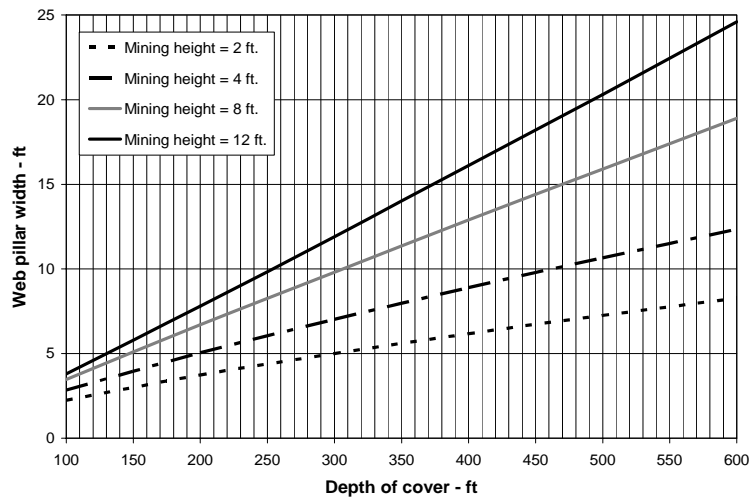
Figure 2B – Suggested web pillar width with stability factor of 1.6, coal strength of 900 lb/in² and 12-ft wide cut.

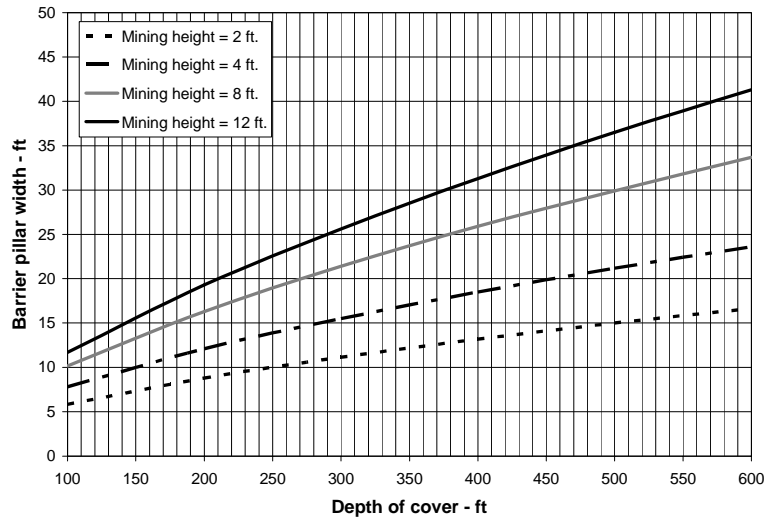
Figure 3A – Suggested barrier pillar width for 100-ft-wide panel assuming coal strength of 900 lb/in² and stability factor of 1.0.

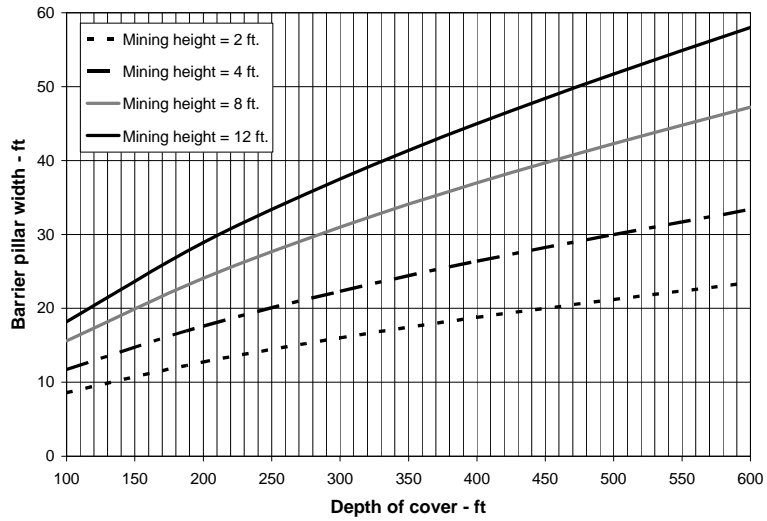
Figure 3B – Suggested barrier pillar width for 200-ft-wide panel assuming coal strength of 900 lb/in² and stability factor of 1.0.

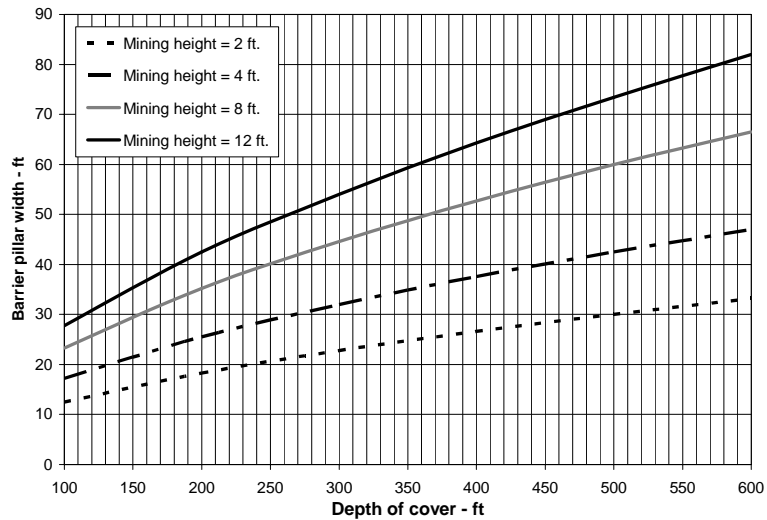
Figure 3C – Suggested barrier pillar width for 400-ft-wide panel assuming coal strength of 900 lb/in² and stability factor of 1.0.

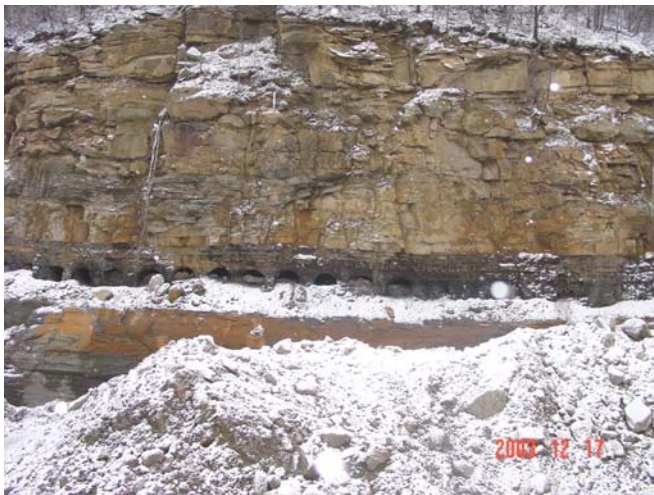
Photograph 3. A Previously Augered Stockton Seam Highwall.

This case history involves re-mining a previously augered Stockton seam highwall in Southern West Virginia. The auger mining was done using a single head 42-in (3.50-ft) diameter auger in the bottom split of the Stockton seam to produce a clean, direct ship product. This resulted in leaving a substantial amount of head coal given the 7.32-ft to 4.30-ft range of mining height in the proposed re-mining area. A portion of the previously auger highwall is shown in Photograph 3.

The auger-web-width ranged between 14-in and 22.5-in with an average width of 17.6-in. Although the depth of the auger holes is unknown, the company engineer said that based upon similar mining on the property 150-ft is probably the deepest penetration. The stability of the existing auger webs left between the 42-in diameter auger holes was examined assuming an average 17.6-in width and using in-situ coal strength of 676 lb/in² based on prior projects in the area.

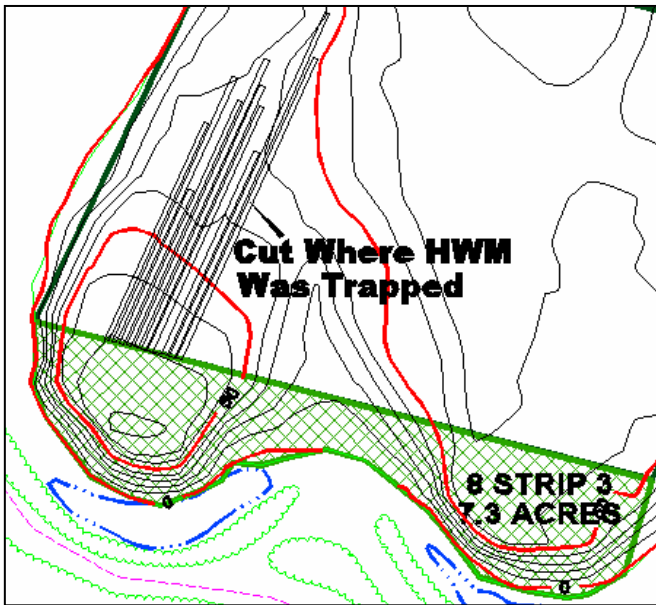
Figure 4. Mine Layout Where HWM was Trapped.

Full penetration of 800 ft was achieved in one cut because roof falls of various magnitudes occurred in each cut. The eleven cuts ranged in depth between 362 and 810 ft. Difficult roof conditions were routinely encountered in each cut within a zone from 400-ft to 600-ft deep. Cut 8 was skipped because of a highwall slide. Cut 10 reached a depth of 810-ft when a roof fall terminated further advance. The highwall miner head had advanced to a depth of 710-ft in cut 11 when a web pillar collapse and roof fall trapped the machine.

The layout of the eleven cuts is shown above in figure 4. The arched roof falls are clearly seen in Photograph 4 that shows the condition of highwall miner cuts 9, 10, and 11. The tail end of the push beams can be seen in cut 11 on the right side of the photograph.

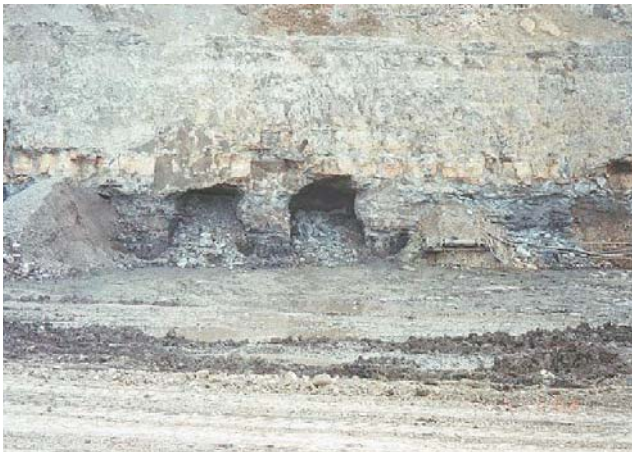
Photograph 4. Roof Falls and Web Collapse

The cause of the web pillar collapse was

- ❑ back-stacked spoil which increased the web pillar loading not being incorporated into the web pillar design and
- ❑ an increase in mining height attributable to the roof falls that reduced the width/height ratio of the web pillar and ultimately the web pillar strength
