# ANALYSIS OF PRACTICAL GROUND CONTROL ISSUES IN HIGHWALL MINING

R. Karl Zipf, Jr., *Mining Engineer*  
Suresh Bhatt, *Mining Engineer*  
National Institute for Occupational Safety and Health  
Pittsburgh Research Laboratory  
Pittsburgh, Pennsylvania USA

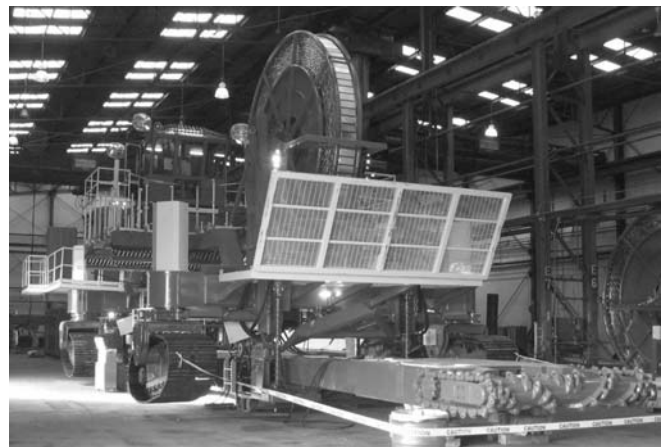
Figure 1. Superior Highwall Miner under construction. Note thin seam cutter-head, control cab and cable reel.

The Superior Highwall Miner Company (5, 6, 10) manufactures the SHM<sup>1</sup> shown in figure 1. In its present design, the miner head is a modified Joy Mining Machinery miner that feeds a series of 20-foot-long pushbeams containing counter-rotating augers for coal transport. Maximum penetration depth is approximately 1,000 feet.

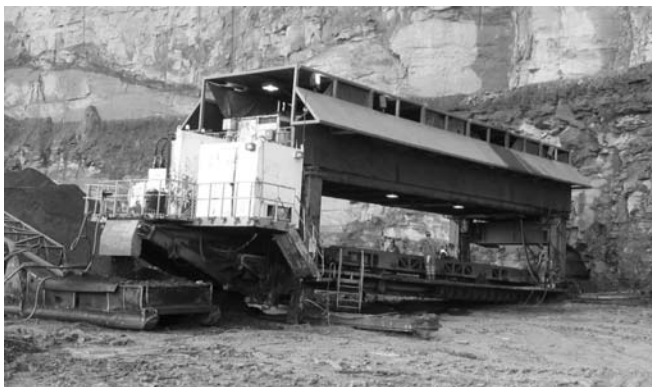
Figure 2. Addcar Highwall Miner in operation. Note: Addcar in launch vehicle, control cab and discharge conveyor.

Mining Technologies Inc. (1, 2, 5, 8, 9, 11) builds the Addcar highwall miner system shown in figure 2. MTI developed its own highwall miner heads that are similar to conventional continuous miners. The miner head discharges onto a series of 40-foot-long cascading conveyor sections known as the Addcars. Penetrations up to 1,600 feet have been achieved. Addcar systems are equipped with cameras that allow the operator to view face conditions, and the latest models feature a gyroscopic guidance system (HORTA) for improved navigational control.

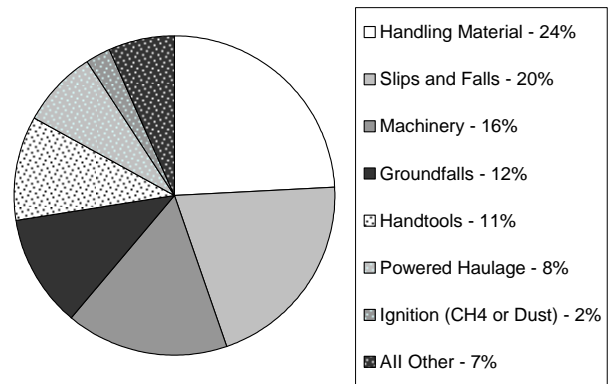
Figure 3. Distribution of 605 incidents in auger and highwall mining.

Figure 3 shows that groundfalls accounted for 70 (12%) of the 605 MSHA-reportable incidents. As shown in figure 4, groundfalls accounted for 1/3 of the 9 fatalities. Close examination of the 70 groundfall related incidents shows that approximately 3/4 of the incidents resulted in serious days-lost injuries (figure 5). In fact, more than 2/3 of these incidents resulted in at least a week off work to recover, and more than half the victims required one month for recovery from their injuries.

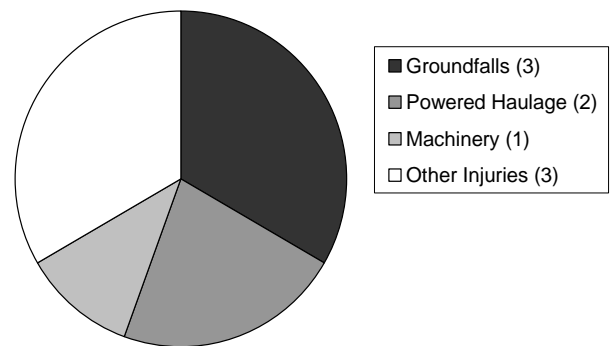
Figure 4. Distribution of fatality causes in auger and highwall mining.

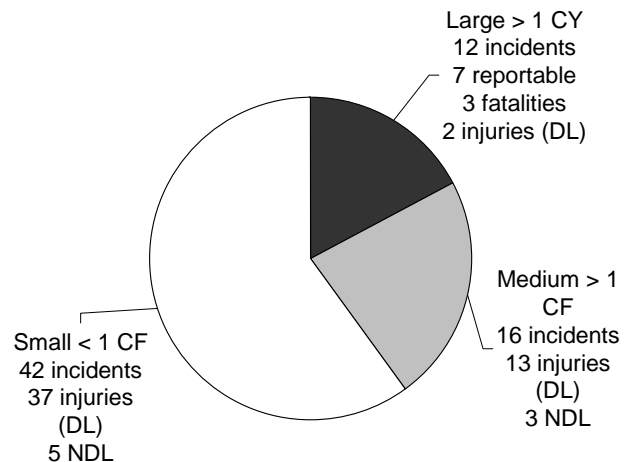
Figure 5 – Size distribution of groundfalls.

Based on the brief descriptions of the groundfalls in the MSHA database, the rock fall sizes were classified as large (more than 1 yd<sup>3</sup>), medium (between 1 yd<sup>3</sup> and 1 ft<sup>3</sup>) or small (less than 1 ft<sup>3</sup>). Figure 5 shows that 12 of the incidents (less than 20%) were large rock falls and that all the fatalities were associated with the large falls. Another 16 incidents were from medium-sized rock falls, and the rest, 42 incidents, were from small rock falls, although most of the incidents reported resulted in days lost injuries. About 2/3 of the injury-producing rock falls were classified as small (less than 1 ft<sup>3</sup>), which is a key piece of

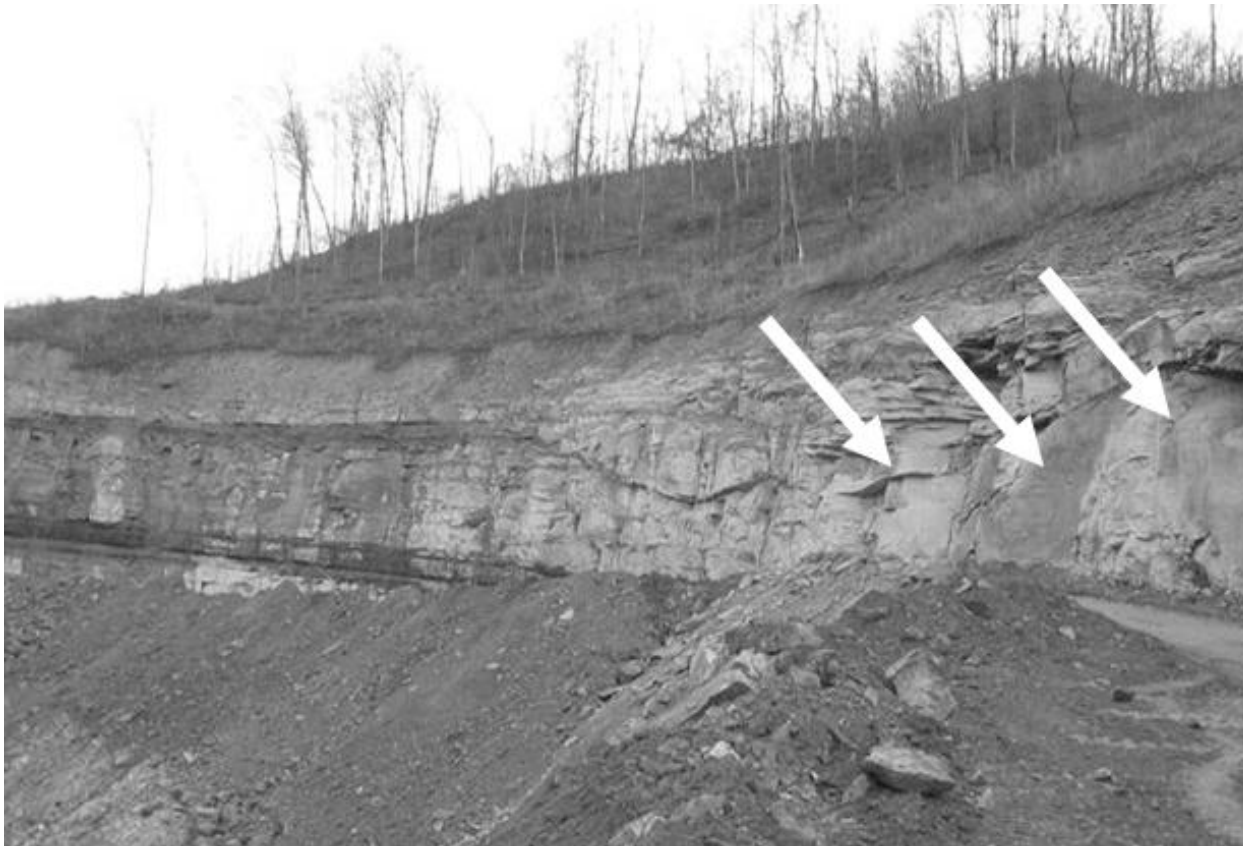
Figure 8. Web pillar failure occurred along highwall to the right. Note that several large rock wedges were dislodged as indicated by arrows. Undamaged highwall is to the left.

essential for highwall stability. Web pillar failure and the subsequent subsidence of the overlying rock can destabilize the highwall face. Figure 8 shows an area where web pillar failure led to large rock falls from the highwall. Figure 9 shows an even more spectacular failure (16). In this case, 30 to 50 web pillars failed suddenly, which caused substantial rock fall from the highwall. The rock fall was sufficient to completely bury a 110 ton coal haulage truck. Fortunately no one was in the pit when this failure occurred.

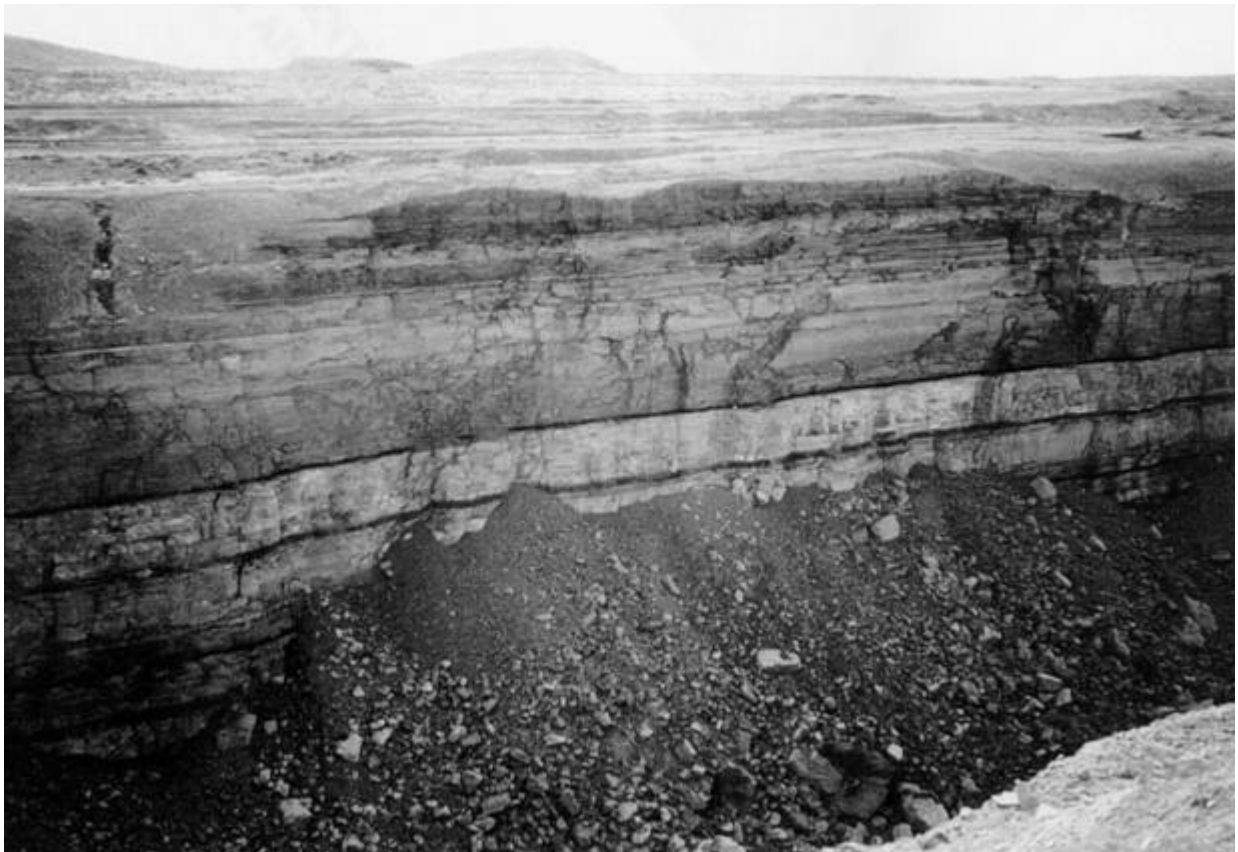
Figure 9. Site of massive web pillar collapse resulting in highwall slope failure. Photograph is taken from adjacent spoil pile. Highwall is about 150 feet high. A 110 ton coal haulage truck is buried in rockfall debris.

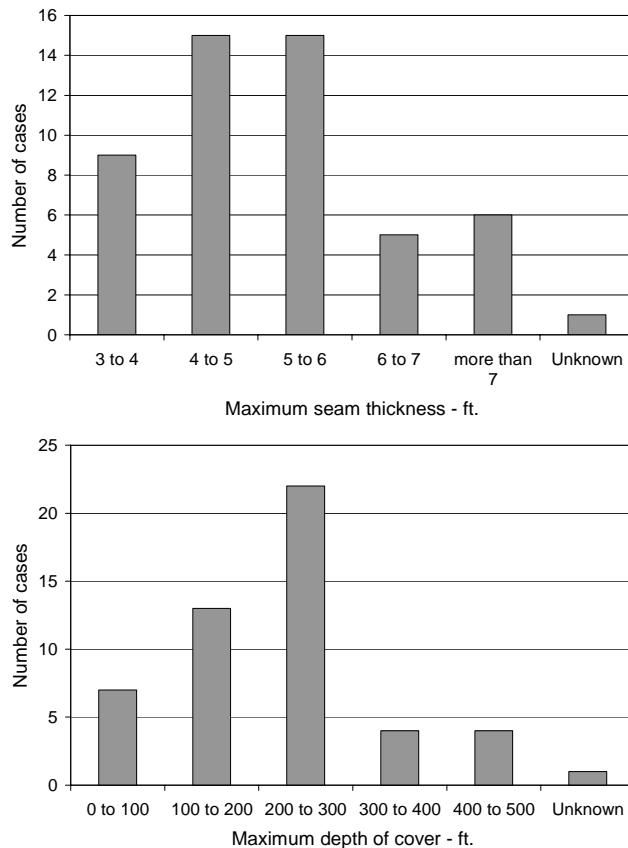
Figure 10. Maximum seam thickness (top) and maximum depth of cover (bottom) distribution from MSHA highwall mining ground control plans.

From these 40 plans, 51 distinct cases were compiled from which to evaluate highwall mining designs. Figure 10 shows the distribution of maximum seam thicknesses and maximum cover depths considered in the plans. In three-quarters of the planned highwall mining, maximum seam thickness is between 3 to 6 feet. Relatively few highwall miners (less than 12%) have planned mining heights greater than 7 feet. Most of these thicker seam operations are in the western U.S. in MSHA District 9. In most operations (about 82%), maximum depth of cover is less than 300 feet. The rest have a planned maximum depth of cover in the range 300 to 500 feet. At this time no one appears to be operating under more than 500 feet of cover, although this could change soon.

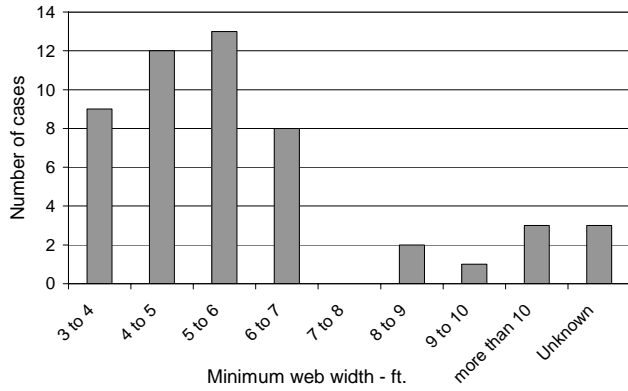
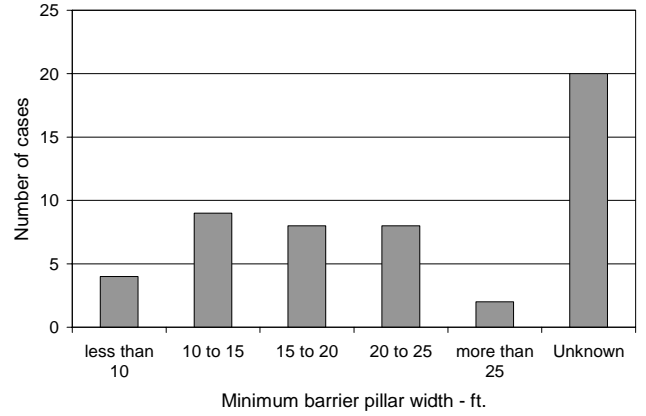
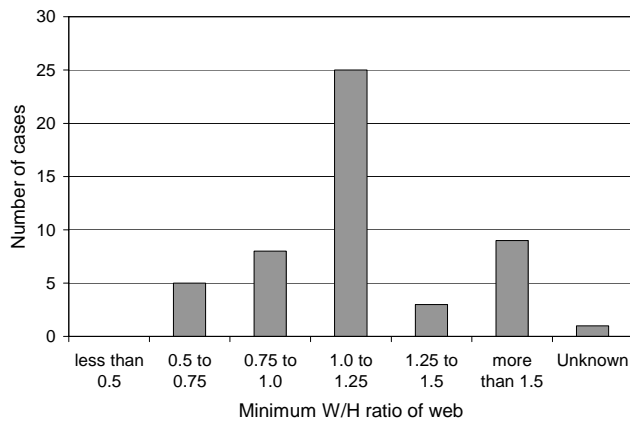
Figure 11. Minimum web pillar width (top), minimum width-to-height (W/H) ratio (middle) and approximate web pillar stability factor (bottom) from MSHA highwall mining ground control plans.

Maximum seam thickness and maximum depth of cover are the main inputs for geotechnical design of web pillar width. In about 15% of the plans examined, the ARMPS program (22) was the analysis method. Over 25% used another form of a tributary area method for analysis. Past experience was the basis for many designs, but unfortunately, the analysis method could not be identified in most of the highwall mining ground control plans examined. As shown in figure 11a, the minimum web width specified in the plans ranges from 3 to 7 feet in over 82% of the cases. More important for stability is the width-to-height (W/H) ratio of these web pillars. Figure 11b shows that W/H is in the 1 to 1.25 range for about 50% of the cases, while it is between 0.5 and 1 in 25% and more than 1.25 in the remaining 25% of cases. In general, keeping the web pillar W/H ratio above 1 is desirable to maintain better web pillar integrity. Designs with W/H ratio less than 0.5 were not encountered.

Finally, figure 11c shows estimates of the web pillar stability factor based on data provided in the ground control plans. The estimates use tributary area method to calculate pillar stress and the Mark-Bieniawski formula (18) to calculate strength of a strip pillar assuming coal strength of 900 psi. In 45 % of the cases, it appears that stability factor exceeds 1.6; while in 31%, the stability factor appeared to range from 1.3 to 1.6. Thus, in over three-quarters of the cases examined, a satisfactory web pillar stability factor most likely exists. However, in a few circumstances (about 8%), stability factor may be in the 1 to 1.3 range, while in another 8% stability factor was apparently slightly less than 1. These stability factor estimates from the ground control plans are estimates only, and judgment of individual plans is not implied.

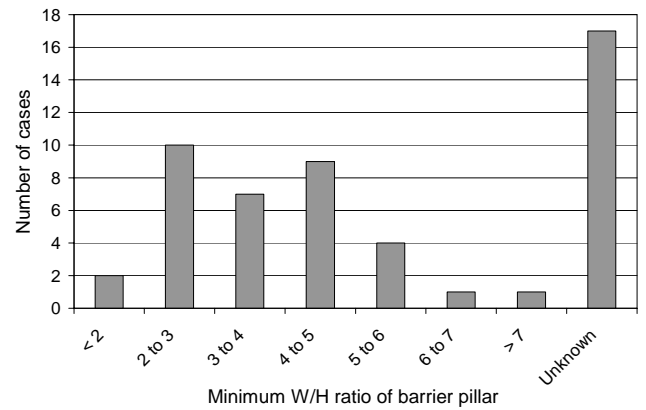
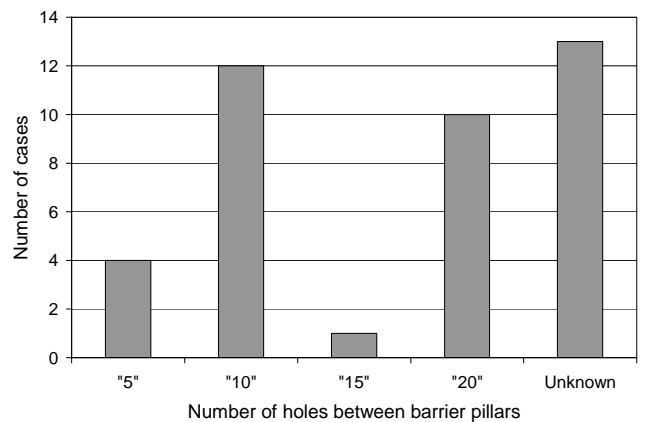
Figure 12. Minimum barrier pillar width (top), minimum width-to-height (W/H) ratio (middle) and number of holes between barrier pillars (bottom) from MSHA highwall mining ground control plans.

Figure 12a provides data on minimum barrier pillar width found in the plans. Most barriers appear to range in width from 10 to 25 feet, but in almost half the cases a firm dimension on barrier pillar width was not specified. In most cases, the reasoning behind the barrier pillar width was unknown. Experience-based design rules were employed in some cases. For example, about 15% of the plans sized barrier pillars as 1 web-pillar-width plus 1 hole-width, while another 15% used 2 web-pillar-widths plus 1 hole-width. In about 10% of the cases, barrier pillar widths were designed using tributary area method with a stability factor of one and the assumption that all web pillars in a panel have failed.

Figure 12b shows data on the W/H ratio of highwall mining barrier pillars. Unfortunately there was no information in about one-third of the cases considered. However, when data was available, the W/H ratio was 3 or more in about two-thirds of the cases and less than 3 in the remaining third. For stability reasons, a barrier pillar with a W/H ratio above 3 has sound geomechanics-based advantages (16).

Finally, figure 12c presents data on the number of highwall miner holes between barrier pillars. When information is available, it appears that about 37% of the plans specify no more than 20 holes between barrier pillars; 44% specify 10 holes, and 15% require as few as 5 holes between barrier pillars. Comment on the number of holes between barrier pillars is reserved for later discussion.
