DEEP COVER PILLAR EXTRACTION IN THE U.S. COALFIELDS

Frank E. Chase, *Research Geologist*
Christopher Mark, *Chief, Rock Mechanics Section*
National Institute for Occupational Safety and Health
Pittsburgh Research Laboratory
Pittsburgh, Pennsylvania USA

ABSTRACT

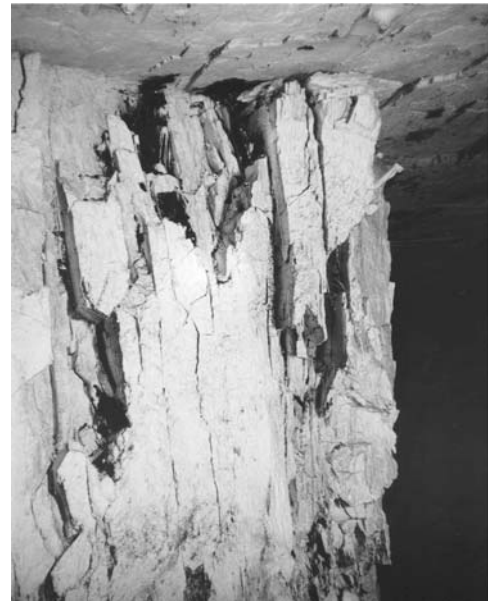
slabs of coal which can roll over without warning (figure 1). Some mines experiencing cleat related rib rolls have been compelled to orient entries 45° to the face cleat to maintain safer travelways in both entries and crosscuts. However, this orientation can cause the cleat to segment the pillar corners into large triangular columns of coal which tend to fail into the intersections. After experiencing these various conditions, some operators have opted to drive entries at a low angle (25-30°) with respect to face cleat in an attempt to minimize rib sloughage problems.

Figure 1. Vertical coal pillar slabs associated with face cleat.

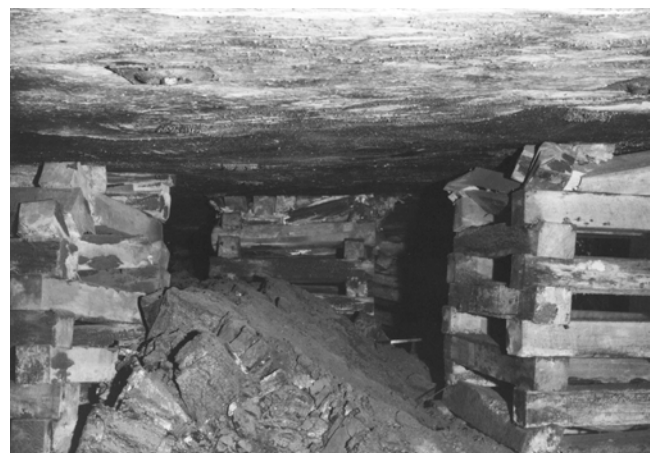
Floor failure can also be a deep cover operational issue. More typically, a competent roof tends to punch overstressed pillars into a weaker floor units causing heave in the roadways. Heave can be so extreme that equipment is not left in the working faces during idle shifts for fear of entrapment. Instances where it was necessary to use the continuous miners to regrade roadways for equipment clearance into the faces have also been documented. In one mine visited in southern West Virginia, approximately 4.5 ft of heave was observed just outby the pillar line in the 9 ft thick Beckley Coalbed (figure 2).

Figure 2. Excessive pillar line floor heave.

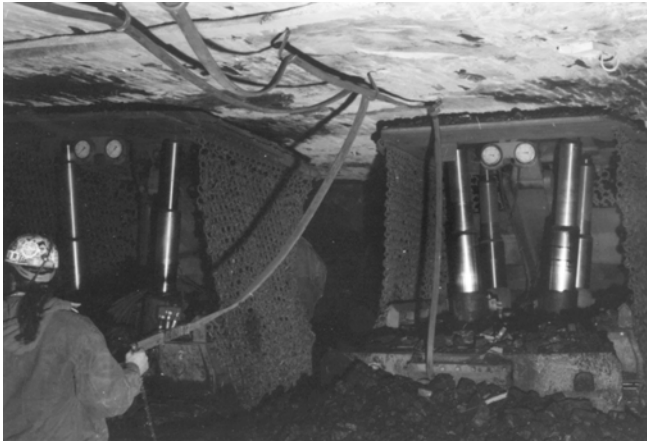
especially true in western mines where there is a scarcity of inexpensive hardwoods. In some of the 12 ft plus thick western reserves, some operators notion of retreat mining is only to mine the floor coal. To combat the posting issues, several operators have turned to mobile roof support usage (figure 4).

Figure 4. Full pillar extraction using mobile roof supports.
