# Demonstration of remote mine seal construction

## Abstract

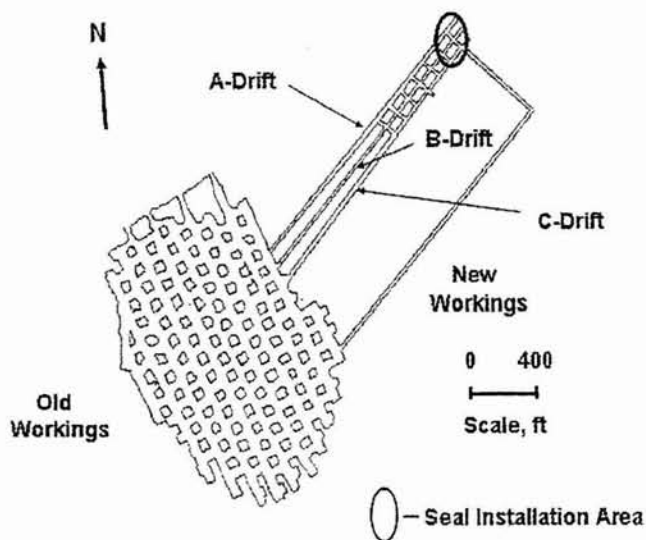
Figure 1 — Layout of the Lake Lynn Laboratory Mine.

The work was conducted at LLL. The Lake Lynn Laboratory is a highly sophisticated underground and surface laboratory located about 100 km (60 miles) southeast of Pittsburgh, Pennsylvania, and 16 km (10 miles) northeast of Morgantown, West Virginia, where large-scale explosion trials, mine fire research and a myriad of other mine safety and health research programs are conducted. The underground workings are sized to match those of commercial mines, thus making them true, full-scale test galleries. Movable bulkheads permit the setup of single-entry, triple-entry and longwall face configurations for experiments (NIOSH, 1999) (Fig. 1).

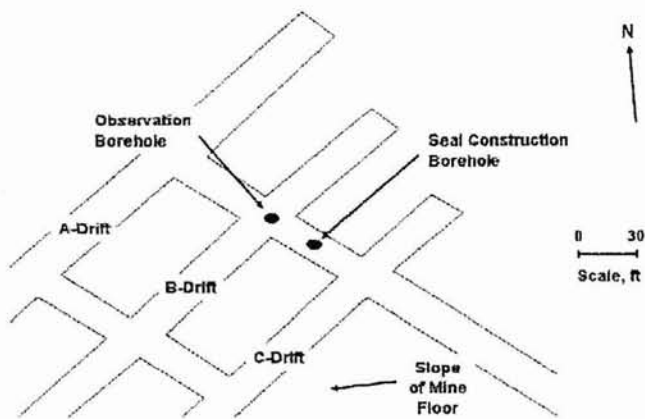
Figure 2 — Underground layout of the seal construction site.

Previously, a 152.4-mm- (6-in.-) diameter cased borehole was completed in the first crosscut between the B and C Drifts of the experimental mine, and it was determined that this borehole was suitable for the seal construction work (Fig. 2). The thickness of the overburden in the area of the borehole is about 60 m (200 ft). The crosscut in the mine measured 5.8 m (19 ft) wide, 12.2 m (40 ft) long and 2.1 m (7 ft) high. The floor sloped on the order of a 1.13% gradient. A second borehole, located about 9 m (30 ft) away, was available for viewing the mine seal installation through use of a downhole video camera. In-mine to surface communication was facilitated through the use of a mine pager phone system.

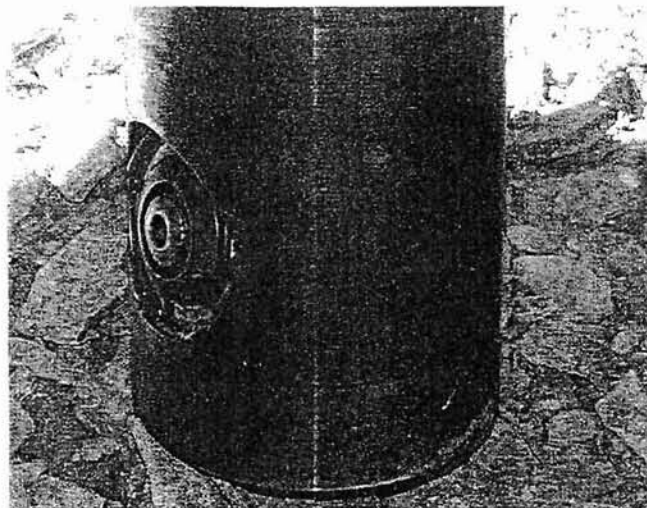
Figure 3 — Spray nozzle.

The first process was designed to use a technique very similar to that used when placing bulk grout with a tremie pipe. The concept called for the bottom of the injection casing to be slotted to facilitate some directional control of the grout stream. The bulk grout material would be placed in separate lifts with time between lifts to allow the material to begin to stiffen. The second placement technique required the use of two strings of pipe (one inside of the other) to convey two streams of material to a spray nozzle. The spray nozzle permitted the blending of the two-part grout accelerator mix while allowing sufficient air velocity to transport the grout to the mine roof-and-rib areas. A spray nozzle was designed by GAI for this purpose (refer to Fig. 3). In both techniques, an on-site volumetric mixing plant was used to blend the grout mixture. The bulk grout was pumped to the borehole using a positive displacement pump and the sprayed grout was moved to the borehole using a conventional grout pump and compressed air.

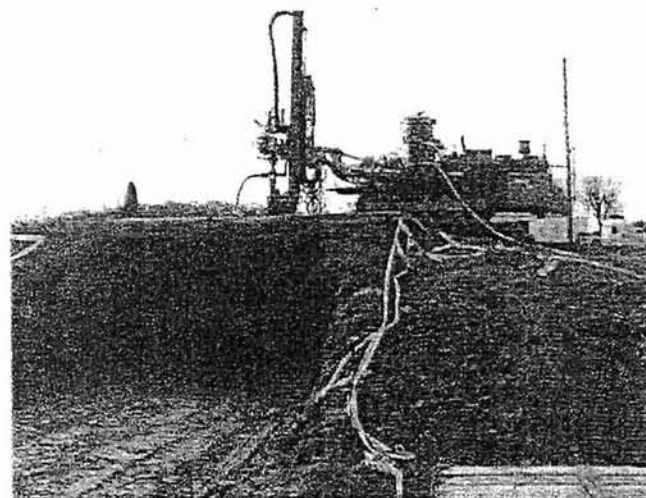
Figure 4 — View of the model mine.

Prior to constructing the mine seal at LLL, a model mine opening was constructed at Howard's facility in Cuddy, Pennsylvania. The model mine opening was constructed for testing and direct observation of the performance of the downhole nozzle and pumping equipment. The model mine opening consisted of a

small excavation in a hillside (Fig. 4). The roof of the model mine was formed using crane mats so a drill rig could be located over the mine void to hold the pipe for the spray nozzle.

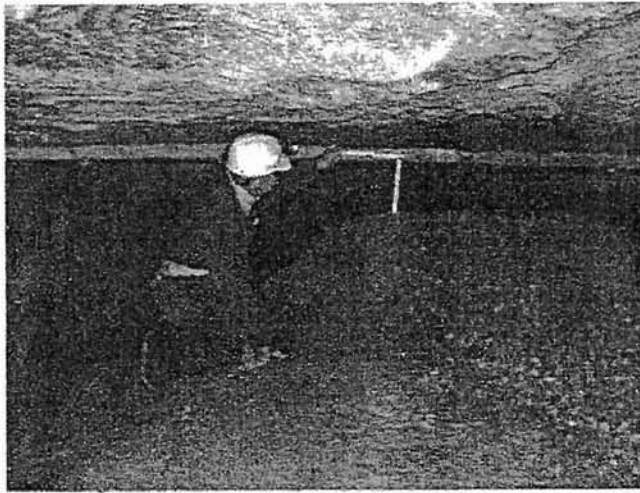
Figure 5 — Underground view of bulk fill material for seal No. 1.

On July 22, 2002, placement of the bulk fill for seal No. 1 was initiated using a mixture composed of 2A crushed limestone aggregate, fly ash and cement. This mixture was pumped into the mine opening using a string of casing. Bulk fill was pumped over different time intervals with a pause between intervals to allow the in-place grout to stiffen. This process was used in an attempt to control the extent of lateral material flow out of the mine cross-cut areas. The pumping time and

the pause intervals were determined by visual observation via a downhole video camera and communication with the mine pager phone. Pumping was terminated after approximately 86 m<sup>3</sup> (112 cu yd) of material had been placed into the crosscut (Fig. 5). Underground examination revealed that the mine opening had not been completely sealed (open spaces were observed at the mine roof-and-rib areas), and some of the bulk fill material had flowed into the adjacent mine areas.

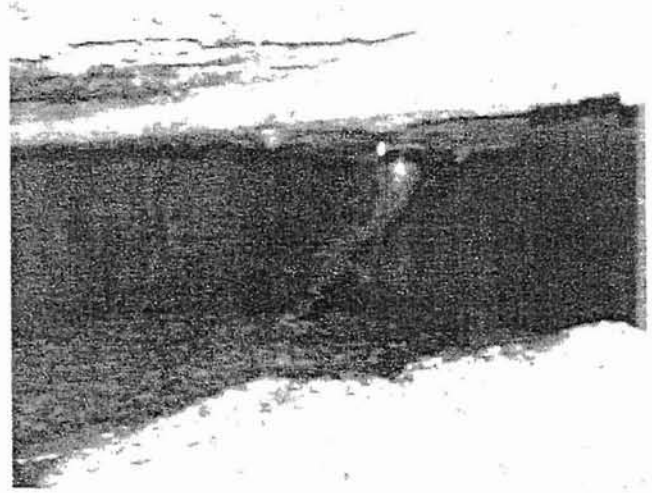
Figure 7 — Underground view of elbow placing bulk fill.

On August 2, 2002, a newly designed elbow was lowered into the mine opening from the surface borehole. Once the elbow was positioned in the mine opening, pumping of the seal material began using a 2A limestone aggregate, fly ash and cement mixture. Compressed air was added to the flow stream to facilitate movement of the material towards the mine rib areas. This material was pumped into select locations along the mine rib areas in an attempt to fill the mine opening (Fig. 7). Pumping was terminated after approximately 75 m<sup>3</sup> (100 cu yd) of material had been placed into the crosscut and after the elbow became plugged.

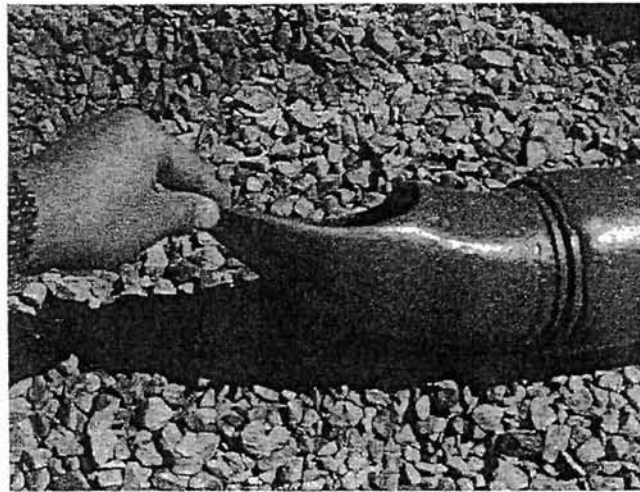
Figure 6 — Elbow for bulk fill placement.

The disappointing results of the spray nozzle application indicated that additional work was needed to further refine the material mix components before the spray nozzle was used again. In the interim, after reviewing the progress made during the placement of the bulk fill, it was decided to fit the end of the casing string of pipe with an elbow to provide a means of directionally controlling the placement of grout material (Fig. 6). It was also thought that this elbow configuration could facilitate roof-rib closure with the bulk fill material.

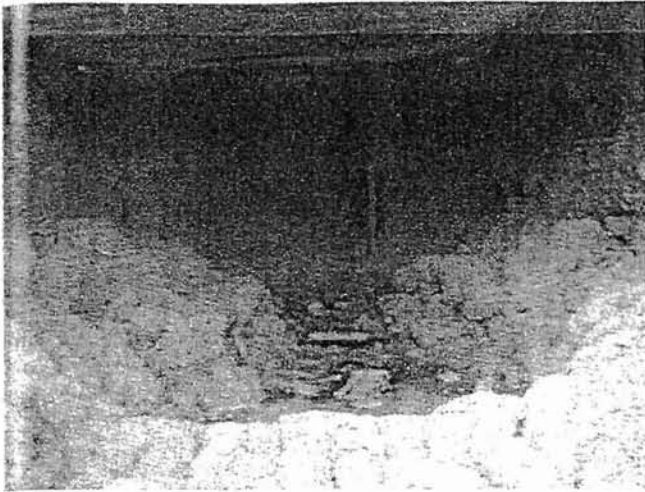
Figure 8 — View of fill placement at model mine.

On October 8, 2002, a test of the spray nozzle was successfully conducted at the Howard model mine site. During the 10-m<sup>3</sup> (13-cu yd) test, engineers were able to successfully spray and build up material on the mine rib areas. The material was sprayed to an estimated thickness of 300 to 380 mm (12 to 15 in.) on the mine rib areas (up to the roof) with no build-up on the floor below the spray nozzle assembly (Fig. 8). This was a much different outcome as compared to that seen during previous tests and during the construction of mine seal No. 1. The GAI engineers attributed the successful outcome of this test to adjustments in the equipment used to control material feed and a significant improvement of the material mix.

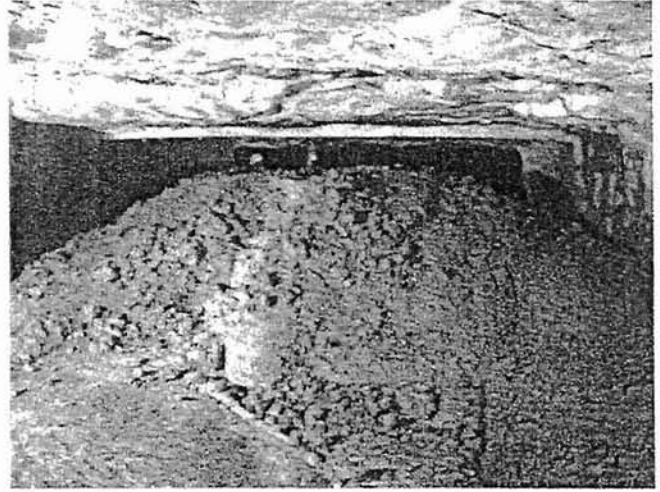
Figure 9 — View of bulk fill placement for seal No. 2.

**Mine Seal No. 2.** On October 8, 2003, the Howard/GAI team initiated the remote installation of mine seal No. 2 at LLL. Pumping of the first part of the remote seal (bulk material) began using a sand, fly ash and cement mixture. This material was pumped into the mine opening using the elbow. The bulk material was pumped in a series of lifts to fill the mine opening. Pumping was terminated after approximately 42 m<sup>3</sup> (55 cu yd) of material had been placed in the crosscut. It should be noted that communication with underground personnel was required to orient the elbow and complete the construction of the base.

Underground examination revealed that the mine opening had not been completely sealed. However, the seal material was placed to within 0.46 m (1.5 ft) of the mine roof below the borehole and within 0.76 to 0.9 m (2.5 to 3 ft) of the mine roof near the rib areas (Fig. 9). It was decided to remove an additional 152 mm (6 in.) of material below the bottom of the

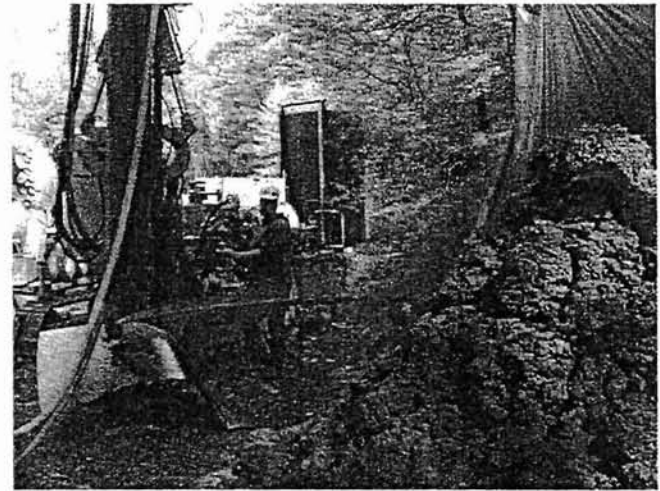
Figure 10 — Surface test of spray grout system.

On October 14, 2003, a 7.6-m<sup>3</sup> (10-cu yd) surface test of the final component of the seal mixture (fly ash, cement and accelerators) was conducted at LLL (Fig. 10). The result of the test showed that the mixture would perform as required (little to no slump). A dual string of drill pipe and casing affixed with the spray nozzle was then placed into the 152.4-mm- (6-in.-) diameter borehole in preparation for the second part of the seal construction.

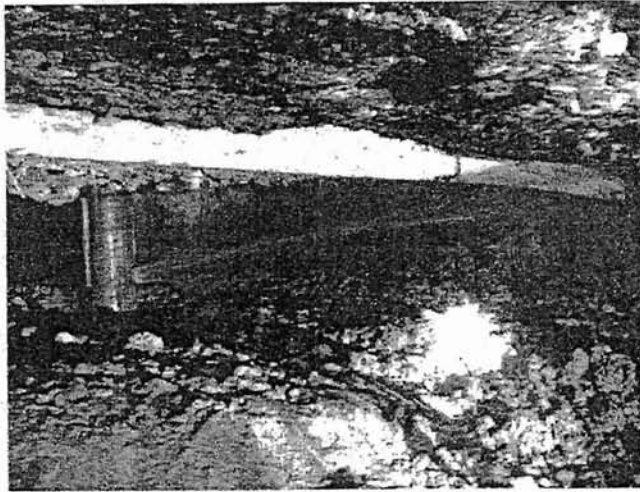
**Figure 11** — Underground view of spray nozzle during seal No. 2 construction.

On October 15, 2003, the second part of the mine seal was installed using the spray nozzle. The material was sprayed in a back-and-forth motion along the mine rib areas to fill in the gaps. Interaction between observers underground and engineers on the surface ensured that the nozzle was aimed in the proper direction. Good mine roof-and-rib contact was made with the sprayed material. The problematic corner areas at the mine roof-rib intersection were filled before the grout began to build up and migrate towards the spray nozzle (Fig. 11).

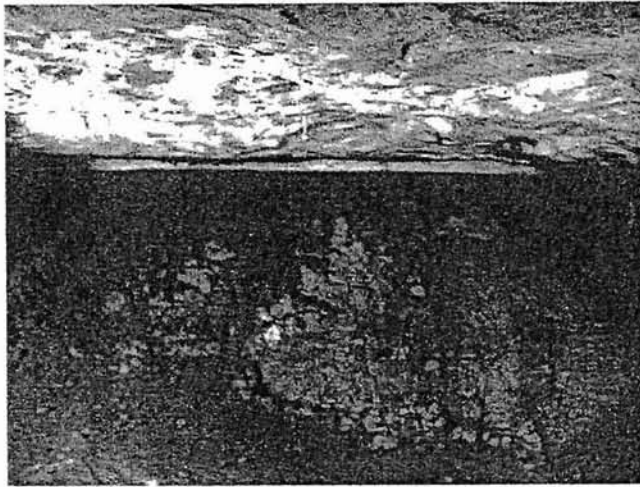
**Figure 12** — Underground view of mine seal No. 2 from the B-Drift.

below the nozzle and then rotating the spray nozzle through a 360° arc. Eventually, the material built up around the nozzle and closed the mine opening (Fig. 12). In all, a total of 17.2 m<sup>3</sup> (22.5 cu yd) of sprayed material was used to close the mine opening. An underground examination showed that the mine seal material (both bulk and sprayed material) had flowed about 3.7 m (12 ft) from the borehole towards the B-Drift and only about 2.7 m (9 ft) from the borehole towards the C-Drift. The shape of the seal approximated a truncated pyramid whose base measured 5.8 m (19 ft) wide (the width of the cross cut) by 6.4 m (21 ft) deep and whose top measured 5.8 m (19 ft) wide (the width of the cross cut) by 0.9 to 1.5 m (3 to 5 ft) deep.
