## DEMONSTRATION OF REMOTE MINE SEAL CONSTRUCTION

### ABSTRACT

Mine seals can be remotely constructed in underground coal mines, through vertical boreholes, when direct access to a fire is impossible or considered to be too dangerous. This method has great merit because boreholes can be drilled to specific mine areas and seals can be positioned close to a fire zone. The technology however, can be largely ineffective if the constructed seals do not provide effective barriers to airflow or cannot be used to impound water and other inert materials. Unfortunately, no viable alternatives exist to sealing the entire mine at the ground surface. Full-scale remote mine seal construction research is being conducted at the National Institute for Occupational Safety and Health's (NIOSH) Lake Lynn Laboratory (LLL). Under this effort, Howard Concrete Pumping Company and GAI Consultants, Inc. have joined forces to evaluate a potentially significant improvement to the current state-of-the-art. This paper will cover development of novel technology for remote mine seal construction, evaluation of the materials used, construction practice, and follow-up testing.

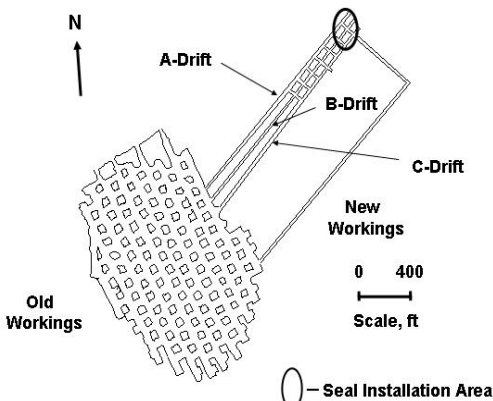
Figure 1. Layout of the Lake Lynn Laboratory Mine.

The work was conducted at LLL. The Lake Lynn Laboratory is a highly sophisticated underground and surface laboratory located about 60 miles southeast of Pittsburgh, PA, and 10 miles northeast of Morgantown, WV, where large-scale explosion trials, mine fire research and a myriad of other mine safety and health research programs are conducted. The underground workings are sized to match those of commercial mines, thus making them true, full-scale test galleries. Movable bulkheads permit the setup of single-entry, triple-entry, and longwall face configurations for experiments (NIOSH 1999) (figure 1).

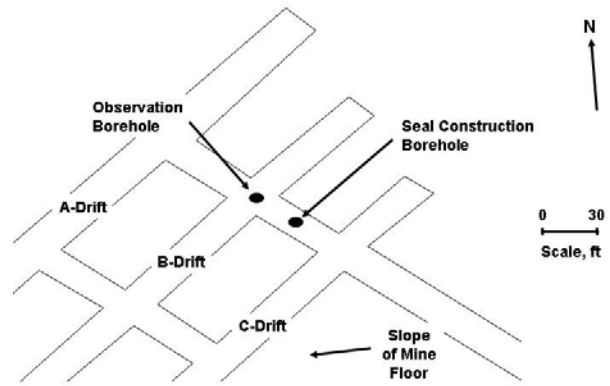
Figure 2. Underground layout of the seal construction site.

Previously, a 6-in diameter cased borehole was completed in the first cross-cut between the B and C Drifts of the experimental mine and it was determined that this borehole was suitable for the seal construction work (figure 2). The thickness of the overburden in the area of the borehole is about 200 ft. The cross-cut in the mine measured 19 ft wide, 40 ft long and 7 ft high. The floor sloped on the order of 1.13 percent gradient. A second borehole, located about 30 ft away, was available for viewing the mine seal installation through use of a downhole video camera. In-mine to surface communication was facilitated through the use of a mine pager phone system.

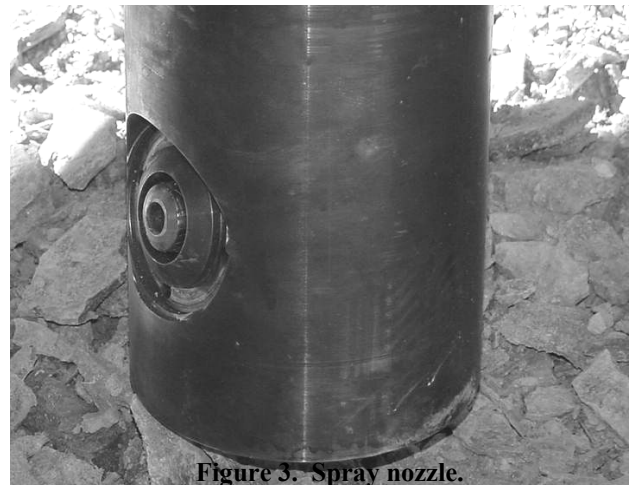
**Figure 3. Spray nozzle.**

The first process was designed to use a technique very similar to that used when placing bulk grout with a tremie pipe. The concept called for the bottom of the injection casing to be slotted to facilitate some directional control of the grout stream. The bulk grout material would be placed in separate lifts with time between lifts to allow the material to begin to stiffen. The second placement technique required the use of two strings of pipe (one inside of the other) to convey two streams of material to a spray nozzle. The spray nozzle permitted the blending of the two-part grout accelerator mix while allowing sufficient air velocity to transport the grout to the mine roof-and-rib areas. A spray nozzle was designed by GAI for this purpose (refer to figure 3). In both techniques, an on-site volumetric mixing plant was used to blend the grout mixture. The bulk grout was pumped to the borehole using a positive displacement pump and the sprayed grout was moved to the borehole using a conventional grout pump and compressed air.

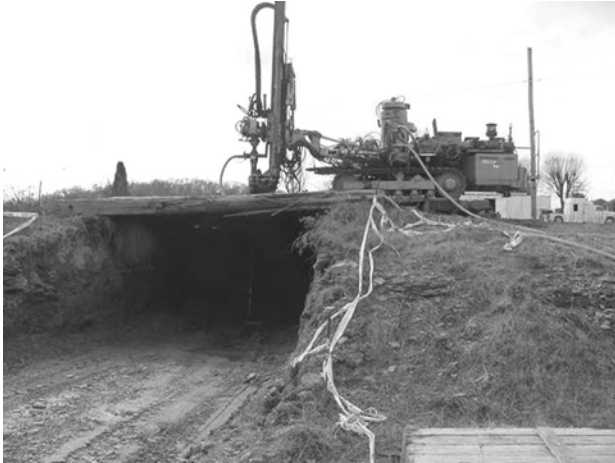
**Figure 4. View of the model mine.**

downhole nozzle and pumping equipment. The model mine opening consisted of a small excavation in a hillside (figure 4). The roof of the model mine was formed using crane mats so a drill rig could be located over the mine void to hold the pipe for the spray nozzle.

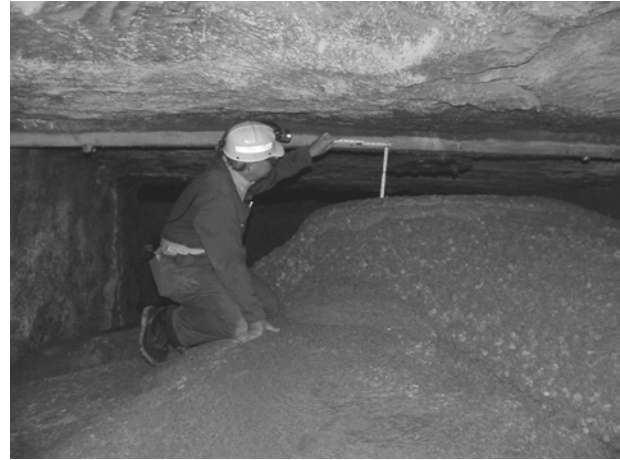
**Figure 5. Underground view of bulk fill material for seal No. 1.**

On July 22, 2002, placement of the bulk fill for seal No. 1 was initiated using a mixture composed of 2A crushed limestone aggregate, flyash and cement. This mixture was pumped into the mine opening using a string of casing. Bulk fill was pumped over different time intervals with a pause between intervals to allow the in-place grout to stiffen. This process was used in an attempt to control the extent of lateral material flow out of the mine cross-cut areas. The pumping time and the pause intervals were determined by visual observation via a downhole video camera and communication with the mine pager phone. Pumping was terminated after approximately 112 yd<sup>3</sup> of material had been placed into the cross-cut (figure 5). Underground examination revealed that the mine opening had not been completely sealed (open spaces were observed at the mine roof-and-rib areas) and some of the bulk fill material had flowed into the adjacent mine areas.

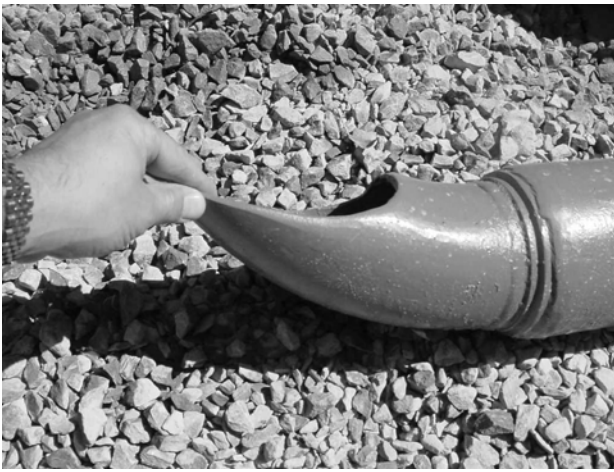
**Figure 6. Elbow for bulk fill placement.**

The disappointing results of the spray nozzle application indicated that additional work was needed to further refine the material mix components before the spray nozzle was used again. In the interim, after reviewing the progress made during the placement of the bulk fill, it was decided to fit the end of the casing string of pipe with an elbow to provide a means of directionally controlling the placement of grout material (figure 6). It was also thought that this elbow configuration could facilitate roof-rib closure with the bulk fill material.

On August 2, 2002, a newly designed elbow was lowered into the mine opening from the surface borehole. Once the elbow was positioned in the mine opening, pumping of the seal material began using a 2A limestone aggregate, flyash and cement mixture. Compressed air was added to the flow stream to facilitate movement of the material towards the mine rib areas. This material was pumped into select locations along the mine rib areas in an attempt to fill the mine opening (figure 7). Pumping was terminated after approximately 100 yd<sup>3</sup> of material had been placed into the cross-cut and after the elbow became plugged.

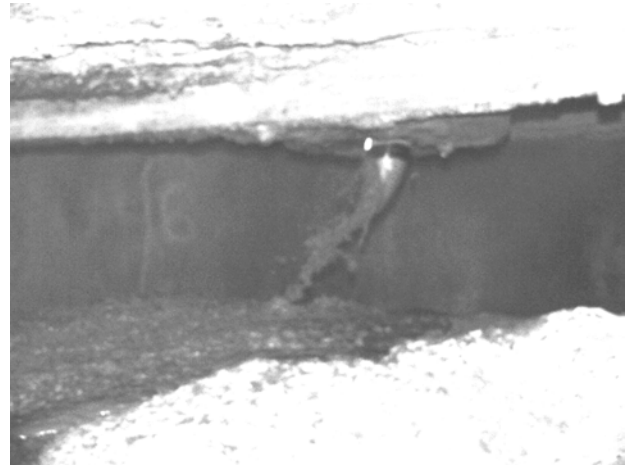
**Figure 7. Underground view of elbow placing bulk fill.**

Underground examination revealed that the mine opening had not been completely sealed, some of the material had flowed beyond the cross-cut and into the adjacent mine areas. The area directly below the borehole and in the immediate vicinity of the elbow had been completely sealed to the mine roof. Several unsuccessful attempts were made to dislodge the plug in the elbow, but it was ultimately decided to terminate the construction of mine seal No. 1 and remove the elbow from the hole. In general before the elbow became plugged, significant progress had been made towards filling the mine opening. A subsequent meeting with Howard/GAI team revealed that additional design and demonstration work was

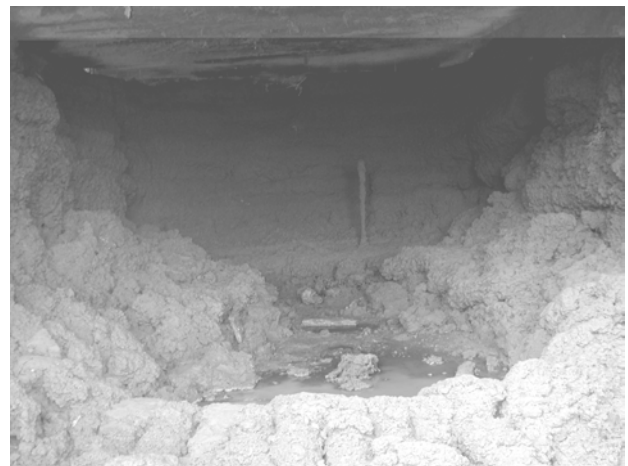
**Figure 8. View of fill placement at model mine.**

On October 8, 2002, a test of the spray nozzle was successfully conducted at the Howard model mine site. During the 13 yd<sup>3</sup> test, engineers were able to successfully spray and build-up material on the mine rib areas. The material was sprayed to an estimated thickness of 12 to 15 inches on the mine rib areas (up to the roof) with no build-up on the floor below the spray nozzle assembly (figure 8). This was a much different outcome as compared to that seen during previous tests and during the construction of mine seal No. 1. The successful outcome of this test was attributed to adjustments in the equipment used to control material feed and a significant improvement of the material mix by the GAI engineers.

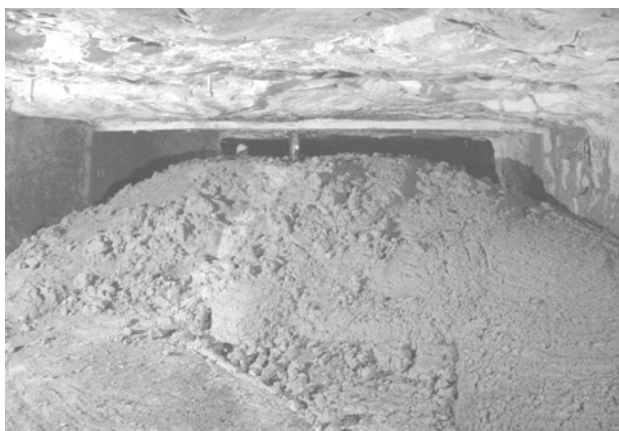
**Figure 9. View of bulk fill placement for seal No. 2.**

On October 8, 2003, the Howard/GAI team initiated the remote installation of mine seal No. 2 at LLL. Pumping of the first part of the remote seal (bulk material) began using a sand, fly ash and cement mixture. This material was pumped into the mine opening using the elbow. The bulk material was pumped in a series of lifts to fill the mine opening. Pumping was terminated after approximately 55 yd<sup>3</sup> of material had been placed into the cross-cut. It should be noted that communication with underground personnel was required to orient the elbow and complete the construction of the base. Underground examination revealed that the mine opening had not been completely sealed, however the seal material was placed to within 1.5 ft of the mine roof below the borehole and within 2.5 to 3 ft of the mine roof near the rib areas (figure 9). It was decided to remove an additional 6 inches of material below the bottom of the borehole to allow sufficient room to test the capability of the spray nozzle.

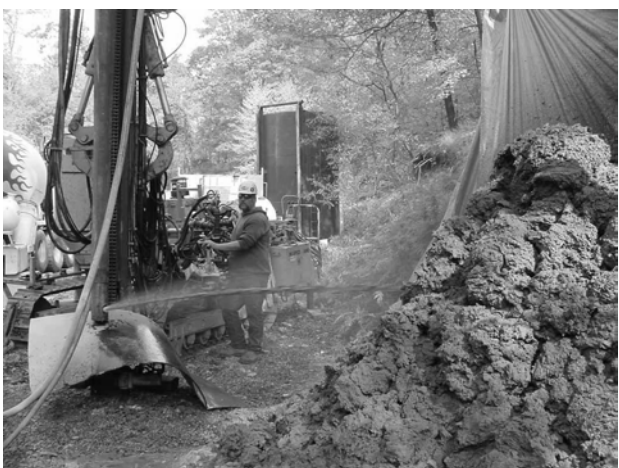
**Figure 10. Surface test of spray grout system.**

On October 14, 2003, a 10-yd<sup>3</sup> surface test of the final component of the seal mixture (flyash, cement and accelerators) was conducted at LLL (figure 10). The result of the test showed that the mixture would perform as required (little to no slump). A dual string of drill pipe and casing affixed with the spray nozzle was then placed into the 6-in diameter borehole in preparation for the second part of the seal construction.

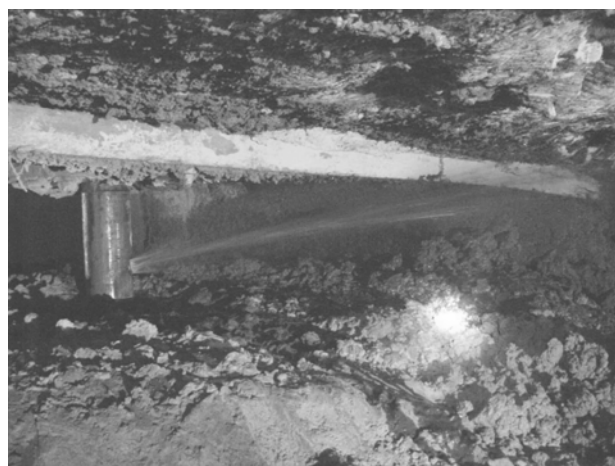
**Figure 11. Underground view of spray nozzle during seal No. 2 construction.**

On October 15, 2003, the second part of the mine seal was installed using the spray nozzle. The material was sprayed in a back-and-forth motion along the mine rib areas to fill in the gaps. Interaction between observers underground and engineers on the surface ensured that the nozzle was aimed in the proper direction. Good mine roof-and-rib contact was made with the sprayed material. The problematic corner areas at the mine roof-rib intersection were filled before the grout began to build up and migrate towards the spray nozzle (figure 11).

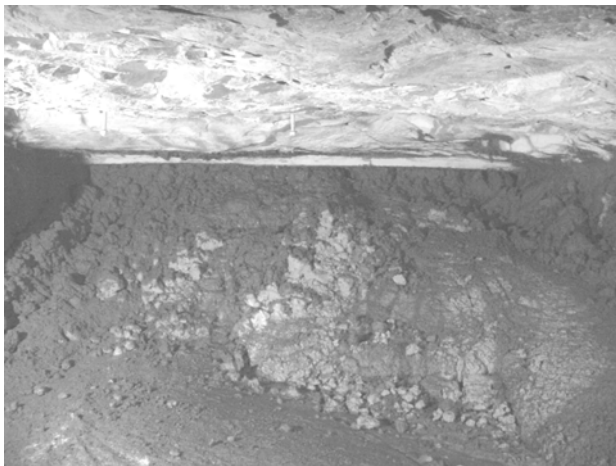
**Figure 12. Underground view of mine seal No. 2 from the B-Drift.**

Filling of the remaining area near the borehole was accomplished by lowering the spray nozzle into the wet material below the nozzle and then rotating the spray nozzle through a 360 degree arc. Eventually, the material built-up around the nozzle and closed the mine opening (figure 12). In all, a total of 22.5 yd<sup>3</sup> of sprayed material was used to close the mine opening. An underground examination showed that the mine seal material (both bulk and sprayed material) had flowed about 12 ft from the borehole towards the B-Drift and only about 9 ft from the borehole towards the C-Drift. The shape of the seal approximated a truncated pyramid whose base measured 19 ft wide (the width of the cross cut) by 21 ft deep and whose top measured 19 ft wide (the width of the cross cut) by 3-5 ft deep.
