Evaluation of deep-seated crib block fire tests

ABSTRACT: The National Institute for Occupational Safety and Health (NIOSH), in partnership with the Mine Safety and Health Administration (MSHA), is conducting research to test, evaluate, improve or modify coal mine fire-fighting strategies and methodologies through large-scale tests. Since wood is the second most abundant fuel available during a coal mine fire, it was decided that series of large-scale wood crib fire tests were needed to measure the products of combustion and to observe the capability of commonly available direct application fire suppression equipment, namely, fire extinguishers, water and gas-enhanced foam. This paper discusses the wood crib fire tests, provides insight into the products of combustion and describes observations made during the application of the fire suppression agents.

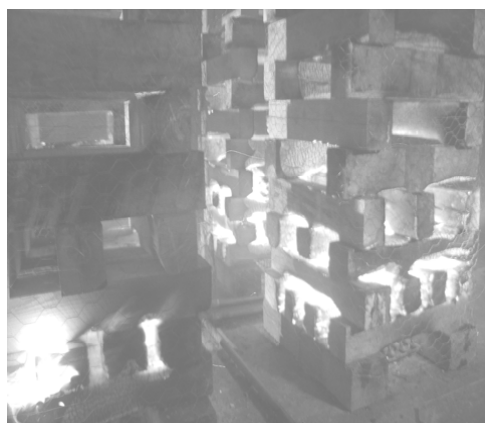
Figure 2. Control test - Burning crib block sets

During test No. 1, after the gas supply was turned off, it was observed that the back set of blocks were burning more intensely than the front set of blocks most likely because they were sheltered from the ventilation air flow by the front set of crib blocks. Although the fire grew vertically through each crib block set, the ventilation air currents caused the fire to burn more intensely towards the back side (downwind side) of each crib block set (figure 2). It was determined that this burning condition would most likely cause the crib sets to topple over rather than collapse vertically. The fire burned unremarkably until 94 minutes into the test when the rear left crib block set fell down. About 18 minutes later (112 minutes into the test) the rear right crib block set fell down. About 30 minutes later (142 minutes into the test) the front left crib block set fell down into the debris of the left rear crib block set and about 20 minutes later (162 minutes into the test) the front right crib block set fell down into the debris of the rear right crib block set. Each time a crib block set fell, the intensity of the fire increased for a short period of time.

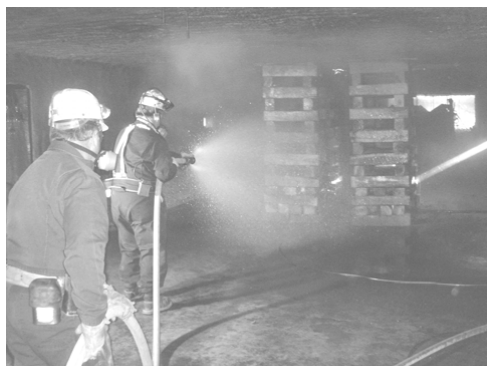
Figure 4. Use of fire hose during crib block fire test No. 3.

This test was designed to observe the effects of water application on a deep-seated crib set fire because water is the most commonly available fire suppression technology. Water is an effective suppression and extinguishing agent because it cools the wood surfaces and therefore reduces rate of pyrolysis. For this test, water was supplied from a fire truck to a fire hose that was equipped with an industrial plastic fog nozzle (the type that is typically available in a coal mine) that was adjusted to form stream flow. A total of 9,100 liters (2,400 gallons) of water was available from the truck for the test. Water was supplied through the fire hose to the nozzle at a rate of 284 l/min (75 gal/min) at 690 Kpascal (100 psi). The test was initiated in the same manner as the control tests. It was decided to apply the water extinguishing agent at about 76 minutes into the test because the fire had reached a steady-state burning rate.

The individuals selected to apply the water to the fire were NIOSH technicians who had previously served as coal miners and had training and experience in the use of a fire hose. The technicians were instructed to apply the water until they observed that the fire had been extinguished. For personal safety reasons, the technicians were also instructed not to progress past a line that had been drawn on the entry floor (perpendicular to the trend of the entry) about 18 in upwind from the leading edge of the crib block sets. This location was selected because it would keep the technicians out of the smoke and away from the heat of the fire. Water was applied to the fire for about 4 minutes when the technicians decided the fire had been extinguished and a total of 300 gallons of water was used (figure 4). Observations of the wood showed that the horizontal surfaces appeared to be wet and water was observed to be actively dripping from the vertical surfaces. About 4 minutes after the water application was completed, hot spots (glowing embers) were observed in the rear left and rear right crib block sets. At about 52 minutes after the water application was stopped, small flames were observed in the rear left crib block set. The embers and flames eventually self-extinguished and no other events were observed.

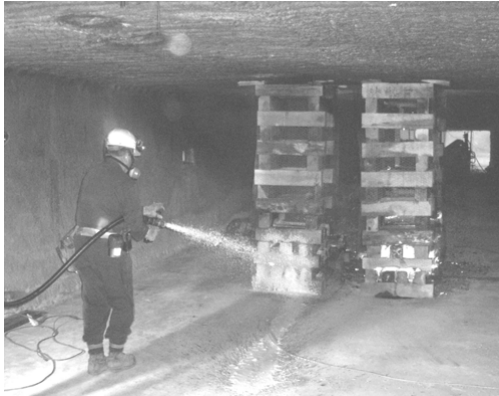
Figure 5. Use of gas-enhanced foam during crib block fire test No. 4.

Compressed air or nitrogen gas, when added to a mixture of foam concentrate and water, creates foam that can expand up to twenty times the original liquid volume. Foam addresses a fire condition through evaporation of contained water and through cooling by energy removal. The system used was a Sentinel 120RS unit supplied by USF Equipment and Services (a research partner in this test). The Sentinel 120RS is a self-contained fire fighting system that uses the patented Hellfighter® mixing chamber to create foam (USF, 2006). The system used was capable of producing 9,100 liters (2,400 gallons) of gas enhanced foam using a mixture of water, a small amount of Mine Fire Fighting Foam® (MFFF) concentrate and nitrogen gas. The system can discharge up to 1135 l/min (300 g/min) of gas-enhanced foam. Prior to the entry into the FSF, the NIOSH technicians were instructed on the proper use of the Sentinel unit and application of the foam product on the fire. As in the previous test, the technicians were instructed to apply the gas-enhanced foam until they observed that the fire had been extinguished.

The test was initiated in the same manner as the previous tests. Gas-enhanced foam application began 103 minutes into the test when the estimated heat release rate of the fire had generally stabilized (figure 5). About 1 minute later, the right rear crib block set fell down. Foam application continued for about 8 minutes when the technicians decided that the fire had been extinguished. A total of 9,100 liters (2,400 gallons) of gas-enhanced foam (the entire capacity of the system) was used. At about 40 minutes after the foam application had been completed, the foam had degraded to the point where it was no longer observed on the vertical surfaces and 120 minutes after the foam application was completed the foam was no longer observed on the horizontal surfaces (on the crib blocks or the simulated mine floor). From a fire perspective, at about 63 minutes after the foam application was completed, a small flame was observed in the lower portion of the front right crib block set and this flame continued to burn until the completion of monitoring for this test. A close inspection of this crib block set area indicated that it was sheltered from foam application and the flame was most likely a result of a glowing ember.

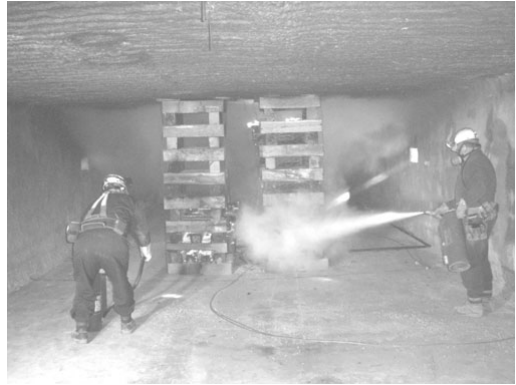
Figure 6. Use of fire extinguishers during crib block fire test No. 5.

This test was designed to observe the effects of using fire extinguishers on a deep-seated crib block fire. Fire extinguishers are rated according to the extinguishing agent's effectiveness in controlling one or more classes of fire. An ABC-rated fire extinguisher is capable of addressing A, B and C class fires (combustible solid materials, flammable liquids, and energized electrical equipment) and is commonly found in underground coal mines. ABC-rated fire extinguishers contain monoammonium phosphate and/or ammonium sulphate powder that leaves a non-flammable layer of material (which melts at a low temperature) and blocks gas and heat transfer at the fuel surface. For this test, four, 13.6-kg (30-lb) fire extinguishers were placed in the FSF upwind of the crib block sets. To ensure that the extinguishers were in proper working order, they were filled with ABC powder and were outfitted with new CO₂ cartridges the day before the test.

The fire test was initiated in the same manner as the previous tests. Use of the fire extinguishers on the fire began at 161 minutes into the test when the estimated heat release rate of the fire had generally stabilized (figure 6). The extinguishing work continued for about four minutes until all of the available material was applied. A total of about 45.4 kg (100 lbs) of ABC powder was used on the fire. The powder was observed on the horizontal surface and some of the vertical surfaces. At about 15 minutes after the application of the extinguishing agent was completed, small flames were observed in the debris from the left rear crib set and glowing embers were observed in the lower area of the front left crib set. The flames and embers continued to burn until the end of the test.
