Cleveland, Ohio
NOISE-CON 2003
2003 June 23-25

Estimated Sound Power Radiated by Surfaces on a Continuous Miner Tail Section Using Vibration Measurements

David S. Yantek
Associate Research Fellow
Health Branch
Hearing Loss Prevention Section
National Institute for Occupational Safety and Health (NIOSH)
626 Cochran's Mill Road
P.O. Box 18070
Pittsburgh, PA 15236
Phone: (412) 386 – 4498 Fax: (412) 386 – 4865
Email: dcy6@cdc.gov

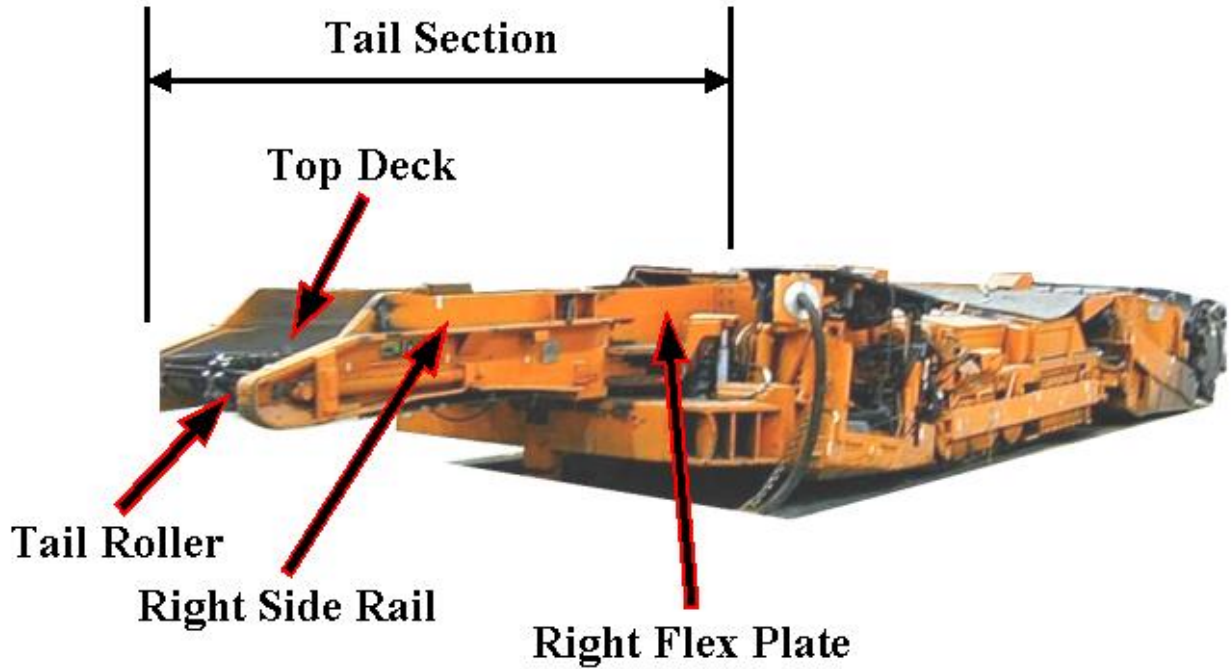
Figure 1. The continuous miner tail section.

Vibration measurements were used to estimate the A-weighted sound power radiated from the surfaces of the tail section of the continuous miner using acceleration measurements.⁴ The vibration data were measured following *ISO/TR 7849:1987 Acoustics – Estimation of airborne noise emitted by machinery using vibration measurement*. The major noise-radiating surfaces of the tail section that were examined include the left and right side rails, the left and right flex plates, the top conveyor deck, and the bottom conveyor deck (see Figure 1).

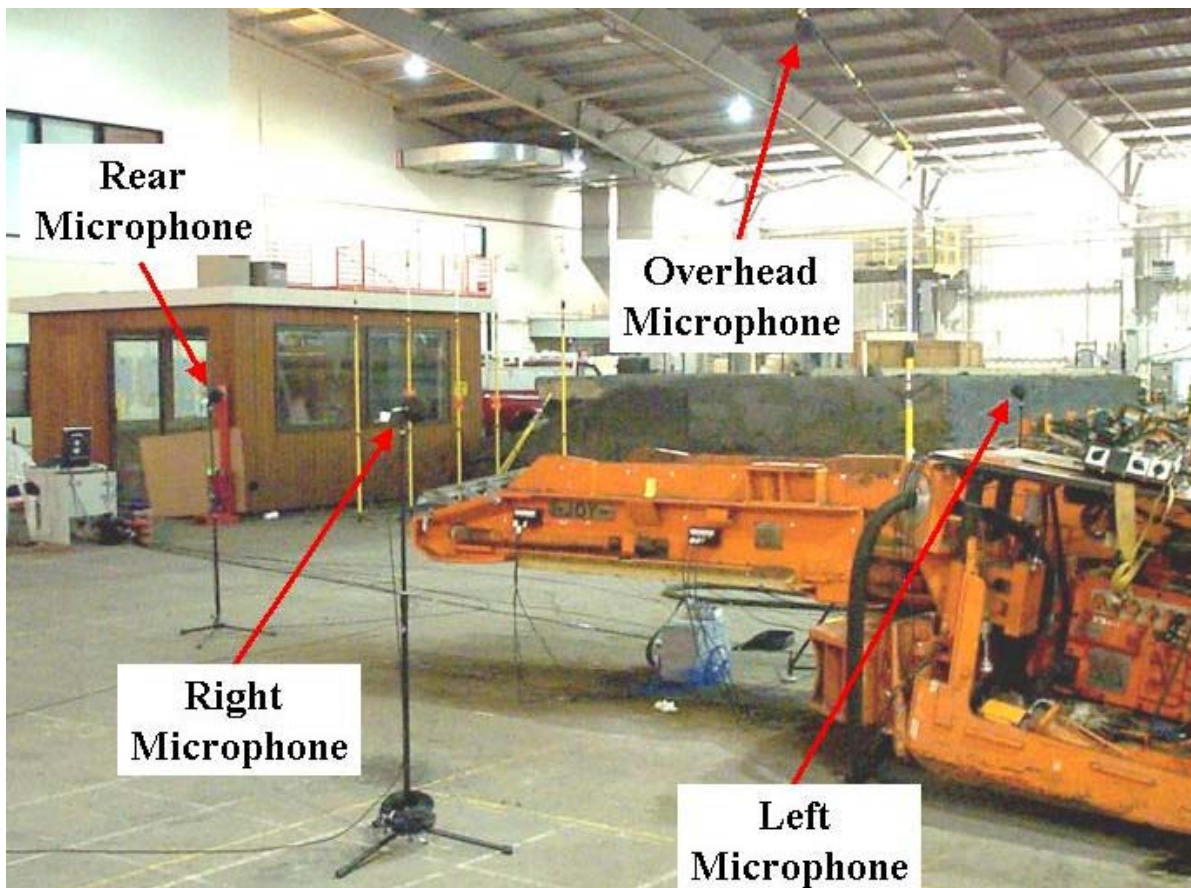
Figure 2. Microphone locations two meters from the reference box around the tail section of the continuous miner.

Four microphones were used to measure the sound pressure during testing (see Figure 2). One microphone was located two meters above a reference box encompassing the tail section and centered across the top deck. Three additional microphones were positioned at a height of 1.5 m and located two meters from the left, to the rear, and to the right of the reference box. The microphones to the left and right of the tail section were centered on the length of the reference box.

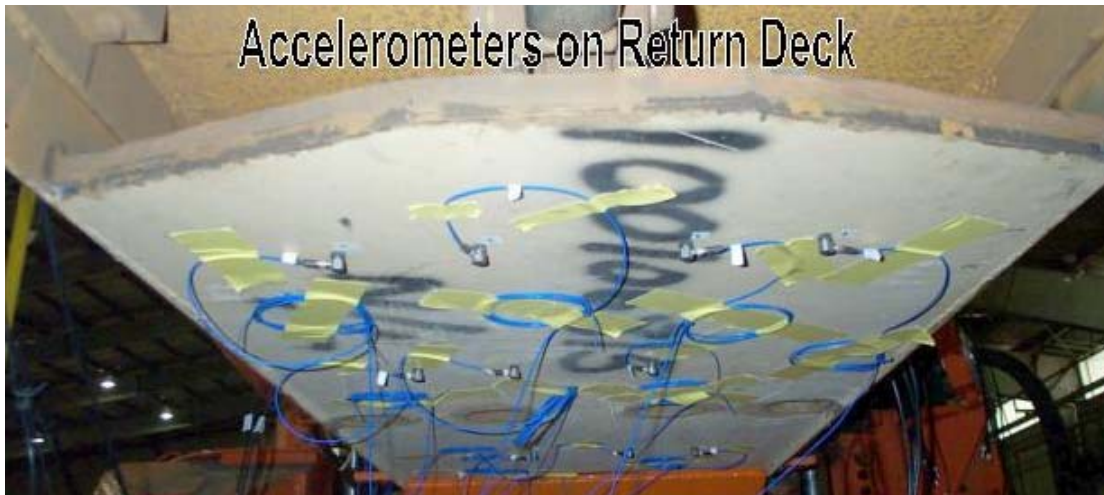
Figure 3. Accelerometer locations on the return deck of the continuous miner.

Using beeswax, ten to twelve accelerometers were mounted on the left and right side rails, left and right flex plates, and the return deck. Figures 3 and 4 show the accelerometer locations used on the return deck and left flex plate, respectively. For the top deck, accelerometers were embedded in the underside of the deck by drilling 6-mm diameter holes approximately 6 mm deep. Epoxy was then used to mount accelerometers into the holes. Shallow grooves were made in the underside of the top deck to run the cables to the outside of the machine (see Figure 5).

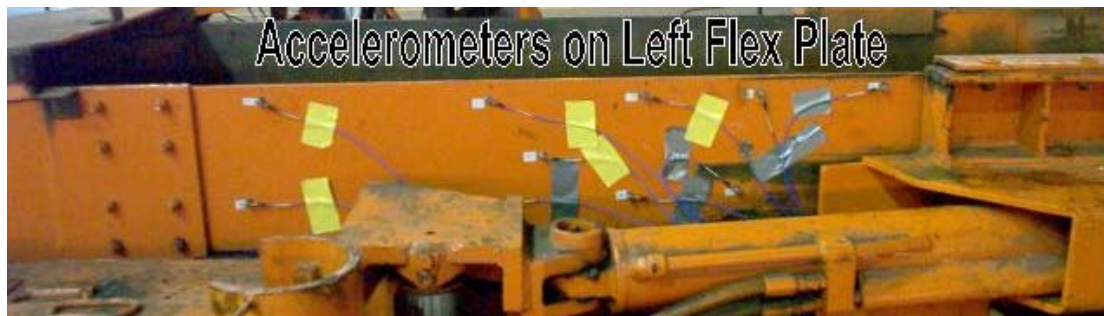
Figure 4. Accelerometer locations on the left flex plate of the continuous miner.

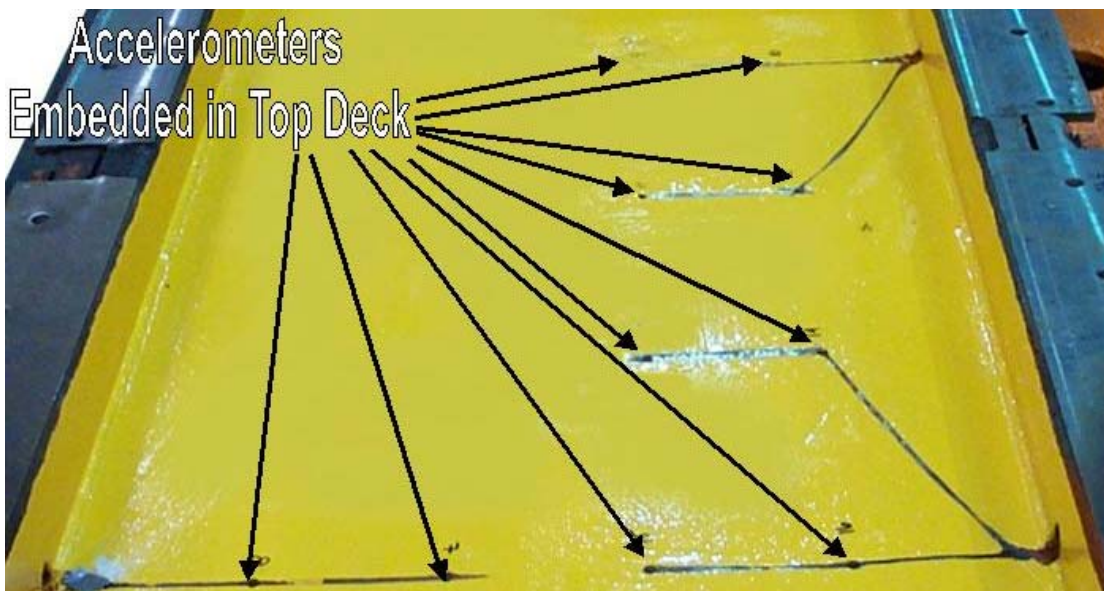
Figure 5. Accelerometers embedded in the underside of the continuous miner top deck.

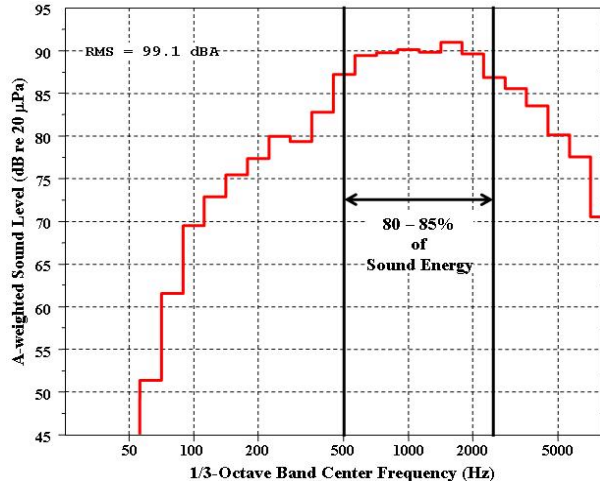
Figure 6. Average A-wtd 1/3-octave sound levels for the baseline continuous miner.

Baseline tests were conducted with no treatments applied to the machine and the data were processed according to the previously discussed procedures. The four-microphone average sound level for the baseline conditions is shown in 1/3-octave bands in Figure 6. The average A-weighted sound level for the baseline tests was found to be 99 dB. The baseline data show that the 500 – 2500 Hz 1/3-octave bands account for 80 – 85 % of the overall A-weighted sound level. Therefore, the estimated A-weighted sound power levels in the 500 – 2500 Hz 1/3-octave bands from each surface were examined. Figure 7 shows a bar plot of the estimated A-weighted sound power level attributed to each test surface in the 500 – 2500 Hz 1/3-octave bands. These data were calculated using equation 2. The sound power levels due to each surface may not be correct in an absolute sense due to the assumption that the radiation ratio is unity. However, the data can be used to assess the relative contribution of each surface. As the figure shows, the return deck is the most significant noise radiator for the baseline conditions followed by the left side board, the left flex plate, the right side board, the right flex plate, and the top deck. These findings indicate that the first attempt at controlling noise must focus on reducing the vibration of the return deck.

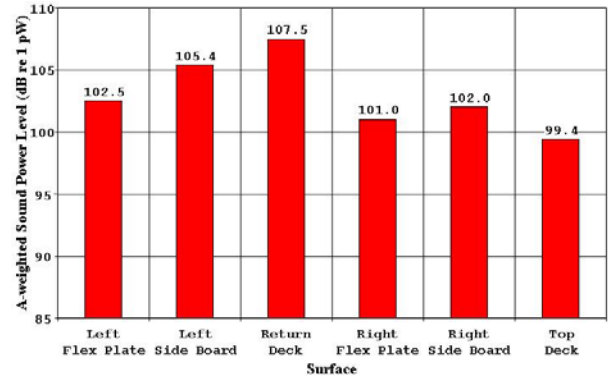
Figure 7. Estimated A-wtd sound power levels for each test surface in the 500 – 2500 Hz 1/3-octave bands for the baseline continuous miner.

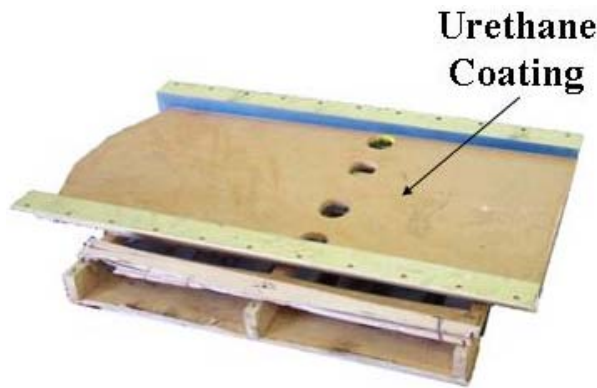
Figure 8. Coated return deck for the CM.

As the flight bars on the conveyor chain begin their return, the flights have been observed to impact the beginning of the return deck. This observation correlates with the high vibration levels and estimated sound power for the return deck under baseline conditions. To address this problem, a urethane coating was applied to the return deck (see Figure 8) to decrease the energy transmitted to the return deck by the flight bar impacts. Figure 9 shows the estimated A-weighted sound power levels in the 500 Hz – 2500 Hz 1/3-octave bands for each test surface with the

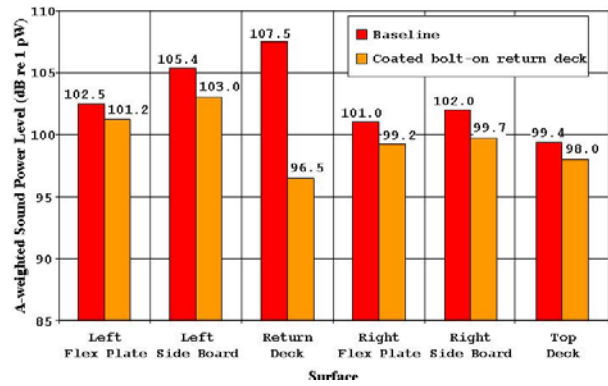
Figure 9. Estimated A-wtd sound power levels for each test surface in the 500 – 2500 Hz 1/3-octave bands for baseline versus coated return deck.

coated return deck compared to the baseline tests. The figure shows that the sound power level from the return deck dropped by 11 dB with the coated return deck. Reductions of 1 to 2 dB occurred on the other test surfaces. With the coated return deck, the figure shows that the most significant noise radiators are the left side board and left flex plate followed by the right side board and right flex plate. The return deck is shown to be the least significant noise radiator. The average overall A-weighted sound level dropped to 97 dB, a 2-dB reduction from the baseline sound level. The results show that the coated return deck is effective at both reducing the average sound level and the return deck radiated sound power. However, the significantly lower sound power level reductions on the other test surfaces indicate that other sources of excitation may be controlling the A-weighted sound level.

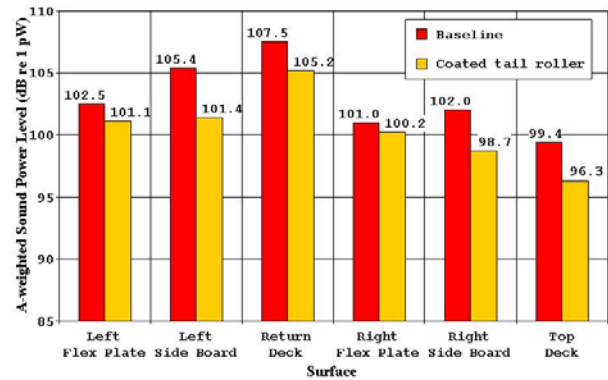
Figure 11. Estimated A-wtd sound power levels for each test surface in the 500 – 2500 Hz 1/3-octave bands for baseline versus coated tail roller.

The flight bars also impact the steel tail roller transmitting energy into the tail section via the tail roller guides, slide plate, and tension springs along the tail section. A urethane-coated tail roller (see Figure 10) was developed to reduce the forces transmitted by these paths. Figure 11 shows the estimated radiated sound power level in the 500 – 2500 Hz 1/3-octave bands for each test surface with the coated tail roller compared to the levels for the baseline test case. The figure shows that the reductions in radiated sound power for individual surfaces ranged from 1 to 4 dB. The most significant reduction occurred for the left side board followed by the right side board, the top deck, and the return deck. The reductions in the sound power levels for the left and right flex plates were determined to be 1 dB. With the coated tail roller, the dominant noise-radiating surface is the return deck followed by the left side board, the left flex plate, the right flex plate, the right side board, and the top deck. The data show that coating the tail roller results in higher reductions of overall radiated sound power compared to the coated return deck. However, the coated return deck reduced the most dominant source better than the coated tail roller. The average overall A-weighted sound level was reduced from 99 dB for the baseline test case to 97 dB with the coated tail roller.

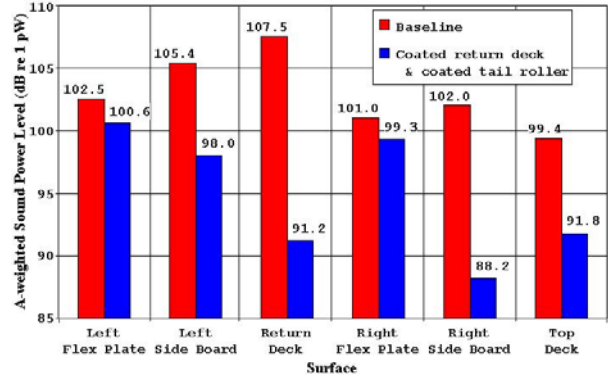
Figure 13. Estimated A-wtd sound power levels for each test surface in the 500 – 2500 Hz 1/3-octave bands for baseline versus coated return deck plus coated tail roller.

Since both the coated return deck and coated tail roller reduced the estimated radiated sound power levels and the average overall A-weighted sound level, tests were performed with both treatments in place (see Figure 12). Figure 13 shows a comparison of the estimated sound power levels in the 500 – 2500 Hz 1/3-octave bands with the coated return deck and coated tail roller compared to the levels for the baseline continuous miner. The sound power level attributable to the return deck, the most significant source for the baseline machine, was reduced by 16 dB. Reductions in sound power level for the left side board, top deck, and right side board were 7, 8, and 14 dB, respectively. The sound power level from the left and right flex plates remained relatively unchanged with reductions of 2 dB. The average overall A-weighted sound level dropped from 99 dB for the baseline test case to 95 dB with the coated return deck and coated tail roller. With these treatments, the data show that the left and right flex plates are the dominant noise-radiating surfaces followed by the left side board. The test data indicate that treatments that reduce the flex plate vibrations, such as constrained layer damping, will be effective in reducing the noise levels around the tail section when combined with the coated return deck and coated tail roller.

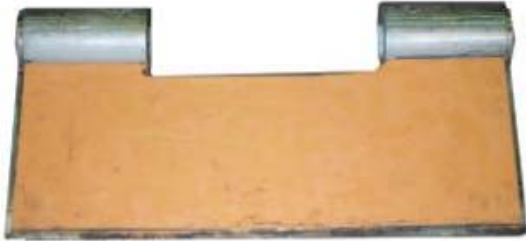
Figure 14. Coated slide plate for the continuous miner.

Since the slide plate is an element that transfers the tail roller-chain impact energy into the tail section, a coated slide plate (see Figure 14) was fabricated. The coated slide plate was installed and the coated return deck and coated tail roller were replaced with the non-coated components. Figure 15 shows the estimated sound power level for each test surface in the 500 – 2500 Hz 1/3-octave bands with the coated slide plate compared to the baseline test case. The figure shows that the return deck was the most significant noise-radiating surface followed by the left side board and left flex plate. Reductions in sound power levels were less than 1 dB for the left side board and 1dB for the return deck. The sound power level from the left flex plate increased by 2 dB. This increase is thought to be a result of the chain being moved towards the left side of the conveyor during installation of the coated slide plate. This would cause the flights to transmit more energy into the left flex plate. The small change in sound power levels from the other surfaces shows that the slide plate by itself is not effective at making a significant impact on the vibration levels. The average overall A-weighted sound level remained 99 dB.

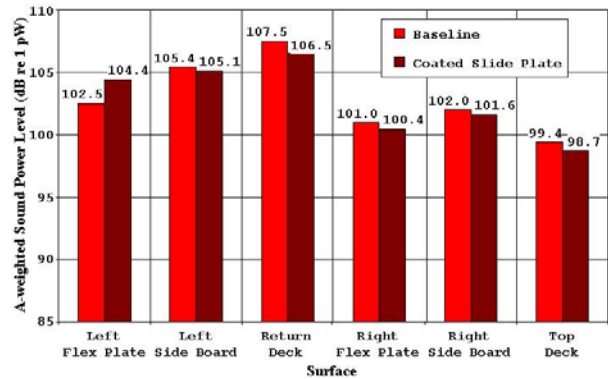
Figure 15. Estimated A-wtd sound power levels for each test surface in the 500 – 2500 Hz 1/3-octave bands for baseline versus coated slide plate.

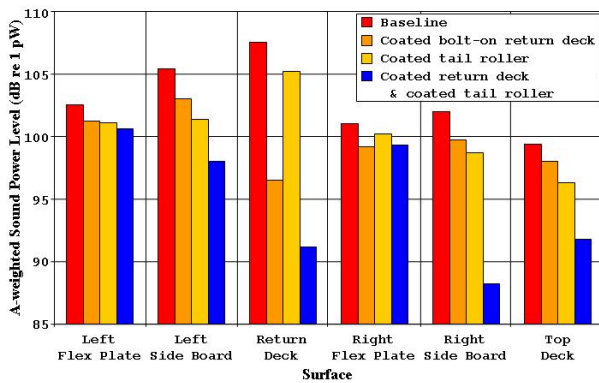
Figure 16. Estimated A-wtd sound power levels for each test surface in the 500 – 2500 Hz 1/3-octave bands for baseline versus effective noise controls.

Figure 16 shows a comparison of the estimated radiated sound power for each surface in the 500 – 2500 Hz 1/3-octave bands in relation to each test case that showed significant reductions in the estimated radiated sound power. The average overall A-weighted 1/3-octave spectra for each test are plotted on Figure 17. Figure 17 shows that the coated slide plate had little effect on any of the 1/3-octave band sound levels. Individually, however, both the coated return deck and coated tail roller were effective at reducing the sound levels in the dominant frequency band. The data show that the coated tail roller is more effective than the coated return deck in reducing noise above 2500 Hz. Although the higher frequencies are currently insignificant, these reductions may play a more important role if other controls can reduce the noise levels in the 500 – 2500 Hz 1/3-octave band.
