# Ground Control Issues for Safety Professionals

**Christopher Mark, Ph.D.**

*National Institute for Occupational Safety and Health (NIOSH), Pittsburgh, Pennsylvania*

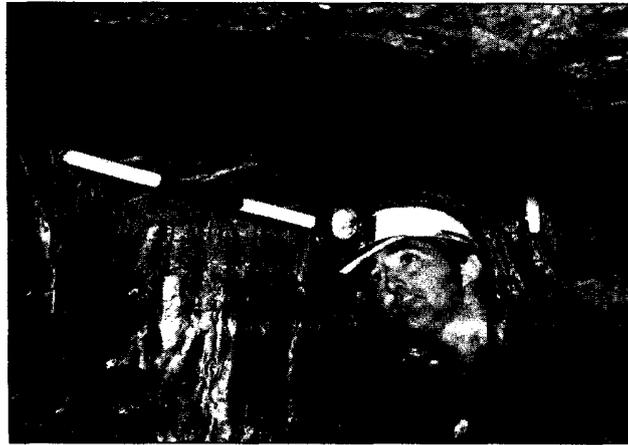
FIGURE 23.1 Large kettle bottom in an underground coal mine (photo by F. Chase)

- *Fossil remains* are the remnants of plants and animals that lived during the time when the sediments that later became rocks were being deposited. For example, kettlebottoms are fossil trees that grew in ancient peat swamps (Figure 23.1). They occur in every U.S. coal basin, but are especially abundant in southern West Virginia and eastern Kentucky. Dinosaur footprints are another fossil remain found in the roof rocks of coal mines in Utah, Wyoming, and Colorado. Fossil remains can fall without warning and should always be carefully supported (Chase 1992). Roof boltholes should never be drilled directly in fossil remains, because the vibrations could cause them to be dislodged.

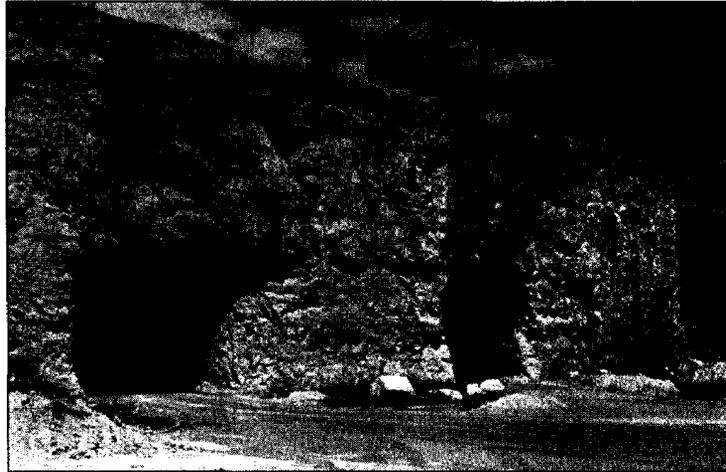
**FIGURE 23.11** Smooth roof line produced by a persistent bedding plane lamination within the roof rock beam

A stable roof beam is generally massive, strong, thick, and persistent. Additionally, a persistent, smooth roof profile at the bottom of the stable roof beam is very helpful in creating a stable roof. Natural laminations, bedding planes, or interfaces between rock layers often providing the best roof lines (Figure 23.11). Too many bedding planes or rock layer interfaces can allow the roof to separate with time into many thin layers that are inherently unstable. Thicker roof beams sag less than thinner beams and therefore are less likely to fail (Figure 23.12). A meter or more of competent rock has been observed to form a stable beam in rooms up to 15 m (50 ft) wide.
