BOREHOLE LOCATION SYSTEM CONCEPT
DEMONSTRATION TESTS

FINAL REPORT

Contract No. J0177074
DEMONSTRATION OF A BOREHOLE LOCATION SYSTEM

May 5, 1978

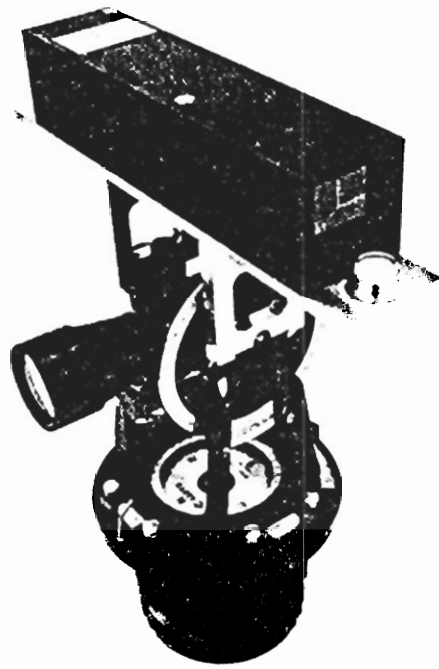
FIGURE 4
MAGNETOMETER/TRANSIT SETUP
